## Aftersales Bulletin – Action Required

Area **Service Information**  
Subject S 12 2015 02 On Board Owner's Manual missing after programming  
Group 61  
Reference S 12 2015 02 - 61 12 15  
Published date 10 December 2015  
Version 1  
Department Service Operations/TS  
Recipients All Service Managers, Aftersales Managers and Service Technicians of Rolls-Royce Motor Cars Dealers

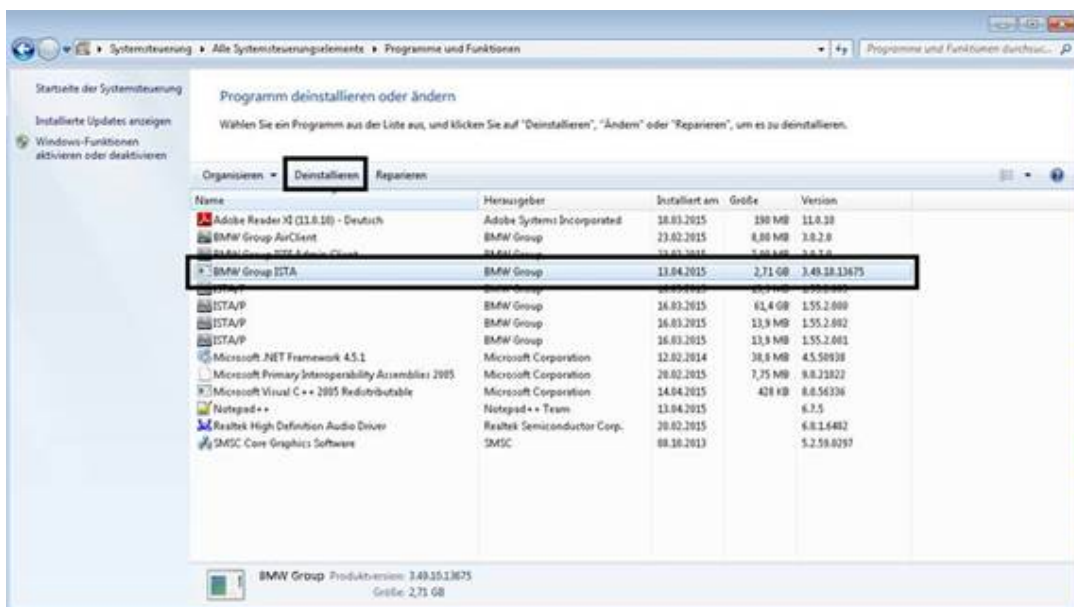
1. Uninstall ISTA/P from the device
  - a. Go to programs and features
  - b. Select ISTA/P – Note: **DO NOT** uninstall BMW Group ISTA!
  - c. Select De-installation

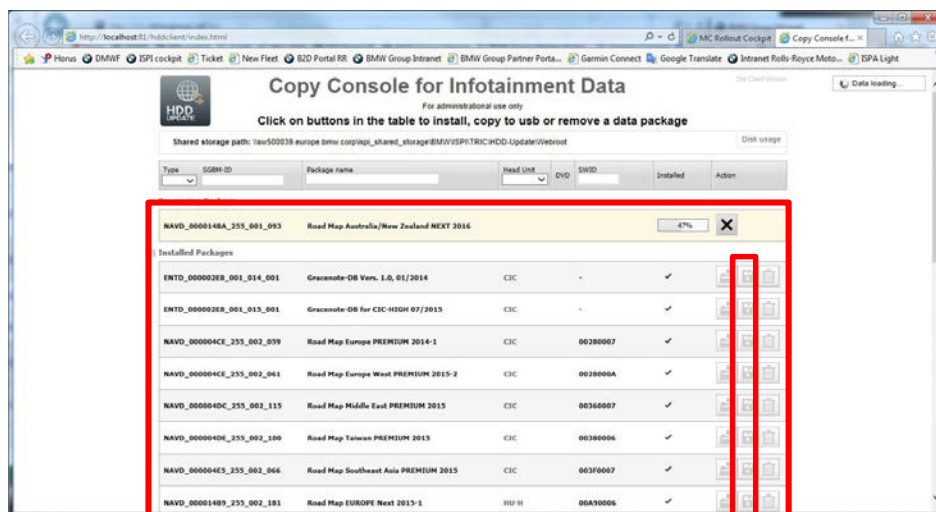
#### 2. Select the desired map for the list of installed packages and click the transfer to USB button

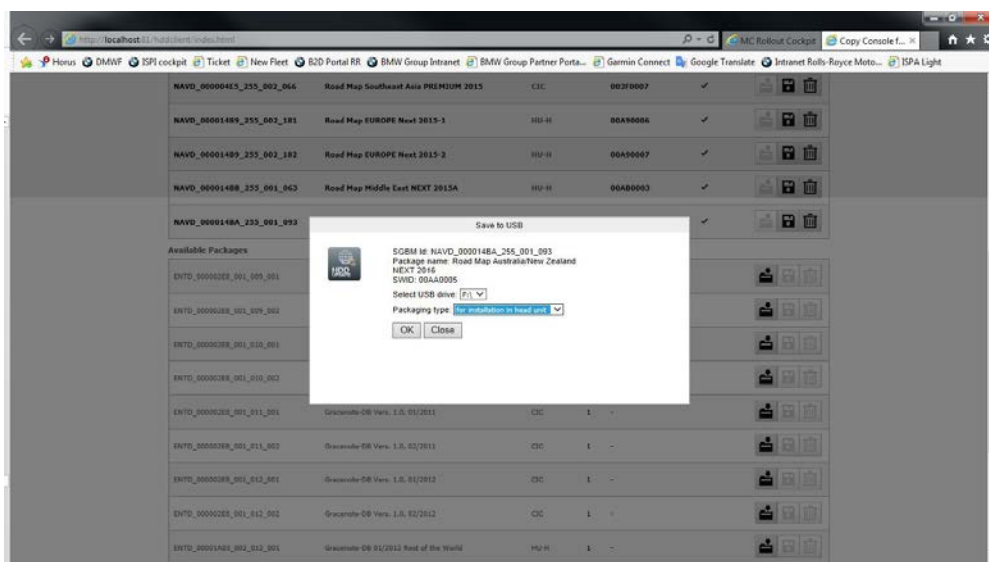
#### 3. Select the USB drive from the drop down menu, and select "for installation in head unit"

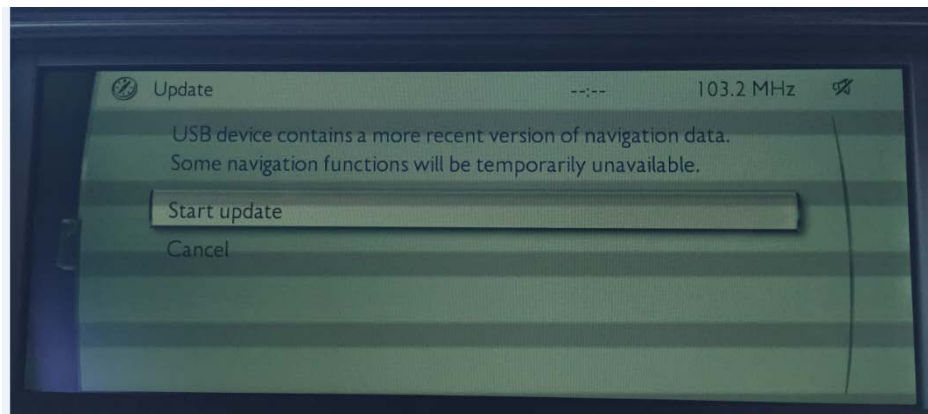
4. Insert the USB stick into the vehicle, the USB socket is located in the centre console. Select start update when prompted:

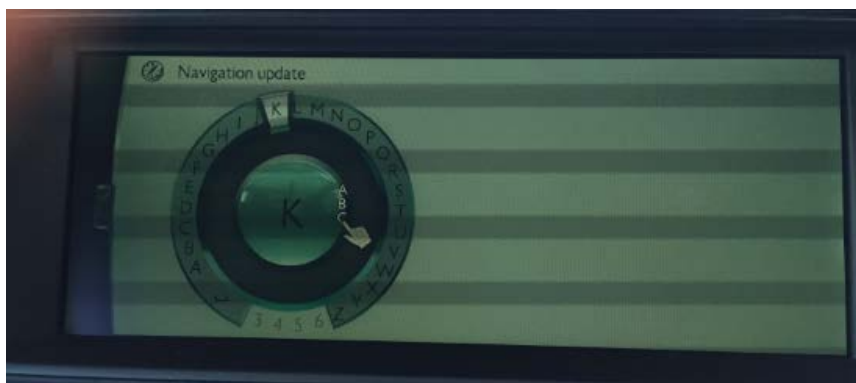
5. Enter the release code using the controller, this will then start the map update process:
