SERVICE CAMPAIGN BULLETIN

TITLE: McLaren P1™ Vehicle Software Update to Platform 8.0

CAMPAIGN REFERENCE 03F

DOCUMENT NUMBER: 12 M 002

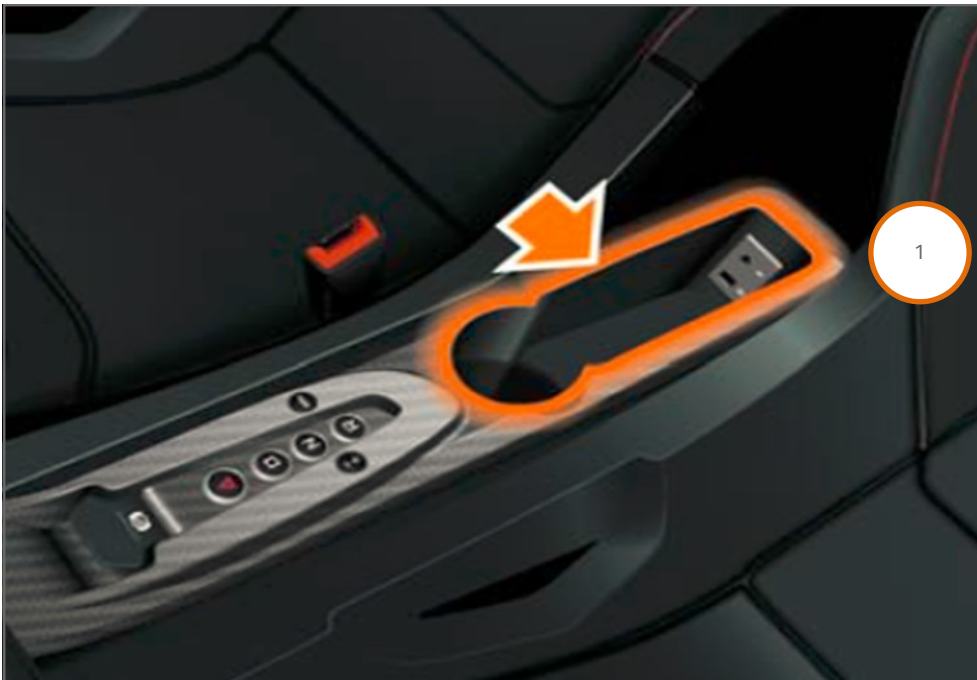
Care Point: During the update the key must be positioned at the rear cup holder/stowage area (1).

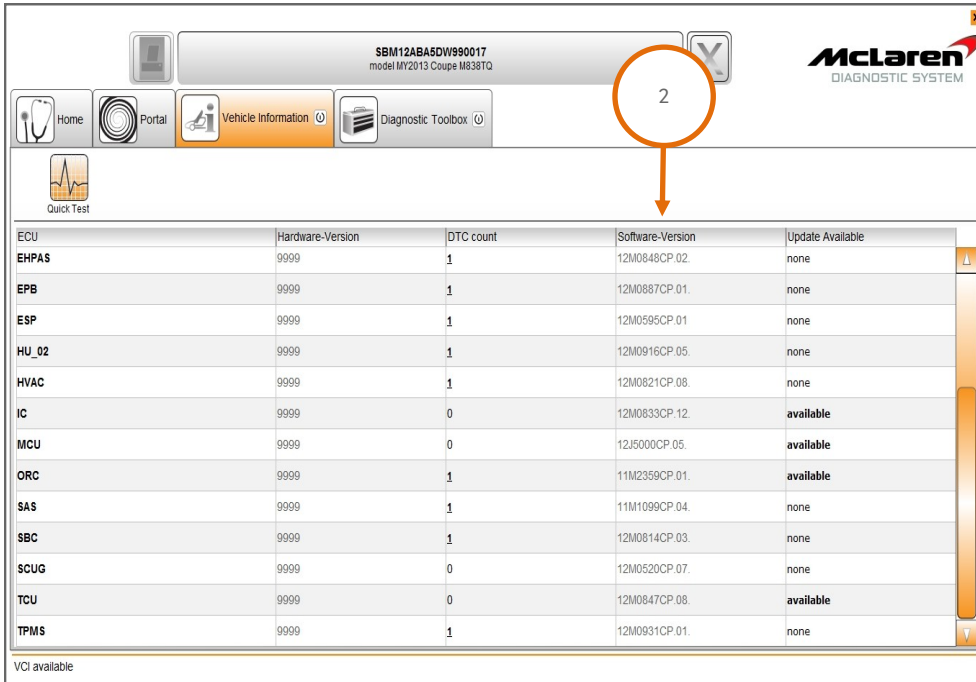
Care Point: The IC, TCU, CCU, ECM, BMS, MCU and ORC will display software update is still available after they have been reprogrammed, this should be ignored. Check that the Software-Version (2) matches the table at page 1 to confirm the modules are at the latest level.

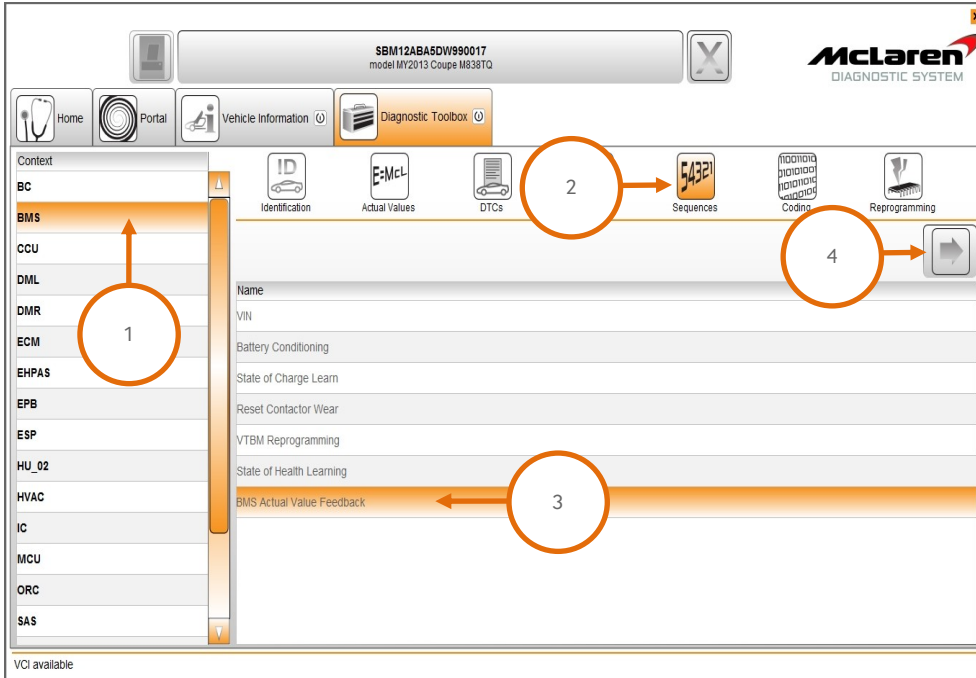
1. Connect the McLaren Diagnostic System (MDS) to the vehicle.
2. Select BMS (1), then select Sequences (2) and then select BMS Actual Value Feedback (3) followed by the arrow button (4).

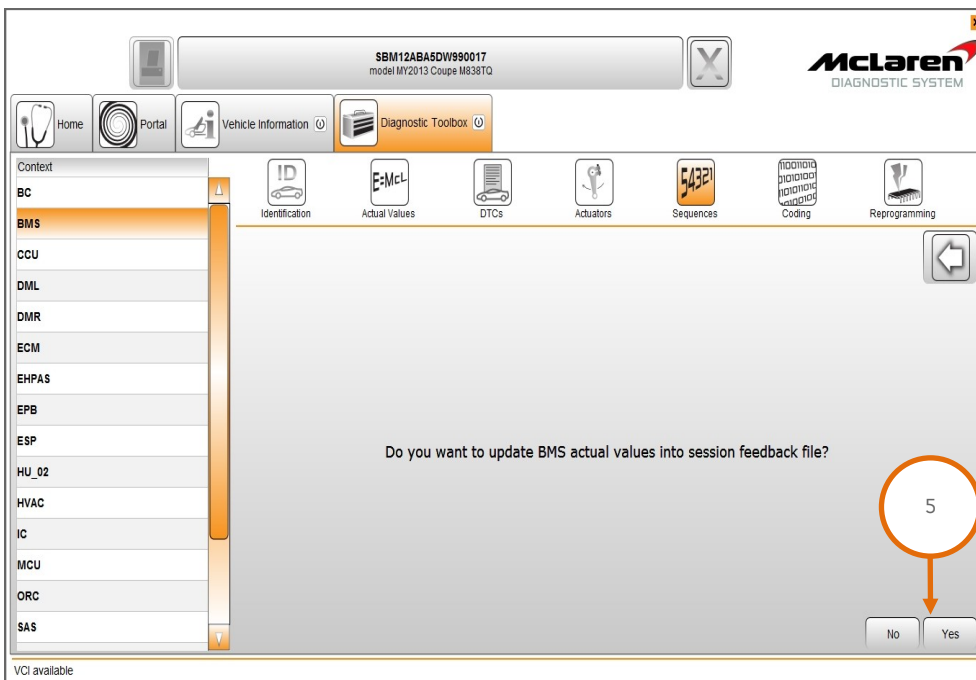
3. Press YES (5) for the MDS to store the BMS Actual values.

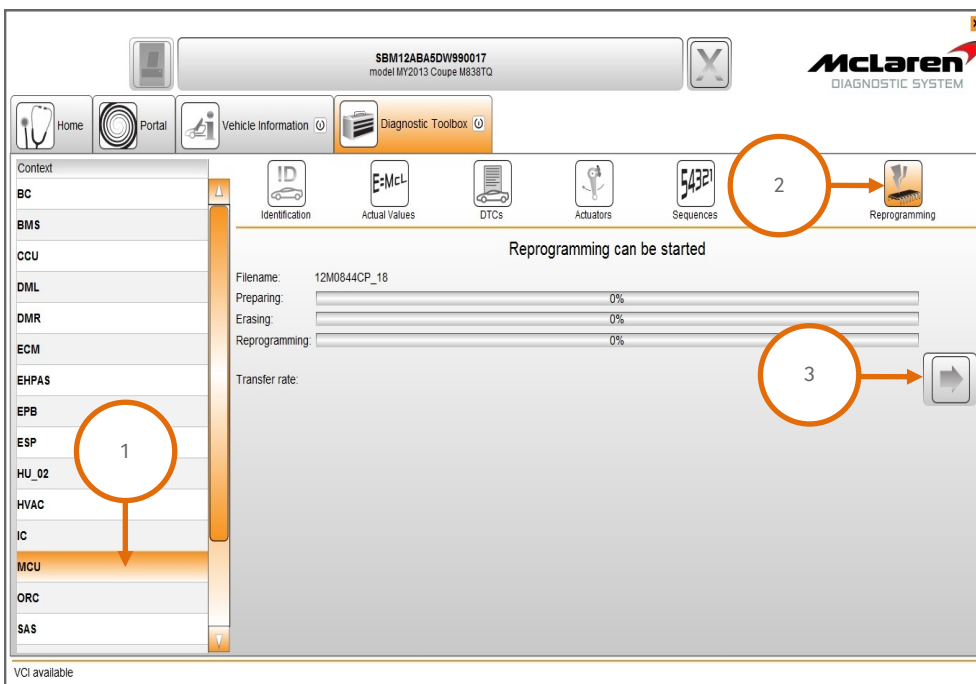
13. Select MCU (1), then Reprogramming (2) followed by the arrow button (3). Select YES to initiate programming.
