| L624-A.10.15 | <b>To:</b> Official After Sales Network<br><b>Subject:</b> Software Update Of Headlight Alignment Adjustment Control Unit (AFS)<br><b>Date:</b> 02/20/2015<br><b>Pages:</b> 16 | |

Software update of headlight alignment adjustment control unit (AFS).

All Lamborghini Huracán 2015 From VIN FLA00163 to FLA02206

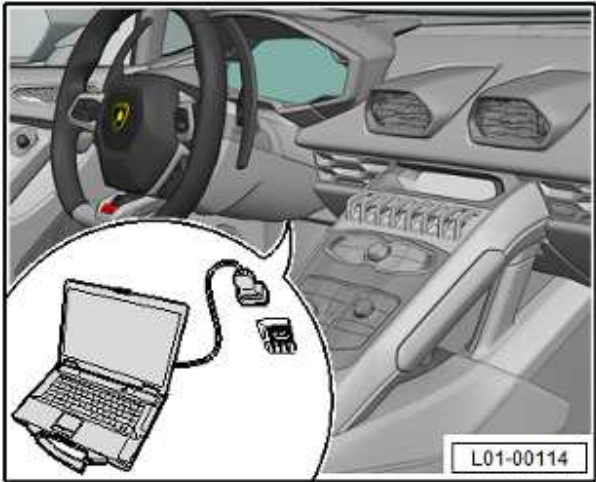
3. Please connect the VAS5054 interface to the vehicle's OBD plug and to the diagnostic laptop.
- Turn the ignition ON

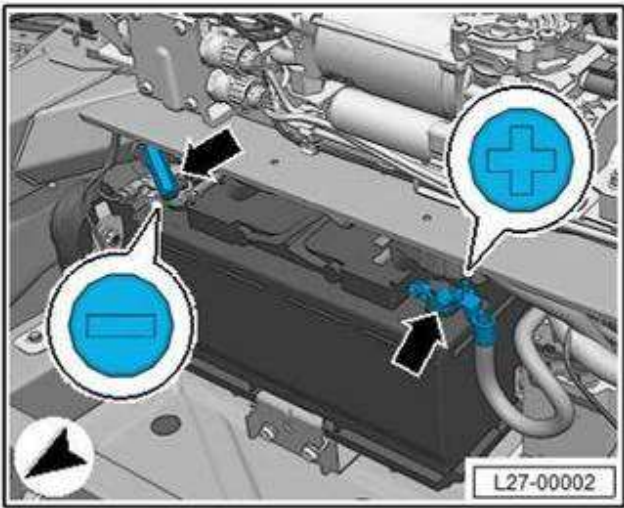
2. Please connect a battery charger to the recharge points available in the front luggage compartment, as shown in picture.

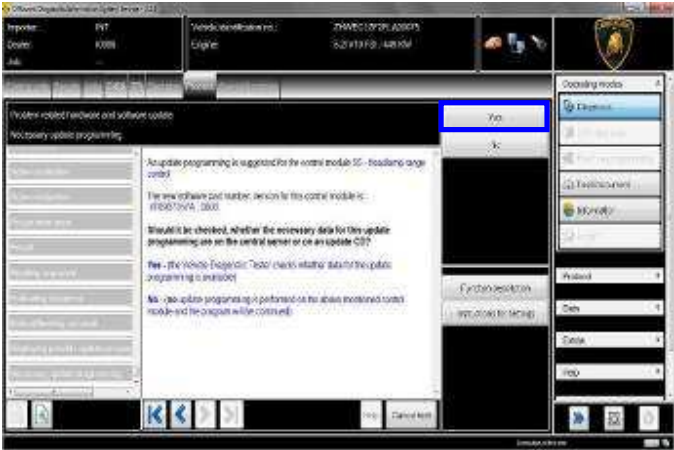
### 18. AFS System Software Update

The example in the figure below refer to software part number and version of the Headlight regulation AFS control unit Software.

**4T0907357A; 0003**

Click “Yes” to check the availability of the updated software on Your Mirrorserver.

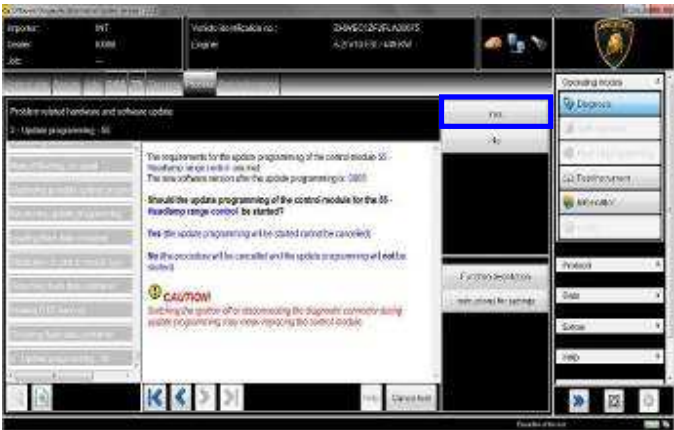
19. Verify the new software data on the AFS system ecu and click “Yes” to update.

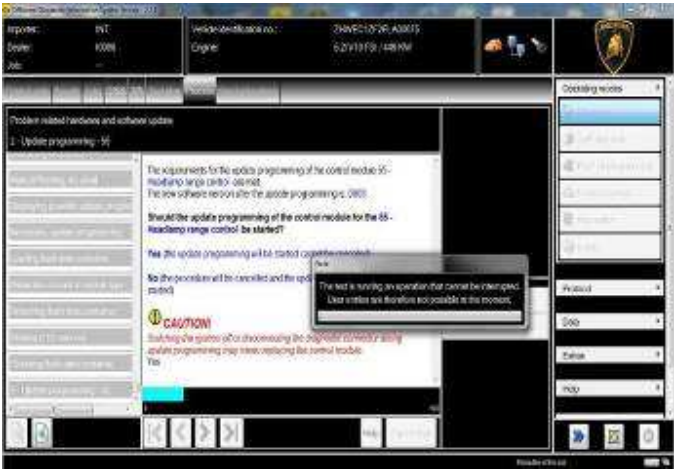
20. Wait until the update programming of the Headlight regulation AFS system ECU is completed.

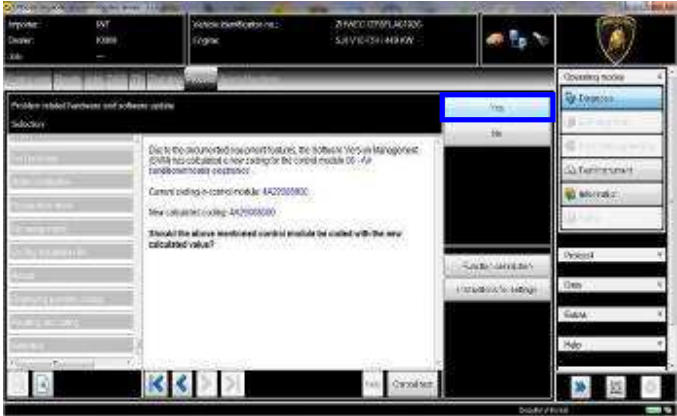
29. New coding has been calculated on the 55 – Headlight Regulation AFS system and must be written in the control unit.  
Click “Yes”.

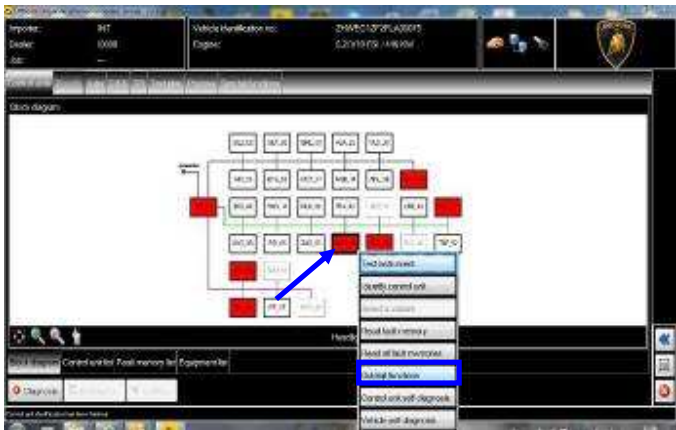
41. Basic Settings ECU 55 – AFS System

Select 55 – Guided Functions to enter in AFS Guided Functions.

To remove the error present on the Headlight Regulation control unit, the AFS Basic Setting has to be performed.

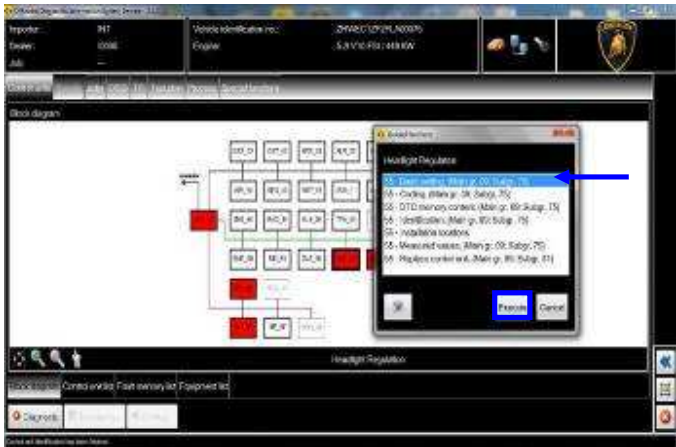
42. Select 55 – Basic setting to execute the AFS basic setting.

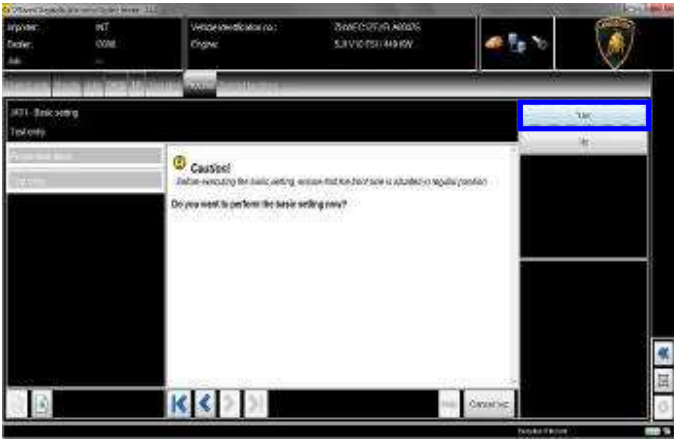
Make sure the Lifting System (is present on the car) is in regular – down position.

45. Click “Done/Continue” to perform a memory DTC reading on AFS ECU.

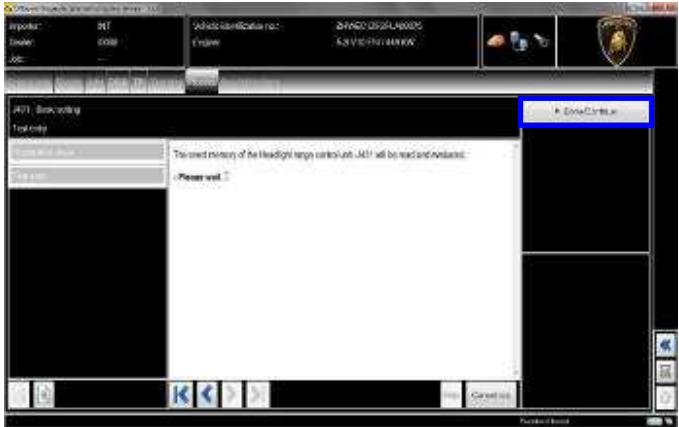
46. Basic setting in progress: adjust now manually the headlight regulation following the Workshop Manual indications, only if needed.

The AFS software update doesn’t change the headlight regulation, therefore no manual operation is needed in this step.

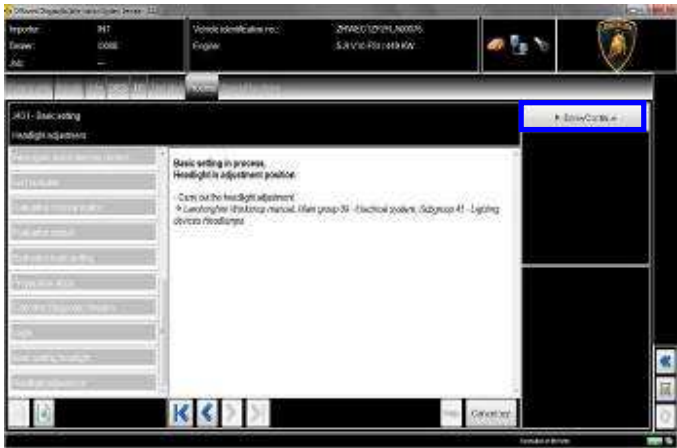
Click “Done/Continue”.

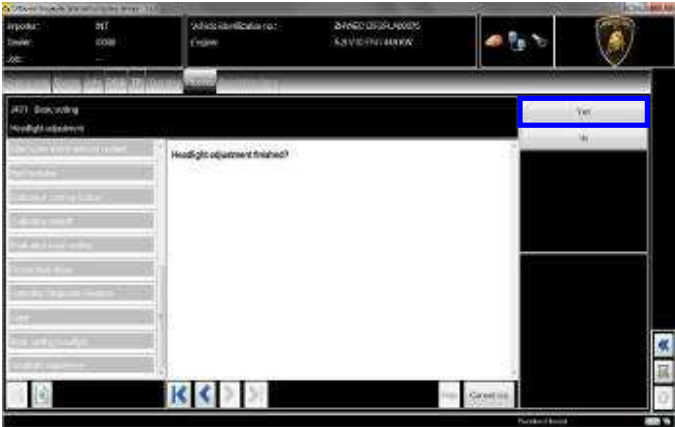
47. Click “Yes”

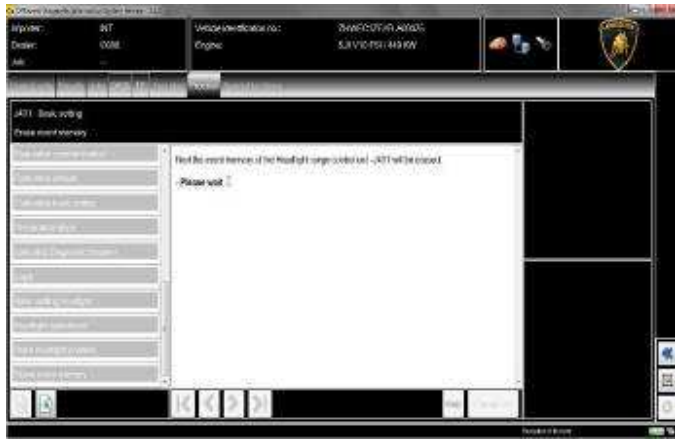
48. Wait the erase of all errors in AFS control unit.

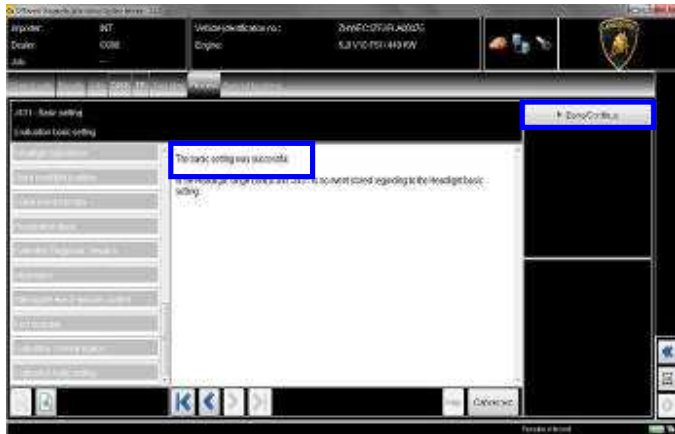
49. Click “Done/Continue” to end the basic setting.

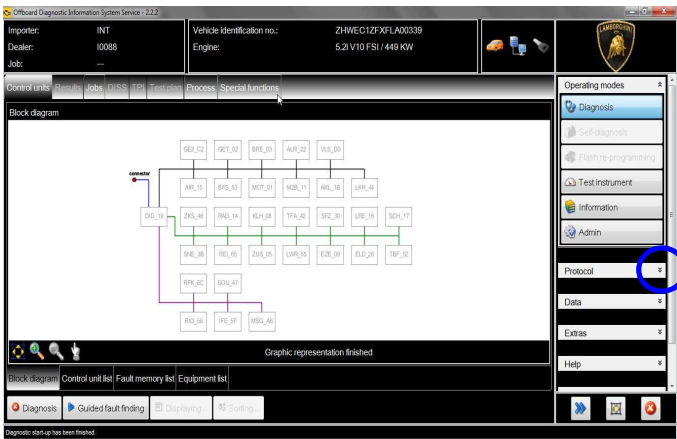
1. At the end of previous steps, expand the menu ‘**Protocol**’ on the right side (menu bar).

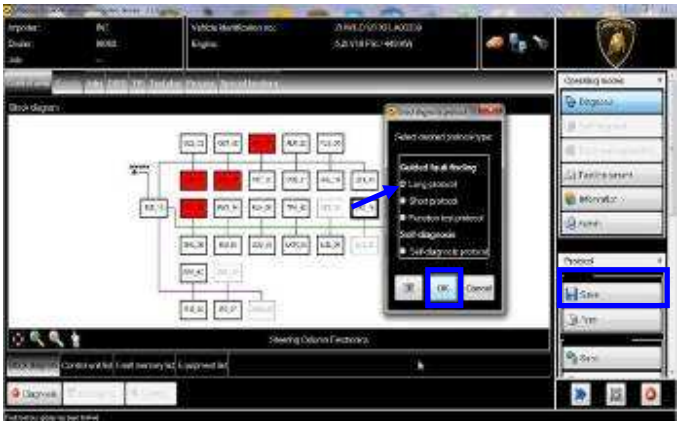
2. Click “Save” in the subgroup of buttons “General”.

In the diagnosis protocol window under GFF select:

- **Long protocol.**

By clicking on it. Then click “OK”.

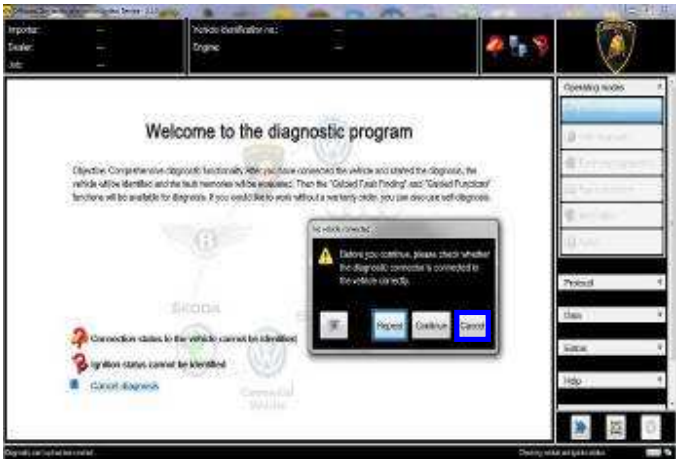
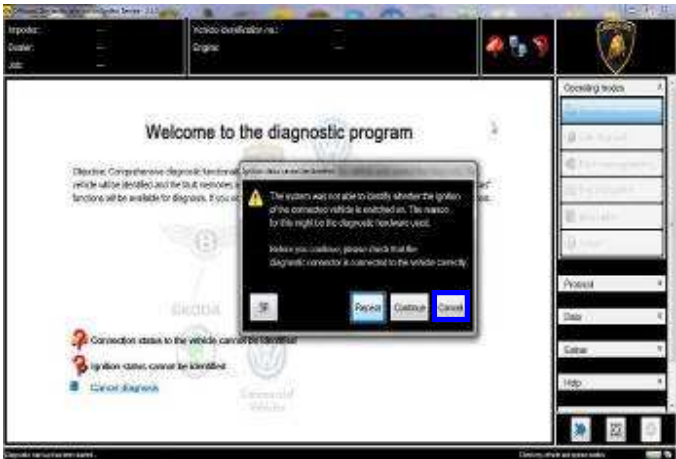
- A. If the error message regarding the VAS5054 interface and the 2 icons for status of on board connection and key on are shown as in the picture below:
- Click “Cancel”;
  - Repeat the VAS5054 HW interface installation following the procedure (\*) “VCI Manager v2.0”, by entering in the menu “Extras” on the right side and clicking on “Diagnostic interface”.

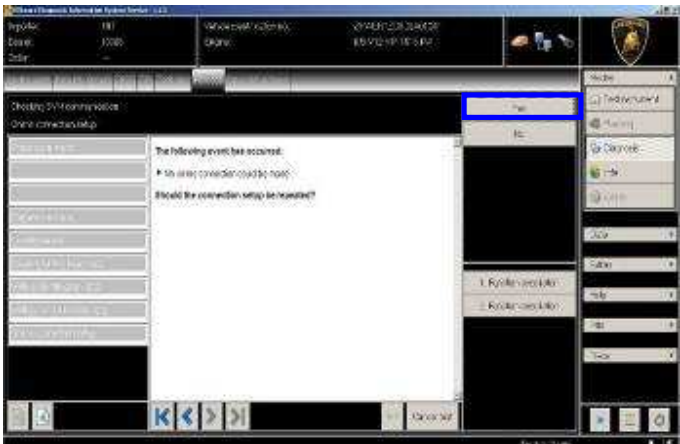
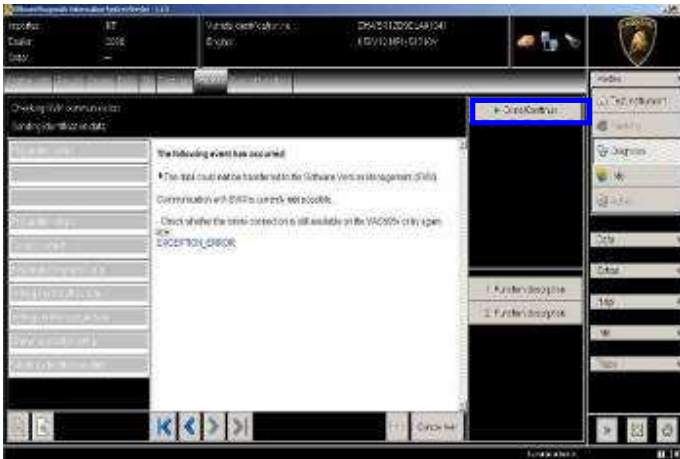
- B. If one of the connection errors screens is shown as in the pictures below:

- it is not possible to establish a connection with the central server. Please check carefully that the diagnosis laptop is properly connected to the internet network and retry clicking “Yes” or “Done/Continue”.

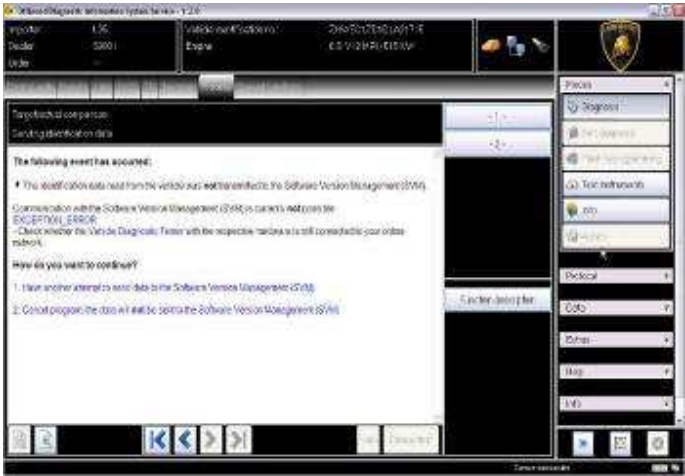
- C. If the loss of connection happens during the target/actual comparison.

- It is not possible to connect to central server, check the working connection of internet and retry by clicking “1”.

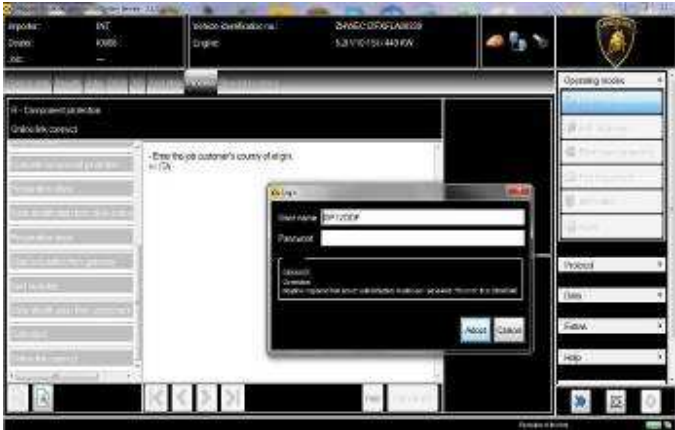
**D.** If the incorrect identification message is shown as in the picture below (error code: ODS1007E):

- be sure that your Geko account is valid;
- be sure that the label “Geko” is written on the token that you are using for the authentication;
- be sure the Password inserted is correct;
- click on Cancel and perform the application test (see document “ODIS\_Checking\_ConnectionServer\_SVM\_2.0” (\*)).

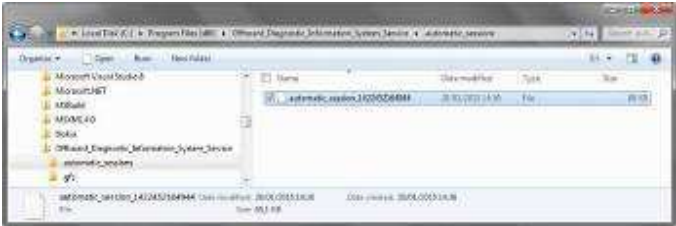
- quit ODIS;
- Enter the folder C:\Program Files (x86)\Offboard\_Diagnostic\_Information\_System\_Service\automatic\_sessions on your diagnosis laptop

- delete the only file present in that folder
- re-Start ODIS Service under following conditions:
  1. Network connection available;
  2. ODIS connection set on “Internet”;
- Retry the application test and the SVM with your GeKO Token.
