AT14-019a

2014 QX60 HYBRID; CVT JUDDER

APPLIED VEHICLE: 2014 QX60 Hybrid (L50)
APPLIED TRANSMISSION: CVT

SERVICE PROCEDURE

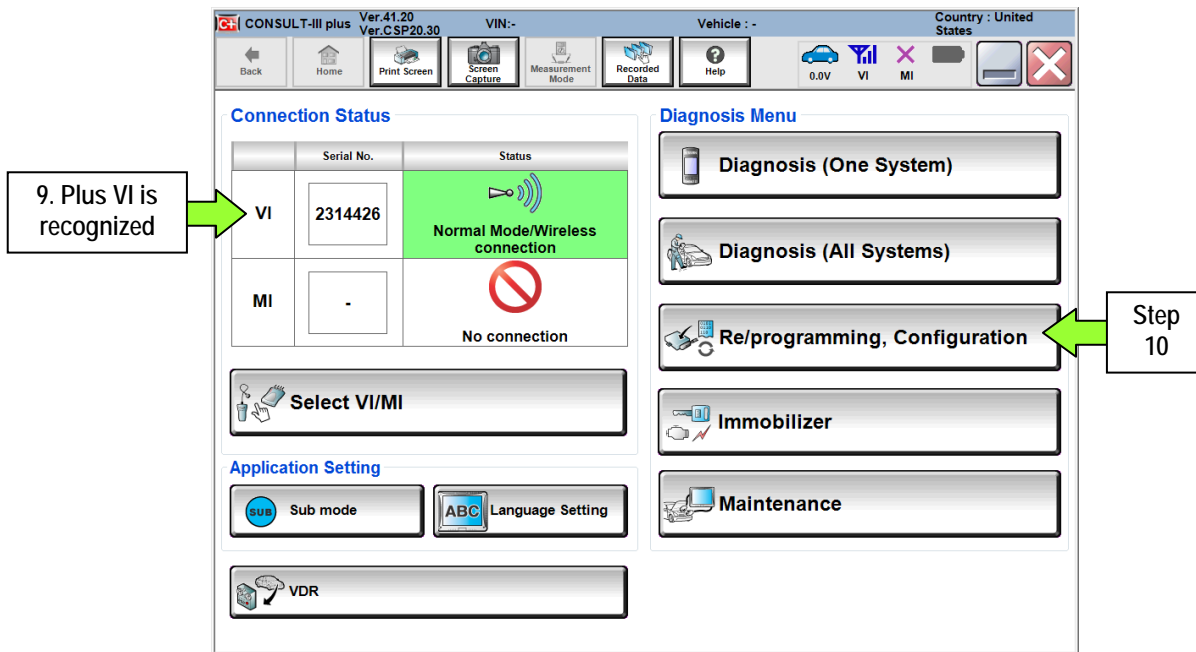
Figure 1

10. Select Re/programming, Configuration.

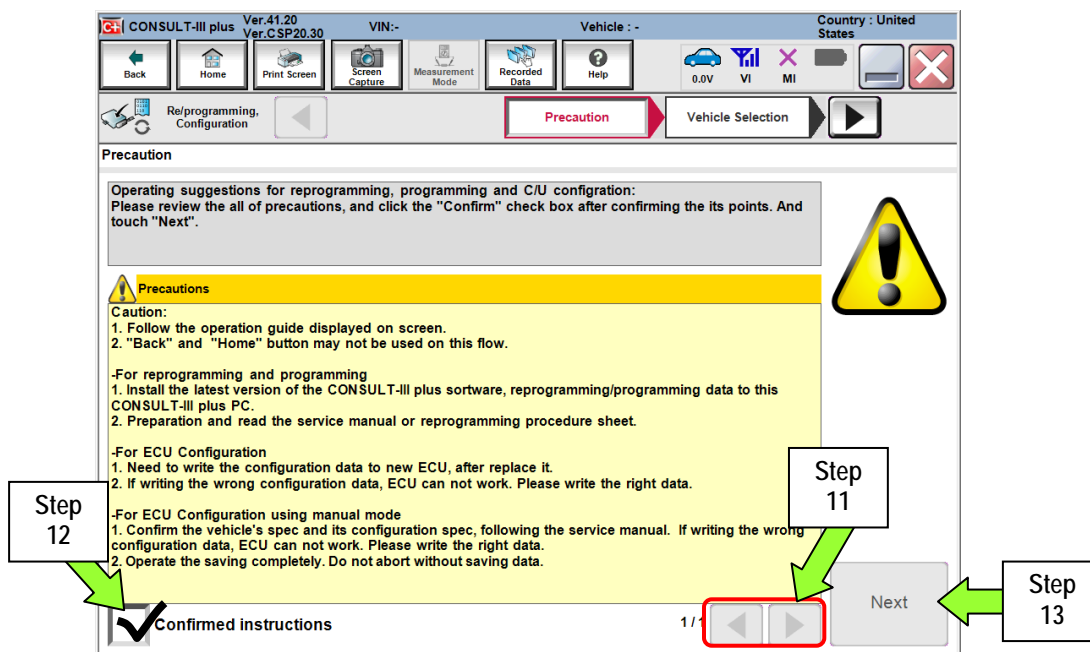
Figure 2

11. Use arrows (if needed) to view and read all precautions.

12. Check the box confirming the precautions have been read.

13. Select Next.

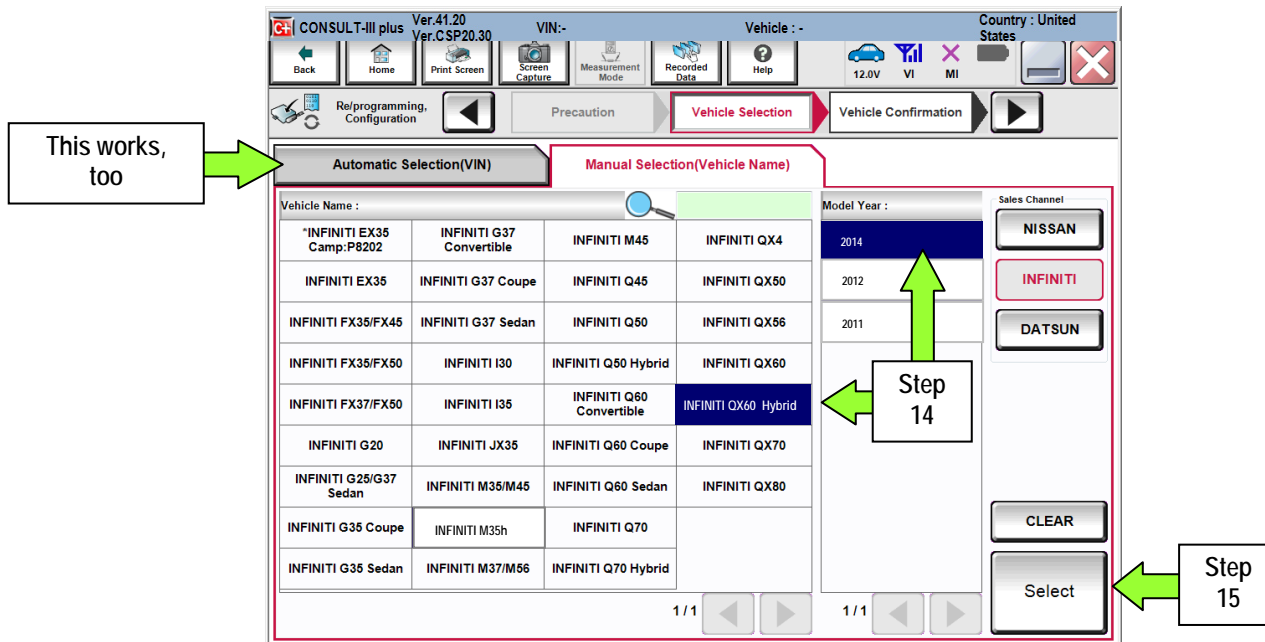
14. Select QX60 Hybrid and 2014, or Automatic Selection (VIN).

- If Automatic Selection (VIN) is selected, wait for the Reading VIN screen to complete.
- If the screen in Figure 3 does not display, skip to step 16.

15. Select Select.

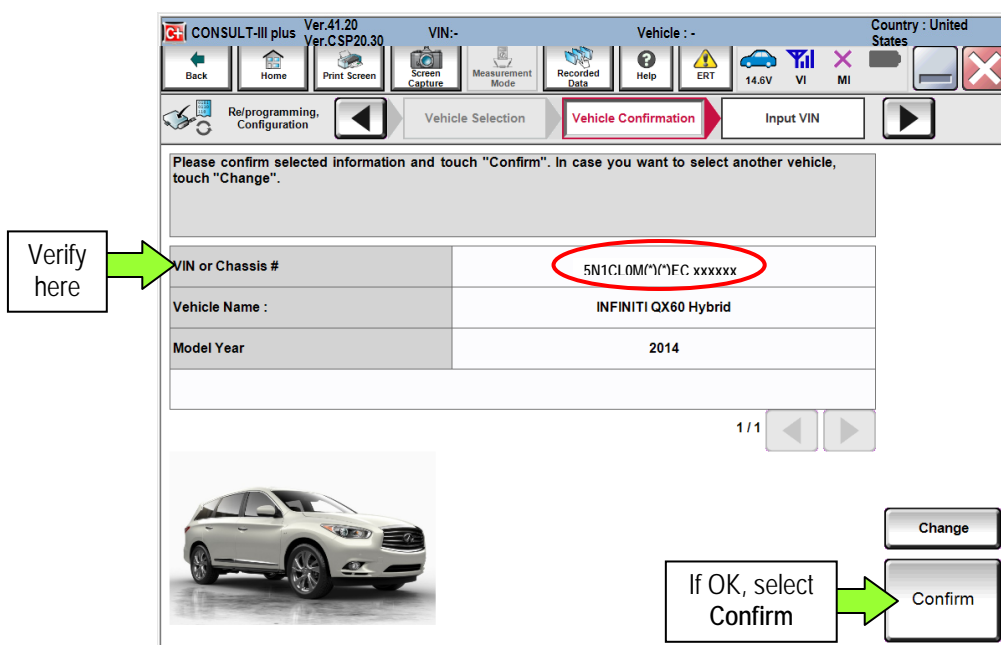
Figure 4

16. Verify the VIN in VIN or Chassis # matches the vehicle being reprogrammed.

- If the correct VIN is displayed, select Confirm.

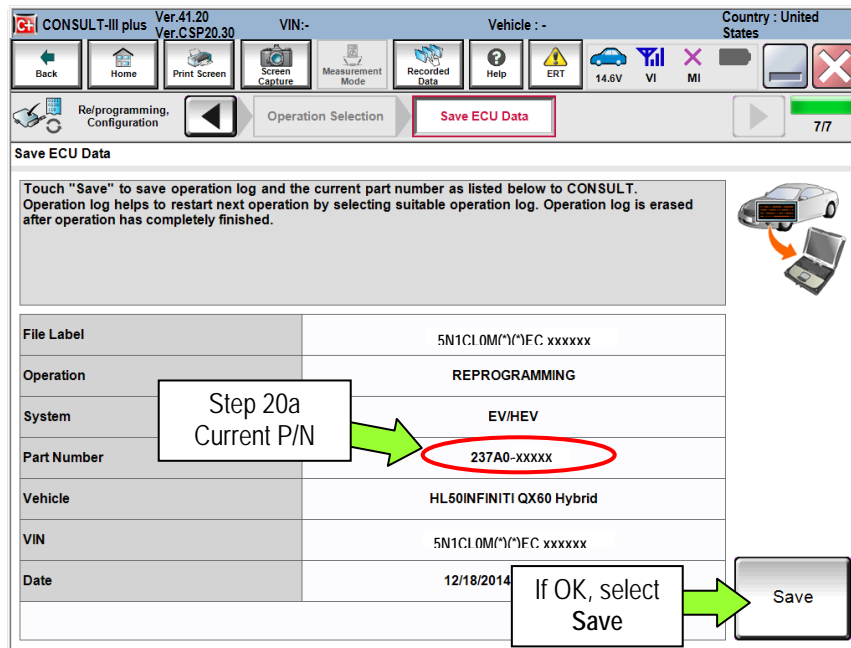
Figure 8

20. When you get to the screen shown in Figure 8, confirm this bulletin applies as follows.

- a. Find the **EV/HEV Part Number** and write it on the repair order.

NOTE: This is the current EV/HEV Part Number (P/N) and will also be needed for claims information.

1. Refer to step 20 and **TABLE A** on page 8 first in the SERVICE PROCEDURE to confirm this bulletin applies to the vehicle you are working on.
2. If this bulletin applies, reprogram the **EV/HEV** (Hybrid Powertrain Control Module) and the **TCM** (Transmission Control Module).

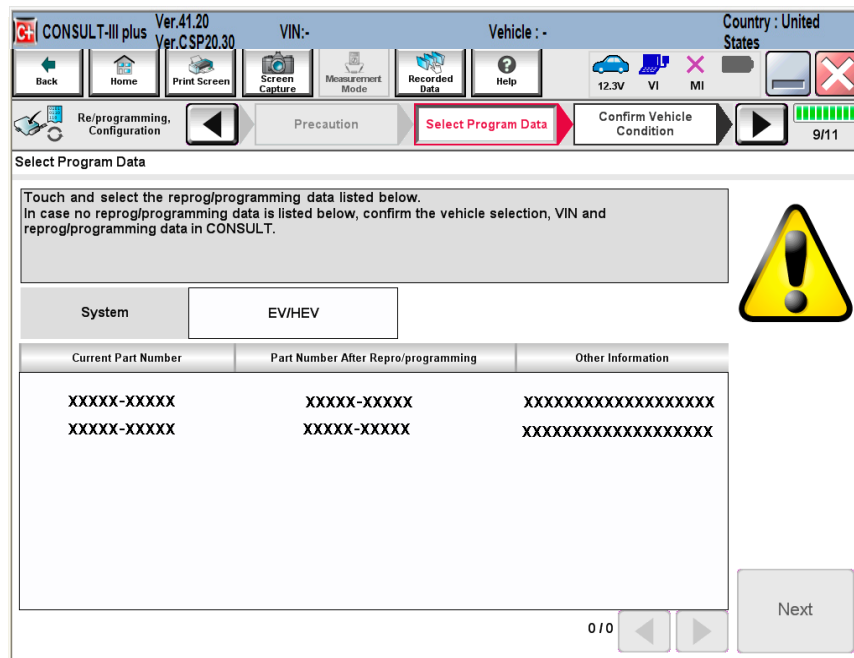
- In some cases, more than one new P/N for reprogramming is available.
 - If more than one P/N is available, the screen in Figure 10 will display. Select and use the reprogramming option that **does not** have the message "Caution! Use ONLY with ITBXX-XXX".
- If you get this screen and it is blank (no reprogramming listed), it means there is no reprogramming available for this vehicle.

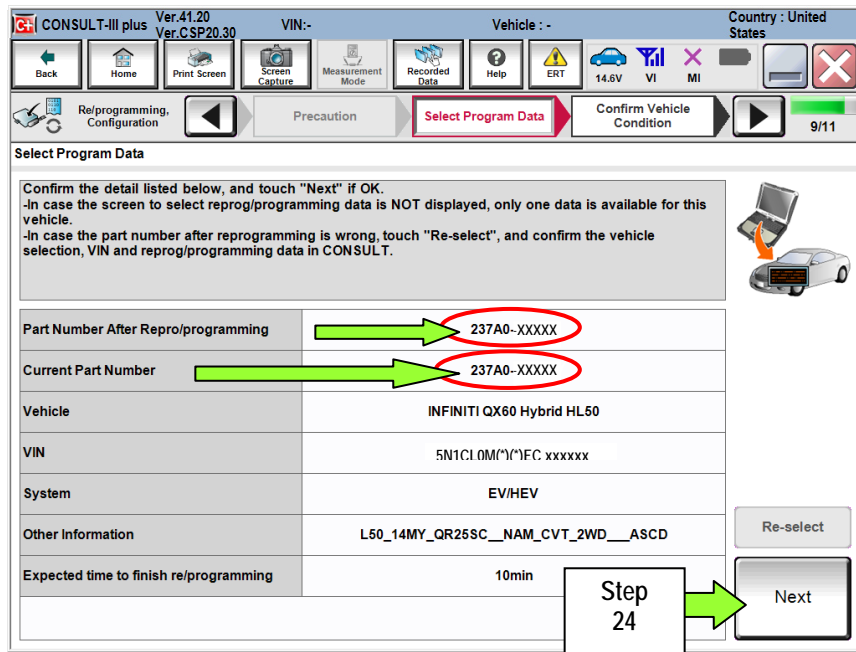
Figure 11

23. Read the **Current Part Number** and **Part Number After Reprogramming**. They should be different.

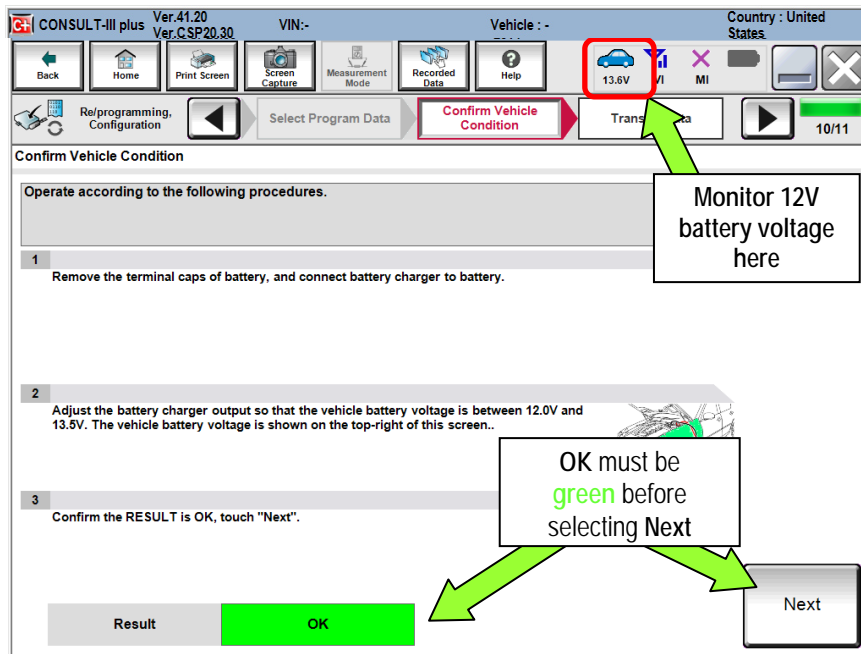
Figure 12

25. Confirm battery voltage is correct, and then select **Next**.

NOTE: Battery voltage must stay within specified range to make the indicator turn **green**.

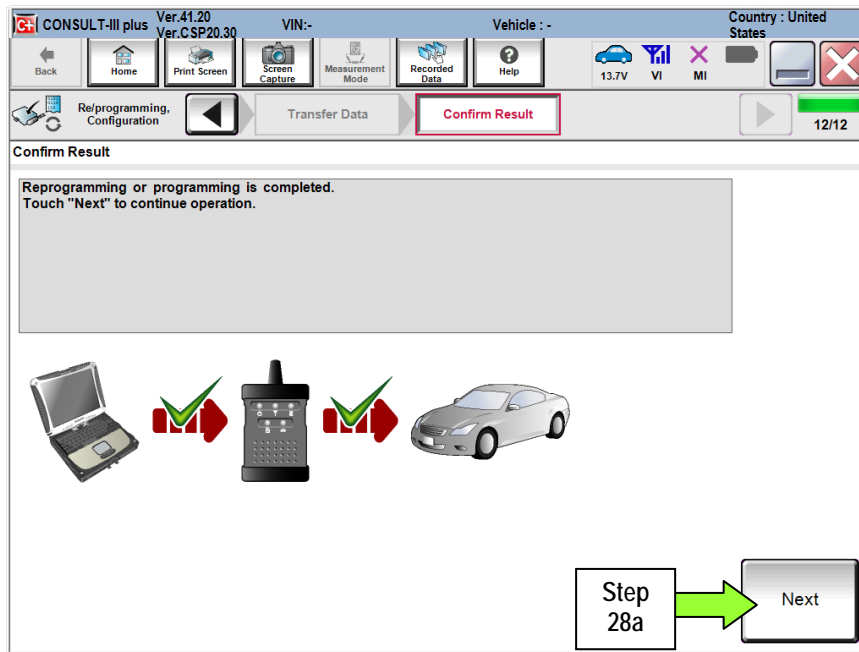
28. When the screen in Figure 15 displays, reprogramming is complete.
- a. Select **Next**, and then wait for System Call to complete.
 - b. Proceed to step 29 on page 14.

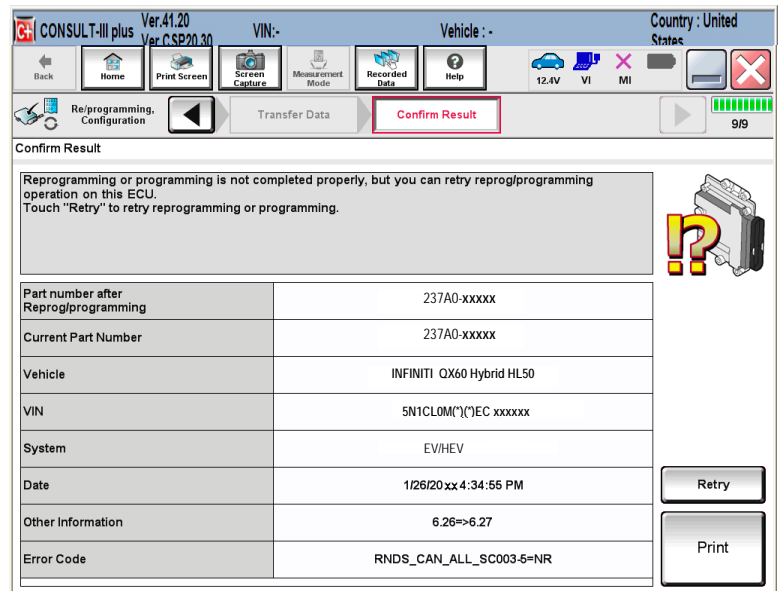
Figure 16

NOTE: If reprogramming does not complete and the **!?** displays as shown in Figure 16:

- Check battery voltage (12.0 - 15.5V).
- Ignition is ON, Ready Mode is OFF.
- External Bluetooth® devices are OFF.
- All electrical loads are OFF.
- Select **Retry** and follow the on screen instructions.
- Retry may not go through on the first attempt and can be selected more than once.

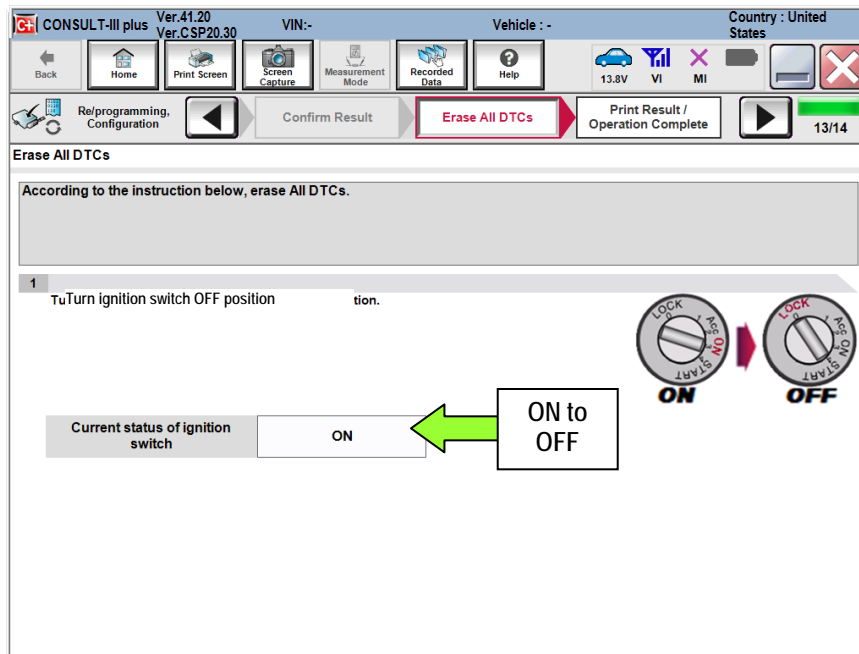
- a. Turn the "ignition" OFF by depressing the power switch once.
 - The screen in Figure 18 will read **OFF** after pressing the power switch once.

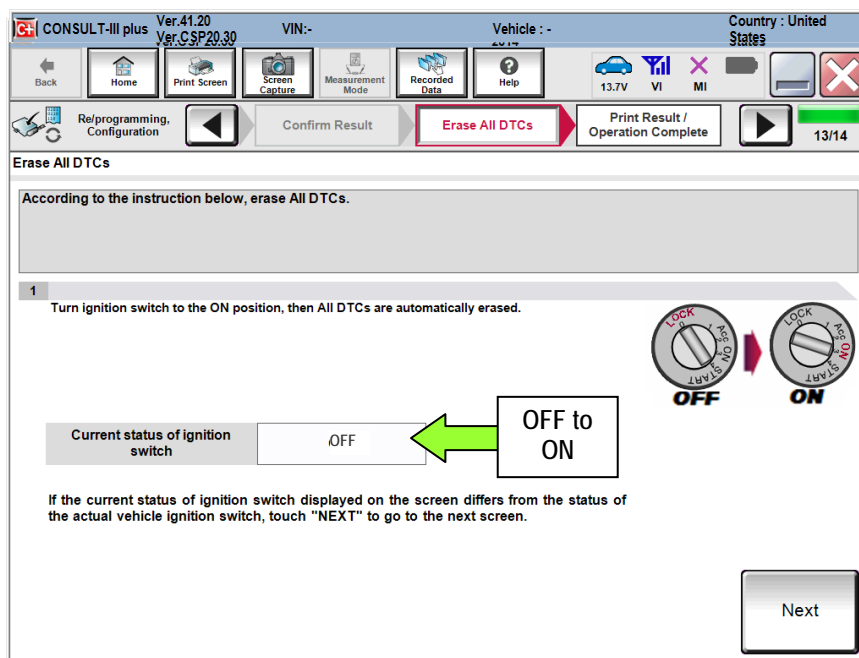
- b. Wait 1 minute with the ignition OFF.
- c. Turn the "ignition" ON by depressing the power switch twice (not Ready mode).
 - Do not step on the brake pedal when depressing the power switch.
 - The screen in Figure 19 will read **ON** after pressing the power switch twice.

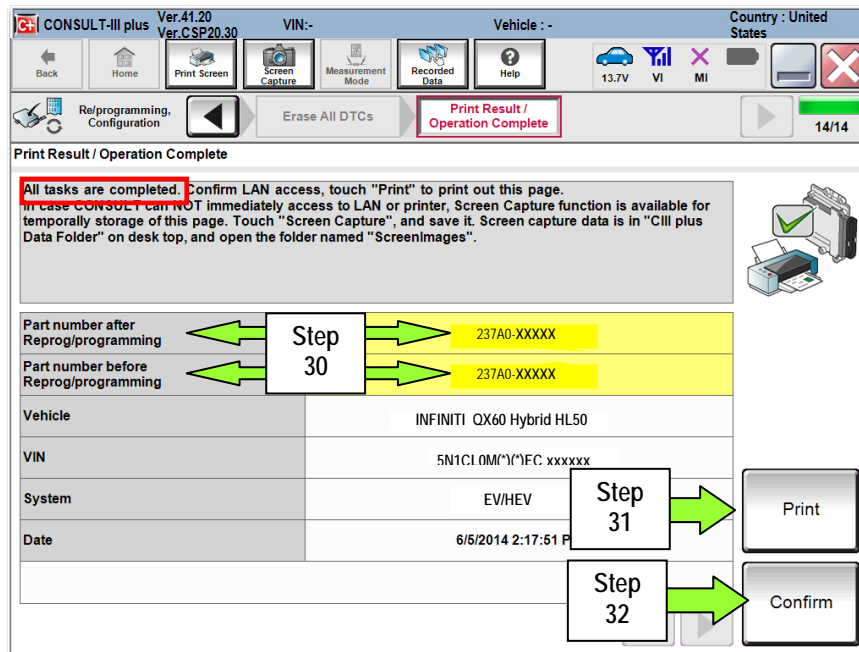
Figure 21

30. Verify the before and after part numbers are different.

31. Print a copy of this screen (Figure 21) and attach it to the repair order.

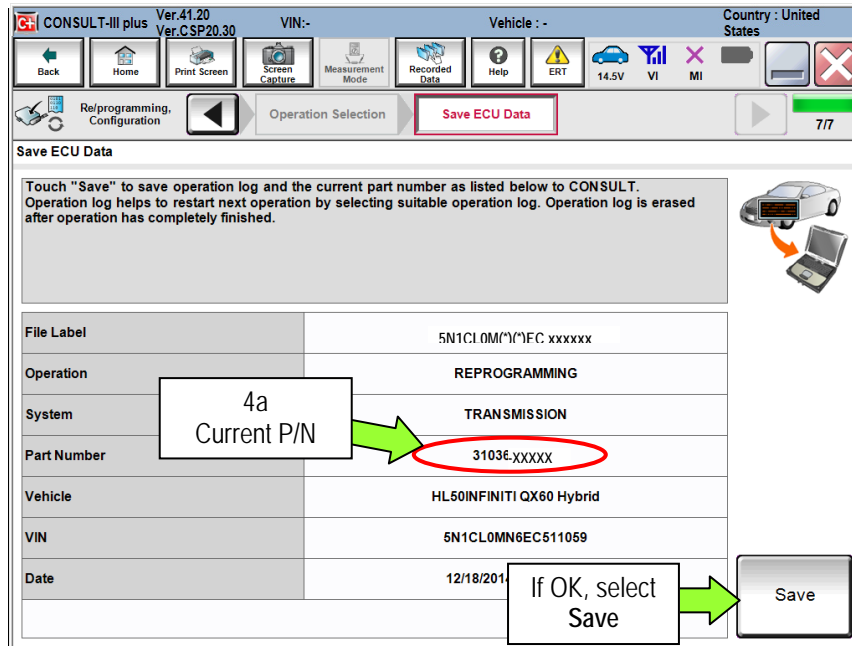
Figure 25

4. When you get to the screen shown in Figure 25, confirm if this TRANSMISSION (TCM) update has already been applied as follows.
 - a. Find the TCM Part Number and write it on the repair order.

NOTE: This is the current TCM Part Number (P/N) and will also be needed for claims information.

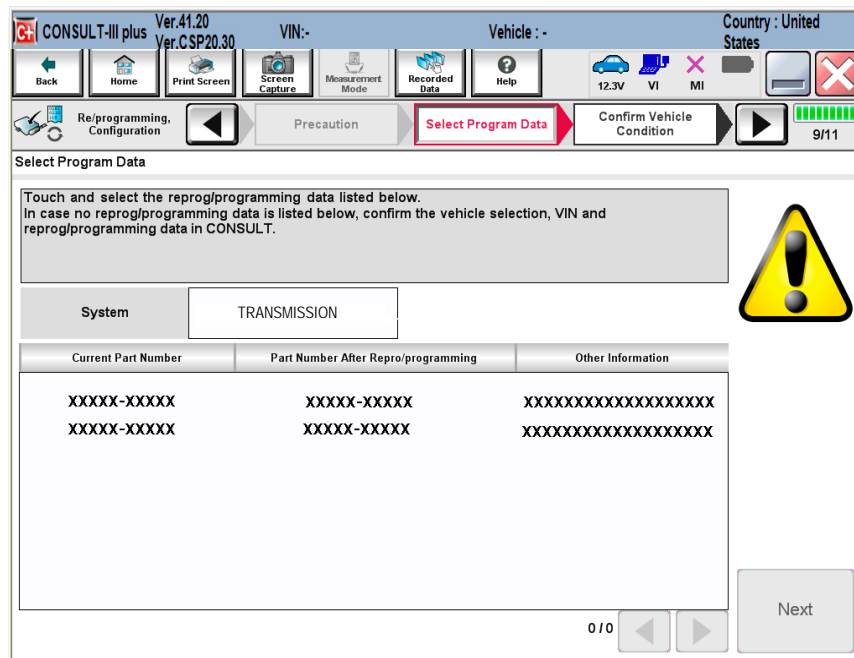
- In some cases, more than one new P/N for reprogramming is available.
 - If more than one P/N is available, the screen in Figure 27 will display. Select and use the reprogramming option that **does not** have the message "Caution! Use ONLY with ITBXX-XXX".
- If you get this screen and it is blank (no reprogramming listed), it means there is no reprogramming available for this vehicle.

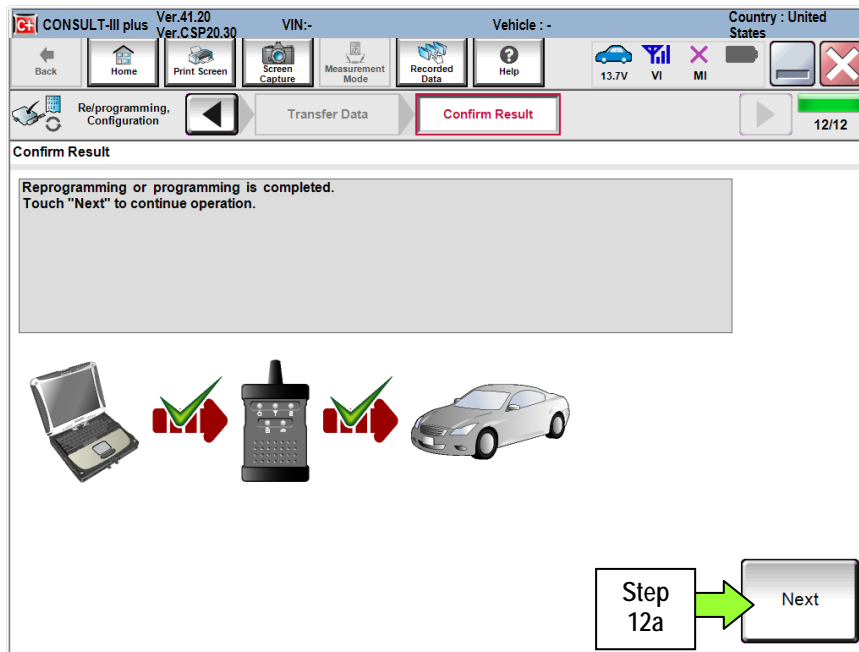
12. When the screen in Figure 32 displays, reprogramming is complete.
- a. Select **Next**, and then wait for System Call to complete.
 - b. Proceed to step 13 on page 24.

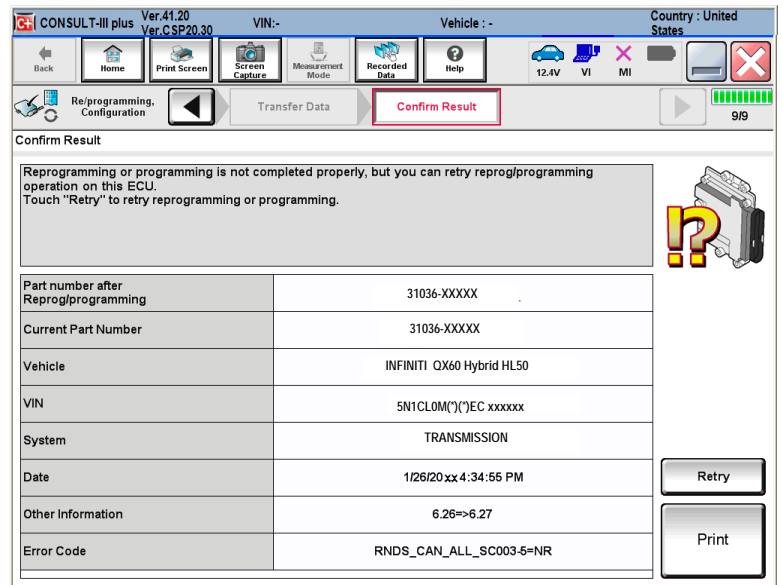
Figure 33

NOTE: If reprogramming does not complete and the **!?** displays as shown in Figure 33:

- Check battery voltage (12.0 - 15.5V).
- Ignition is ON, Ready Mode is OFF.
- External Bluetooth® devices are OFF.
- All electrical loads are OFF.
- Select **Retry** and follow the on screen instructions.
- Retry may not go through on the first attempt and can be selected more than once.

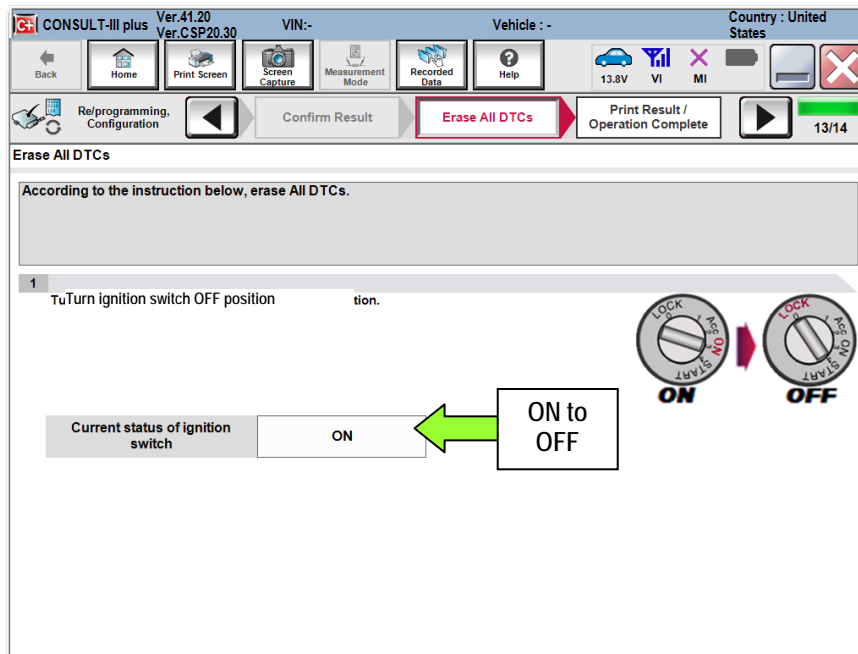
- a. Turn the "ignition" OFF by depressing the power switch once.
 - The screen in Figure 35 will read **OFF** after pressing the power switch once.

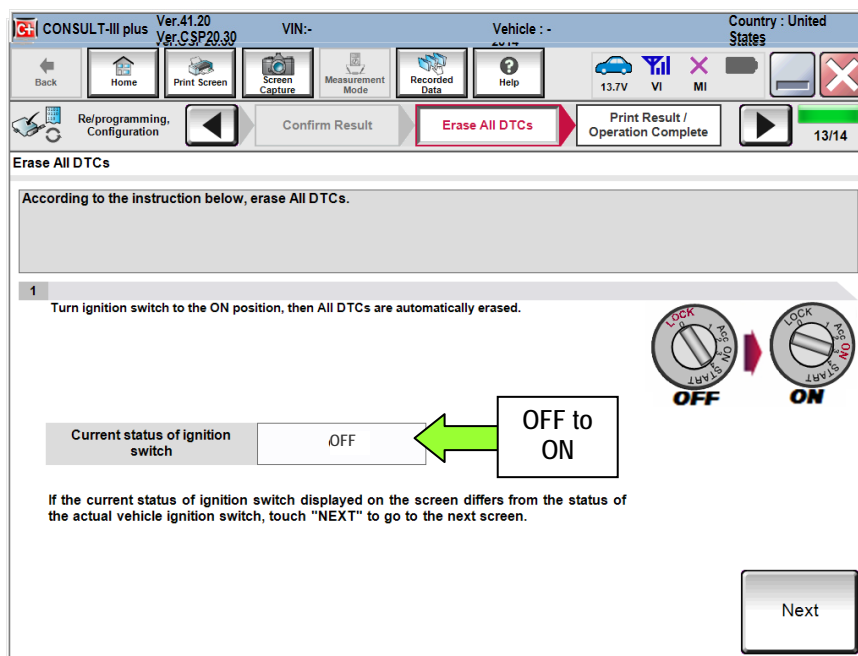
- b. Wait 1 minute with the ignition OFF.
- c. Turn the "ignition" ON by depressing the power switch twice (not "Ready" mode).
 - Do not step on the brake pedal when depressing the power switch.
 - The screen in Figure 36 will read **ON** after pressing the power switch twice.

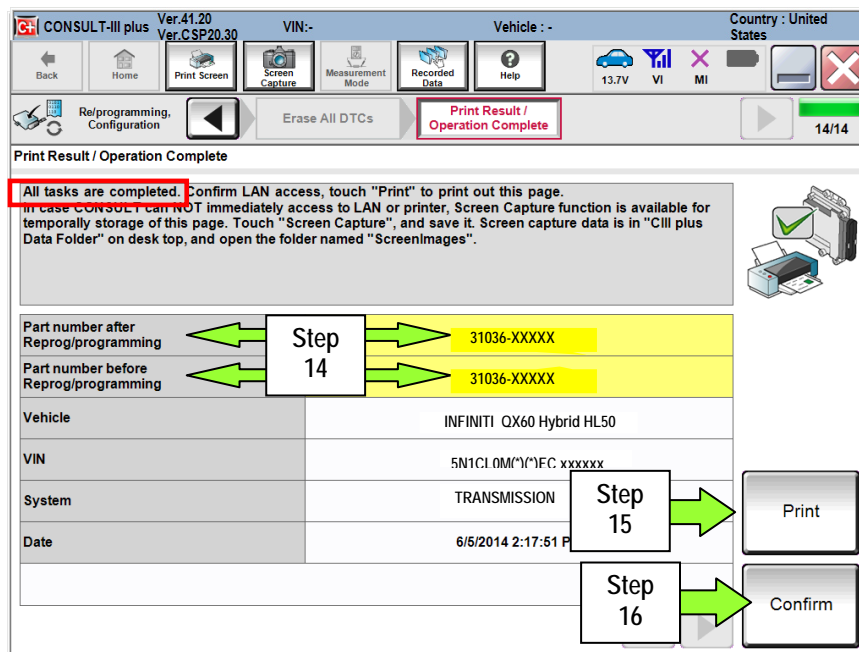
Figure 38

14. Verify the before and after part numbers are different.

15. Print a copy of this screen (Figure 38) and attach it to the repair order.
