EC13-019d

INFINITI; MIL ON WITH DTC P0101 AND/OR P010B

APPLIED VEHICLES: 2011-2012 G25 Sedan (V36) 2011-2013 G37 Sedan (V36)
2015 Q40 Sedan (V36) 2011-2013 G37 Convertible (V36)
2011-2013 G37 Coupe (V36) 2014-2015 Q60 Convertible (V36)
2014-2015 Q60 Coupe (V36) 2013 JX35 (L50)
2013 EX37 (J50) 2014-2015 Q50 (V37)
2014-2015 QX50 (J50) 2012-2013 M37 (Y51)
2013 FX37 (S51) 2014-2015 Q70 (Y51)
2014-2015 QX70 (S51)

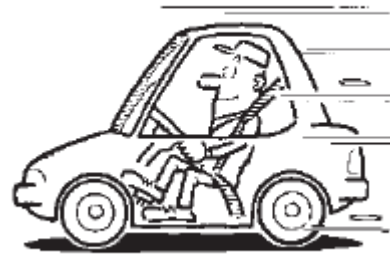
Figure A

- Most instructions for reprogramming with CONSULT-III plus (C-III plus) are displayed on the CONSULT PC screen.
- If you are not familiar with the reprogramming procedure, *click here*. This will link you to the "CONSULT- III plus (C-III plus) Reprogramming" general procedure.
- Take the vehicle for a 10 minute drive in order to meet the following Idle Air Volume Learn (IAVL) conditions:
 - Engine coolant temperature: 70 - 105°C (158 - 221°F)
 - Battery voltage: More than 12.9V (at idle)
 - Transmission: Warmed up
