EC15-018

2015 QX80; MIL ON WITH DTC FOR A/F SENSOR

APPLIED VEHICLE: 2015 QX80 (Z62)**APPLIED ENGINE:** VK56VD (V8)

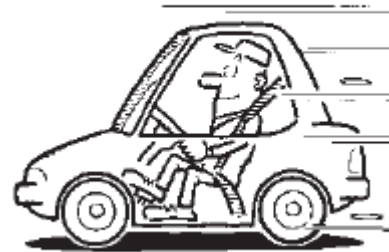
Figure A

- Take the vehicle for a 10 minute drive in order to meet the following Idle Air Volume Learn (IAVL) conditions:
 - Engine coolant temperature: 70 -105°C (158 -221°F)
 - Battery voltage: More than 12.9V (At idle)
 - Transmission: Warmed up

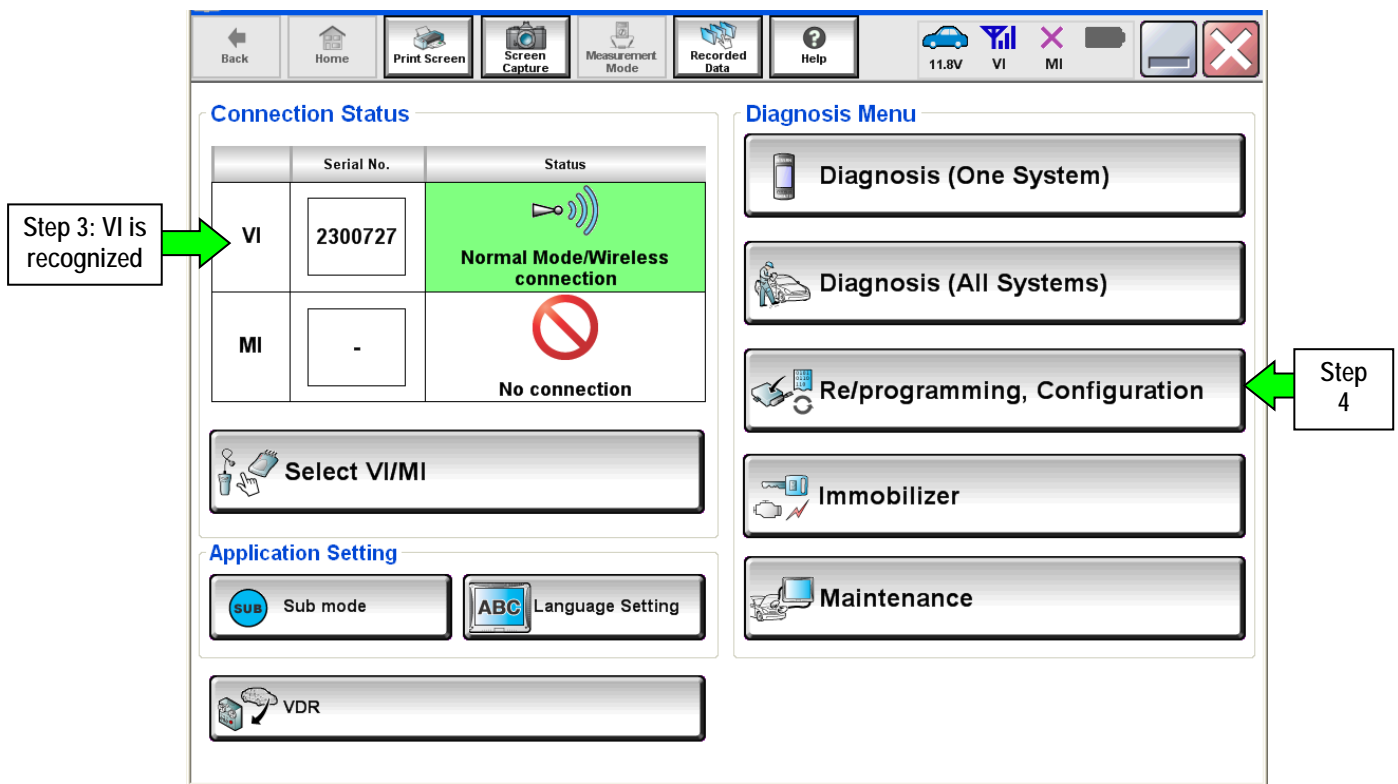
Figure 1

1. Connect the CONSULT PC to the vehicle to begin the reprogramming procedure.
2. Open C-III plus.
3. Wait for the plus VI to be recognized.
 - The serial number (Serial No.) will display when the plus VI is recognized.
4. Select **Re/programming, Configuration**.

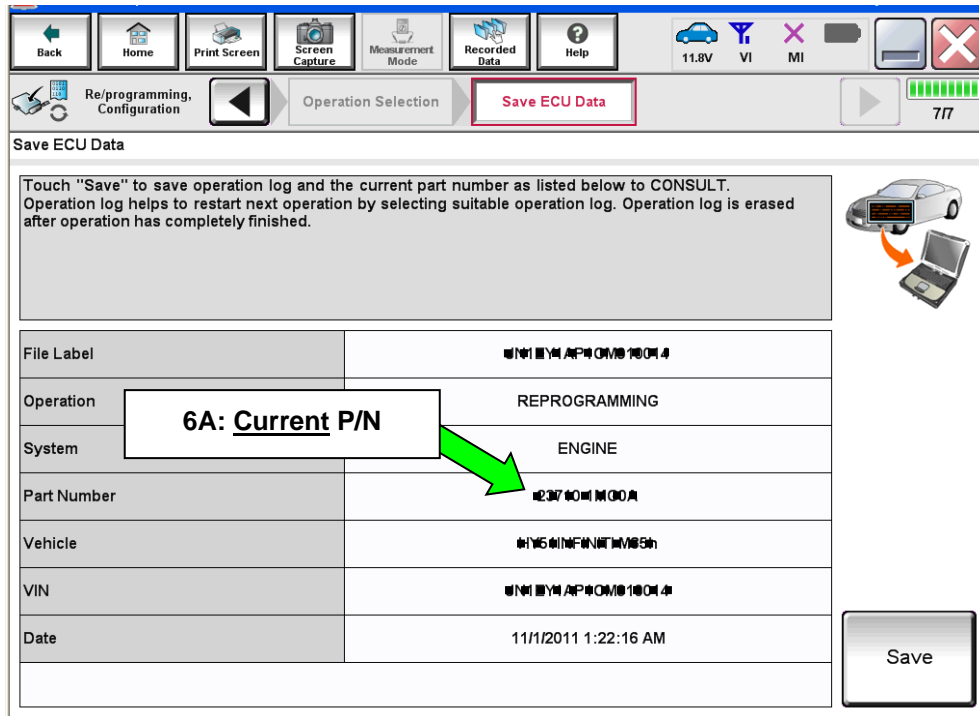
6. When you get to the screen shown in Figure 2, confirm this bulletin applies as follows:

A. Find the ECM **Part Number** and write it on the repair order.

NOTE: This is the current ECM Part Number (P/N).

5. Follow the on-screen instructions and navigate C-III plus to the screen shown in Figure 2 on the next page.

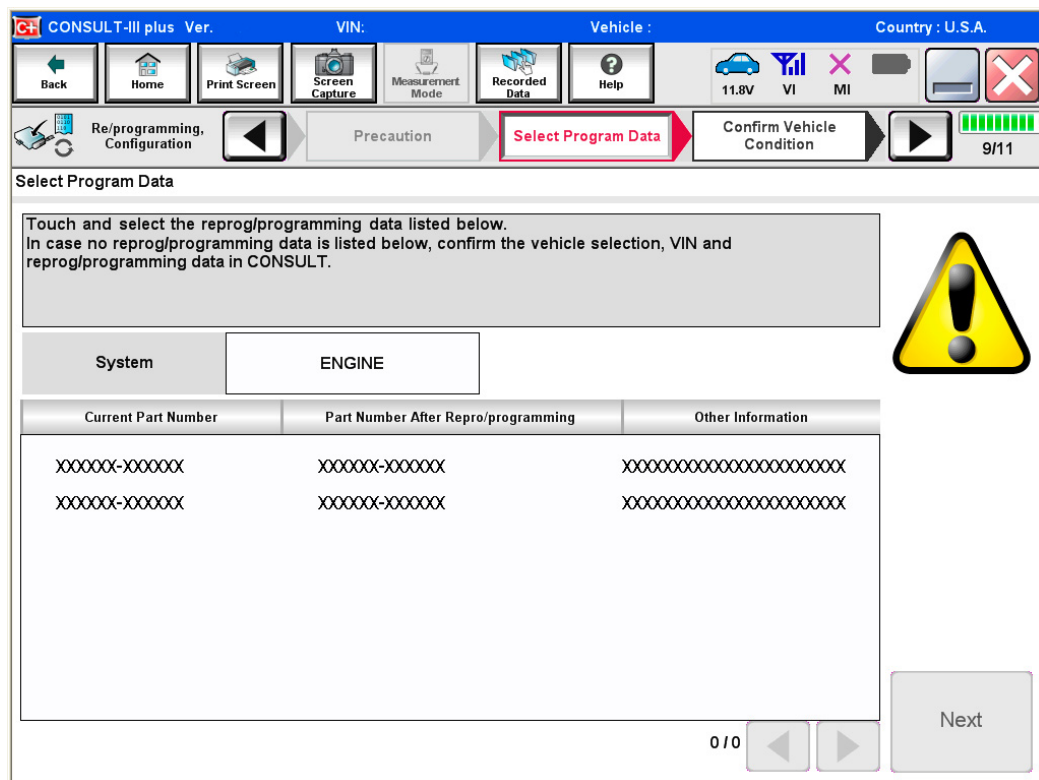
- In some cases, more than one new P/N for reprogramming is available.
 - In this case, the screen in Figure 3 displays.
 - Select and use the reprogramming option that **does not** have the message "Caution! Use ONLY with ITBXX-XXX".
- If you get this screen and it is blank (no reprogramming listed), it means there is no reprogramming available for this vehicle. Close C-III plus and refer back to ASIST for further diagnosis.

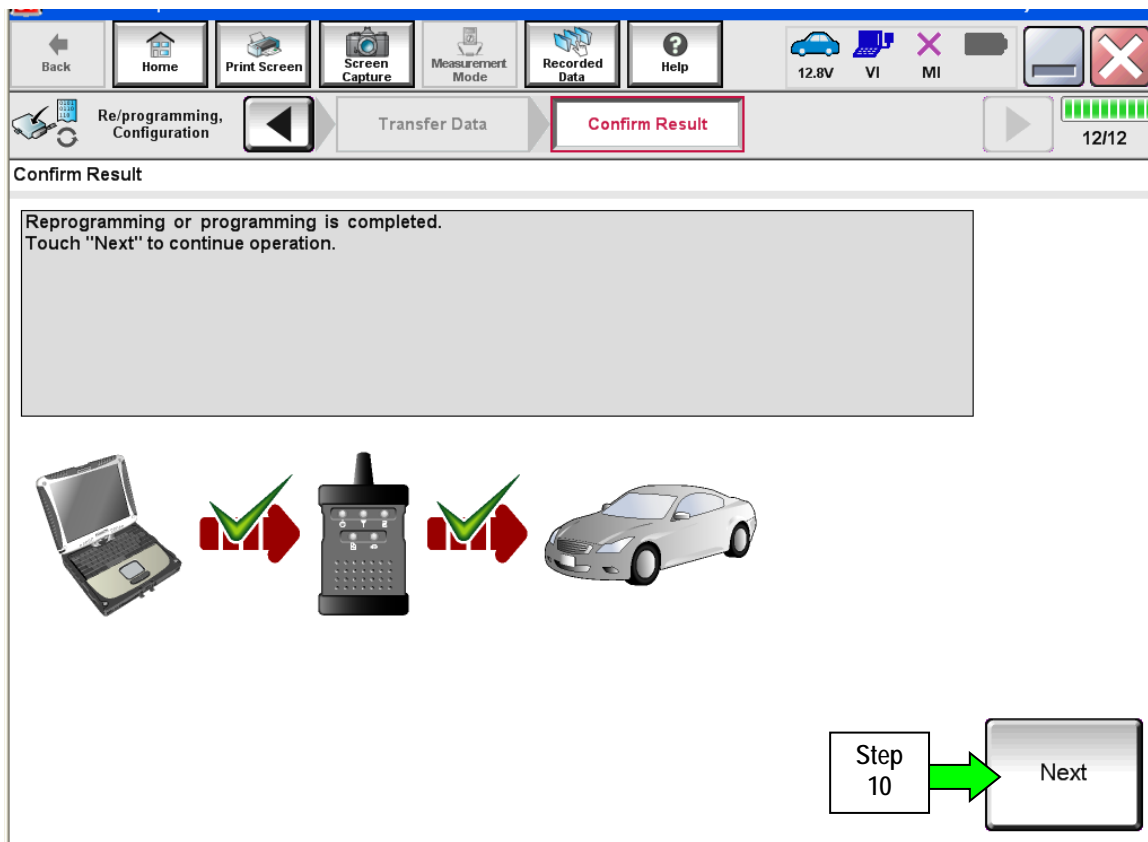
8. When the screen in Figure 4 displays, reprogramming is complete.

NOTE: If the screen in Figure 4 does not display (indicating that reprogramming did not complete), refer to the information on the next page.

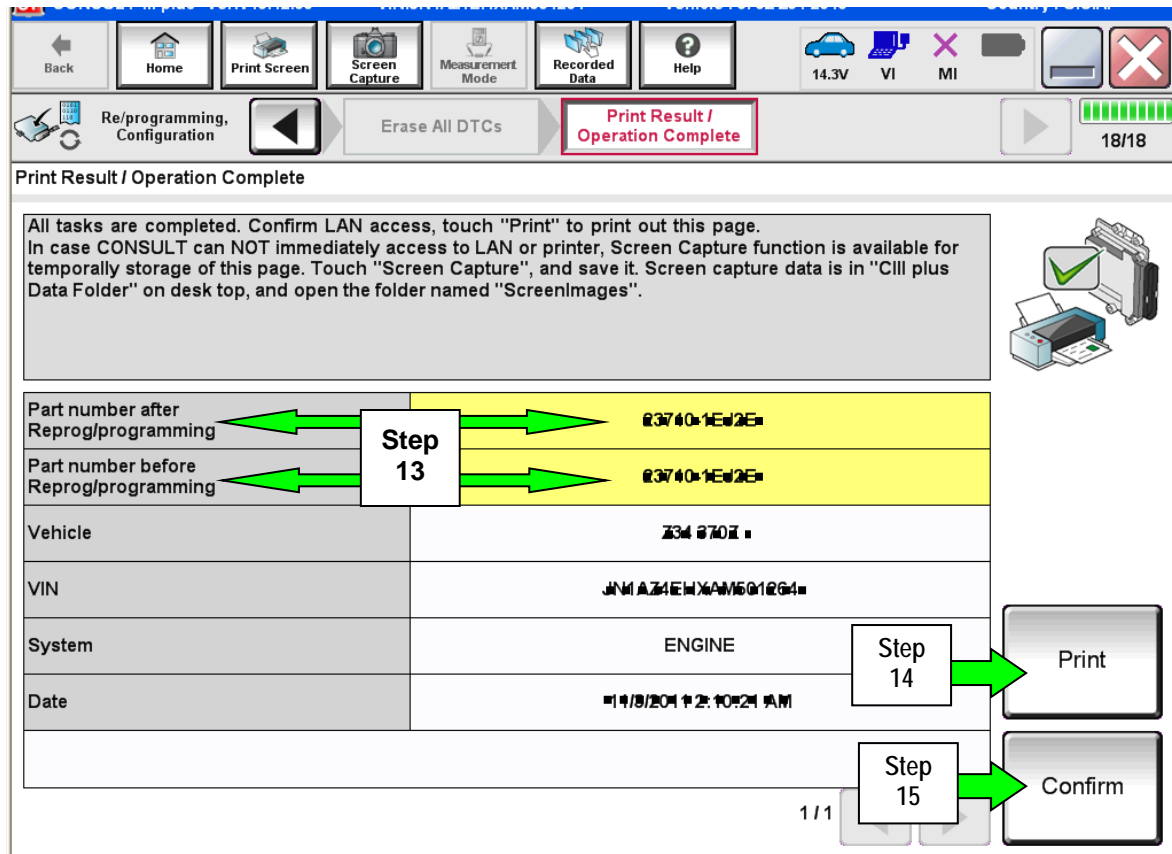
12. When the entire reprogramming process is complete, the screen in Figure 7 will display.
13. Verify the before and after part numbers are different.
14. Print a copy of this screen (Figure 7) and attach it to the repair order for warranty documentation.
15. Select **Confirm**.
