**August 21, 2015**

51788-02200 Version 5

Product Update: Audio and Audio-Navigation Unit Software UpdateSupersedes 13-001, dated June 24, 2014, to revise the information highlighted in **yellow**.**AFFECTED VEHICLES**

Year	Model	Trim	VIN Range
2013	Accord	ALL	Check the iN VIN status for eligibility
2013	Crosstour	ALL	Check the iN VIN status for eligibility

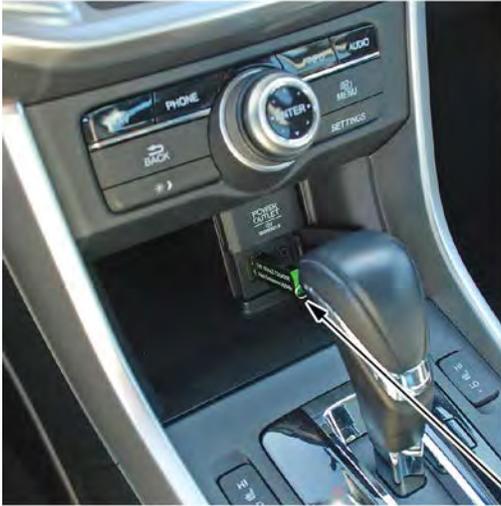
ACCORD

3. Wait for the audio system to boot up, then insert the USB update device into the USB port in the center console. See TOOL INFORMATION.

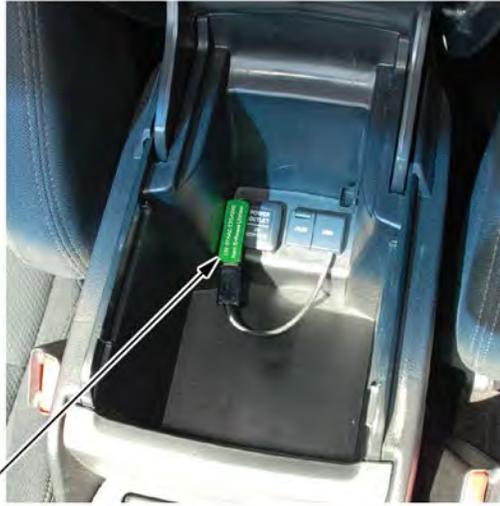
CROSSTOUR

USB FLASH DRIVE - AUDIO ONLY
T/N: 07-AAZ-T2GA210

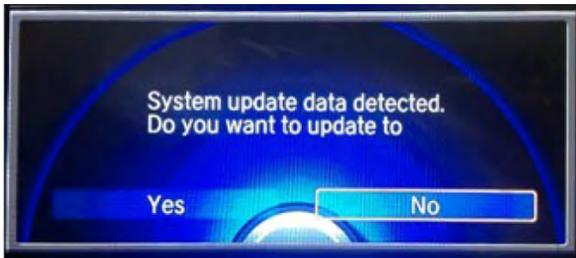
4. When the **System update data detected** screen appears, select **Yes**.

NOTE: If the update is not detected, the vehicle may already have the latest software version installed. Go to step 16 to check the software version.

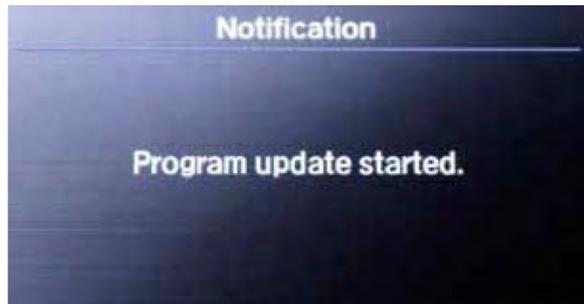
5. Both screens will shut off for about 10 seconds and reboot with the notification shown below on both screens.

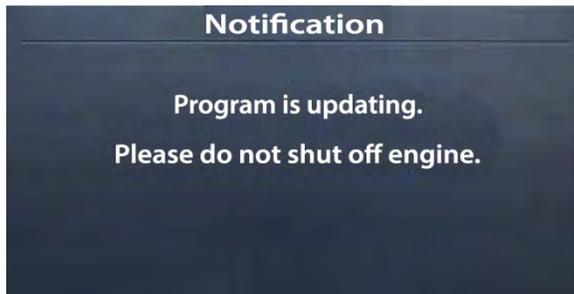
- The notification below will appear on the upper display screen for the duration of the update process.

- The engine does not need to be running, even if it says so on the screen.
- You do not have to oversee the update during this time as no action is needed until the update is loaded.

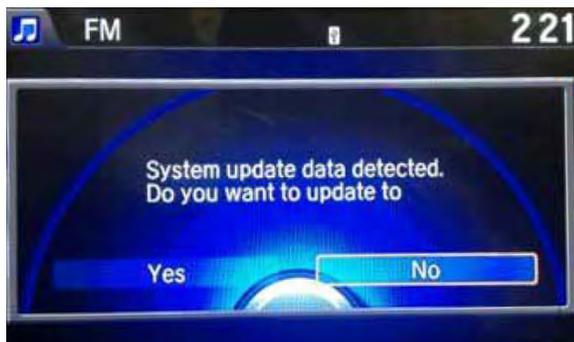
- When the update is complete, the system will reboot to the H screen and the **System update data detected** screen will reappear.

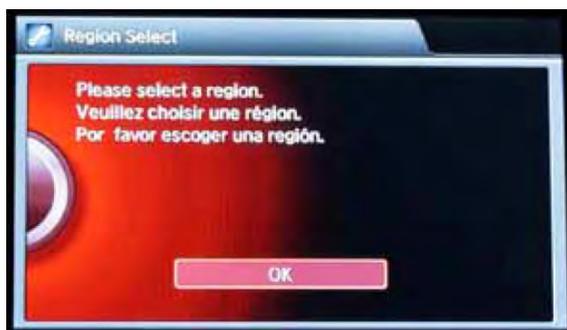
- Select **No**, set the power mode to OFF.
- Remove the USB update device and wait at least 1 minute.
- Set the power mode ON.
- When the **Region Select** screen appears, select **OK**.

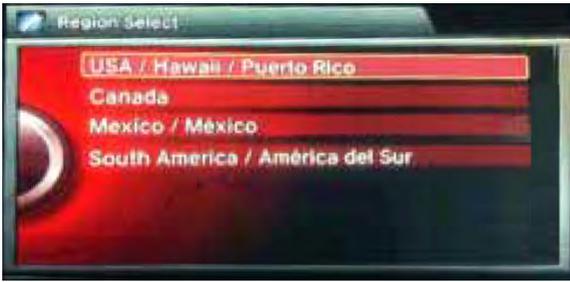
13. Select **USA/Hawaii/Puerto Rico**.

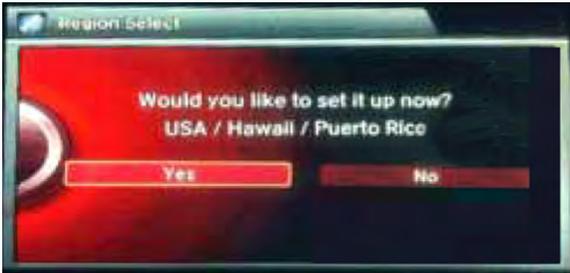
14. Select **Yes**.

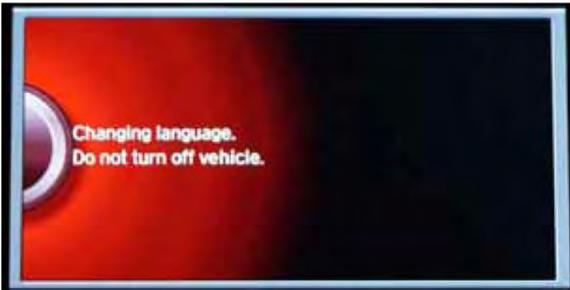
The screen below appears momentarily, then the system reboots to the **Enter code** screen.

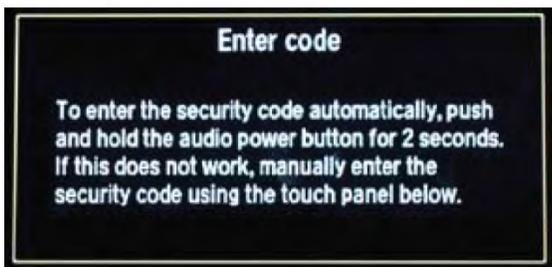
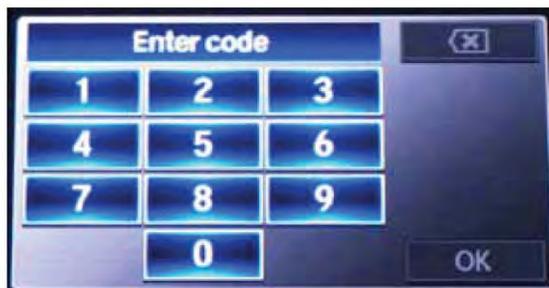
15. The **Enter Code** message and keypads screens will appear, although they may not appear at the same time. Wait for both screens to appear. Then, press and hold the power button for 2 seconds until you hear the beep.

UPPER DISPLAY

TOUCH SCREEN

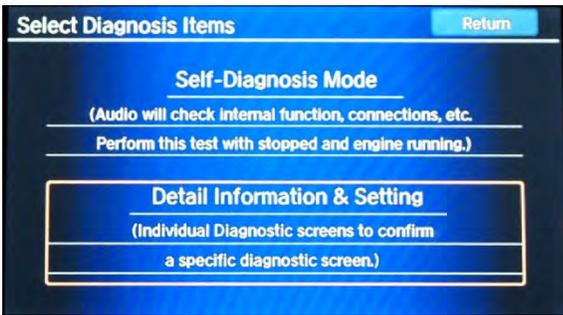
16. Press and hold the **DISP**, **BACK**, and **VOL** buttons until the **Select Diagnosis Items** screen appears.

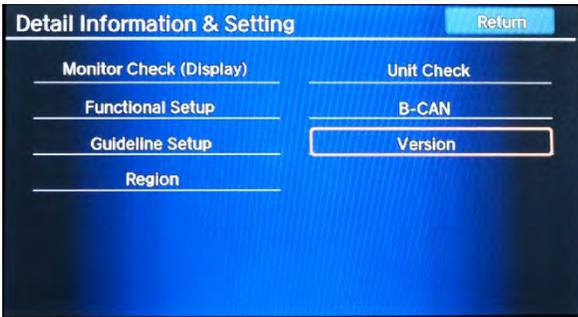
17. Select **Detail Information & Setting**, then select **Version**.

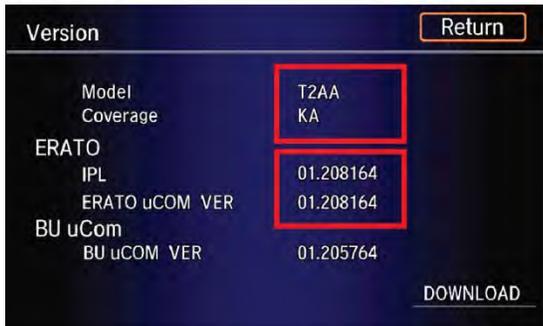
ACCORD

18. Verify that the software was updated to the new version as shown below. If the software is not updated, set the power mode to OFF, and go back to step 2 and repeat the update procedure.

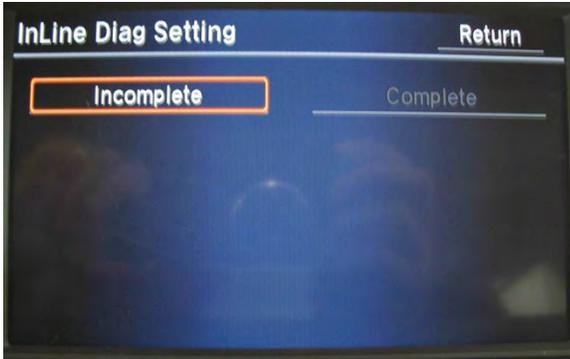
19. Make sure the compass, rear camera, and LaneWatch are working properly. If not, reset the compass, rear camera and LaneWatch.
 - Move the vehicle to an open area. Start the engine if not already done.
 - To enter the In line Diag mode, press and hold the DISP, BACK, and VOL buttons.
 - Press and hold the Day/Night button.
 - Select **Incomplete**. The system restarts.

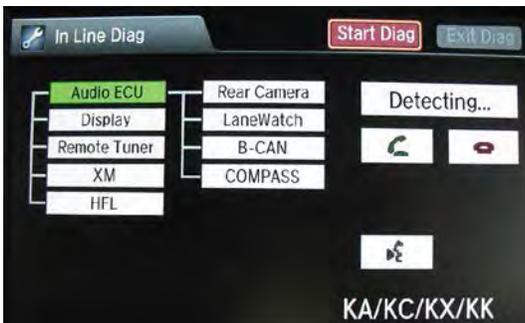
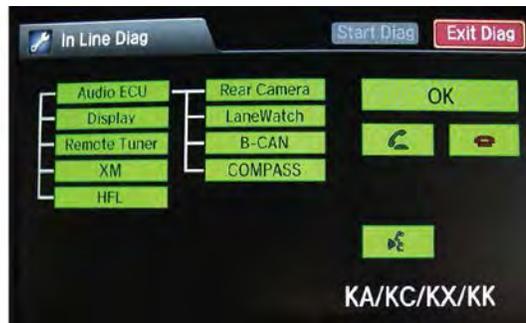
- When the **In-Line Diag** screen appears, select **Start Diag**.
- Make sure all the icons turn green.

- Press the Pick-up button.
- Press the Hang-up button.
- Press the Talk button.
- Snap your fingers in front of the microphone to complete the test.

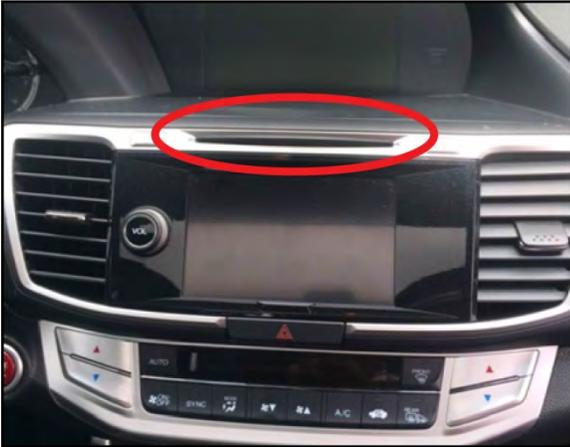
3. Wait for the navigation system to boot up, then insert the DVD into the CD slot in the center console. See TOOL INFORMATION.

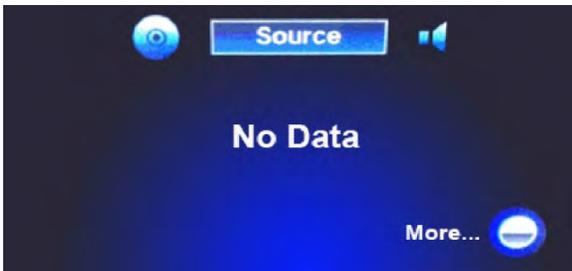
4. The software update will begin. The screen will show a **Reading the Disc** message, then display **No Data**. **Do not eject the disc**. The unit is uploading the update and may take up to 1 minute before beginning. Both screens will shut off for about 10 seconds and reboot with the update started on both screens. The displays should change to a **Notification** screen loading bar.

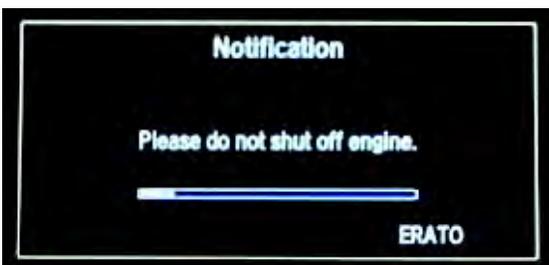
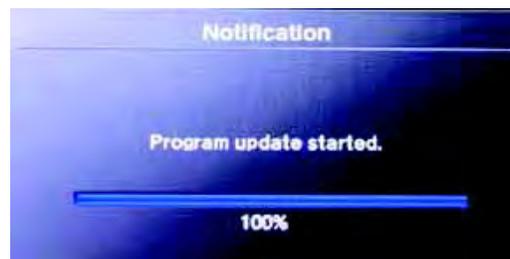
Navigation screen

Touch screen

NOTE: The software update takes about 30 minutes to complete; you do not have to oversee the update during this time as no action is needed until the update is loaded.

On the touch screen, the progress bar will stop at 100% after ERATO is updated and remain at 100% throughout all SH and Utility updates. The progress bar will go back to 0% and resume when the BUuCOM update starts.

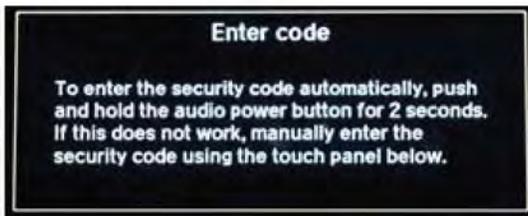
Navigation screen

5. When the update is complete, the system will reboot to the AcuraLink screen. The **Enter code** message and keypad will appear on the screens, although they may not appear at the same time. **Wait for both screens to appear**, set the power mode to OFF.

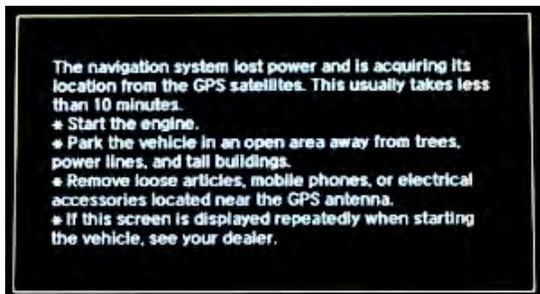
7. Eject the DVD and wait at least 1 minute.
8. Set the power mode to ON. Once both **Enter code** screen appears, press and hold the **power button** for 2 seconds until you hear the beep.
9. The navigation screen will show the GPS initialization message.

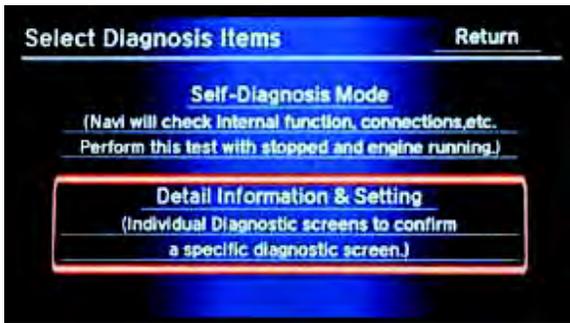
- Press and hold the **NAVI,BACK** and **MENU** buttons until the **Select Diagnosis Items** screen appears.

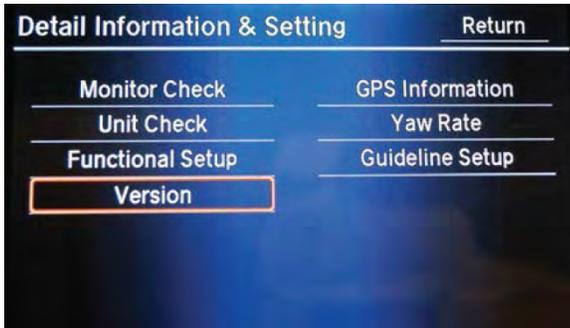
- Select **Detail Information & Setting**.
- Select **Version**.

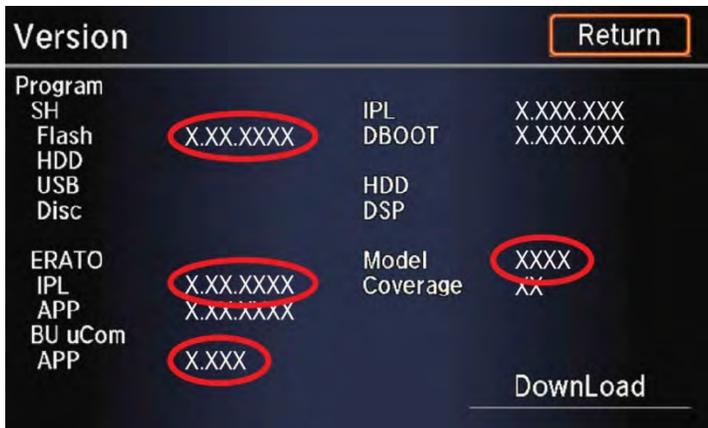
- Verify that the software was updated to the new version as shown below. **Please note the SH-Flash, ERATO IPL and BU uCom APP version information and make sure it matches the table below.**

Software	2013 Accord	Crosstour (ALL)
SH	3.00.2003	3.00.2703
ERATO	3.00.0001	3.00.0001
BU	3.001	3.001
Model	T2AA	TP6X

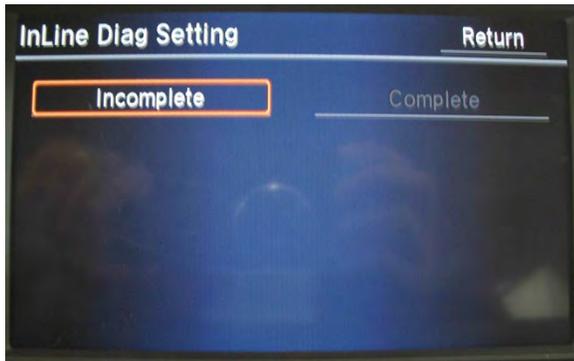
14. Make sure the rear camera and LaneWatch are working properly. If not, reset the rear camera and LaneWatch.
 - Move the vehicle to an open area, start the engine if not already done.
 - Press and hold the **NAVI**, **BACK**, and **MENU** buttons.
 - Press and hold the **NAVI** Button.
 - Select **Incomplete**. The system restarts.

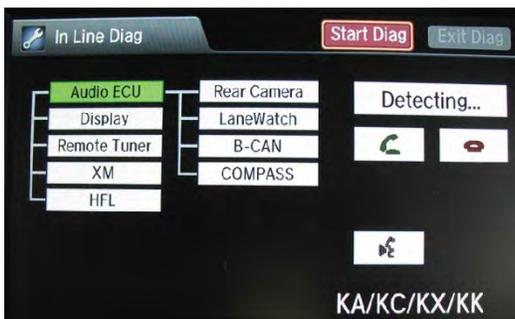
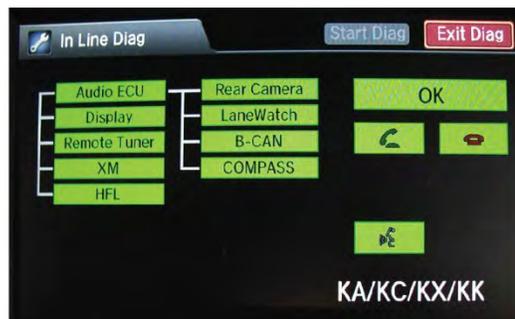
- When the **In-line Diag** screen appears, select **Start Diag**.
- Make sure all the icons turn green.

- Press the Pick-up button.
- Press the Hang-up button.
- Press the Talk button.
- Snap your fingers in front of the microphone to complete the test.
