Applies To: **2013 Accord** – Check the iN VIN status for eligibility
2013 Crosstour – Check the iN VIN status for eligibility

Product Update: Audio and Audio-Navigation Unit Software Update

Update the audio or audio-navigation unit software with the USB device.

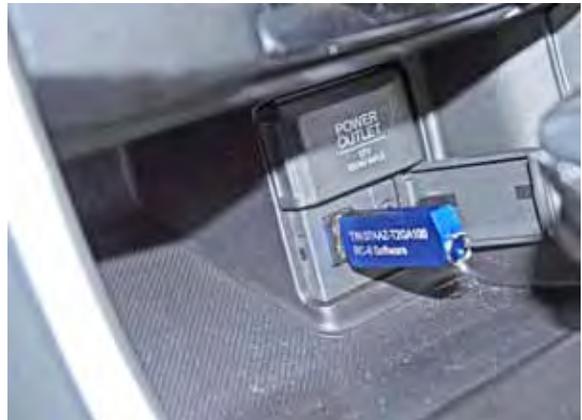
Accord

1. Connect a battery charger to the vehicle and leave it connected during the entire update procedure to maintain a steady voltage.
2. Press the engine start/stop button to select the vehicle ON mode.
3. Wait for the navigation system to finish booting up, then insert the USB update device into the USB port in the center console. See TOOL INFORMATION.

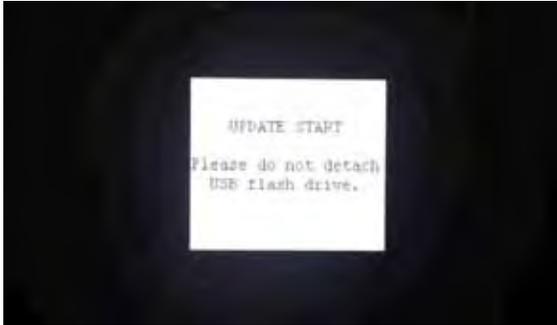
- Both screens will shut off for about 10 seconds and reboot with the notification below flashing on the navigation screen.

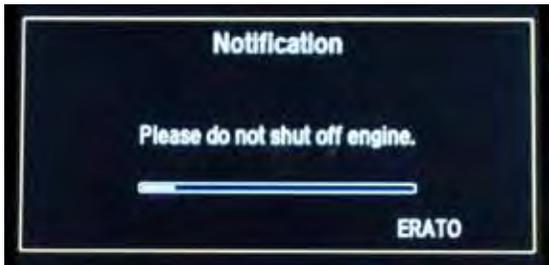
Navigation screen

- The software update will begin. A Notification screen loading bar will display on both screens.

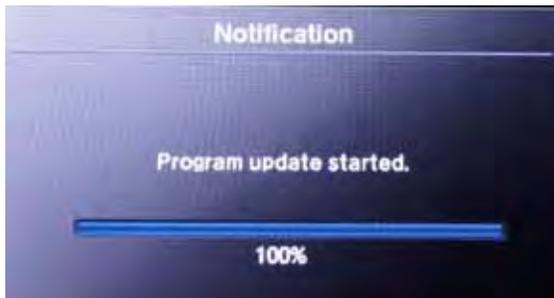
Touch screen

On the touch screen, the progress bar will stop at 100% after ERATO is updated and remain at 100% throughout all SH and Utility updates. The progress bar will go back to 0% and resume when the BUuCOM update starts.

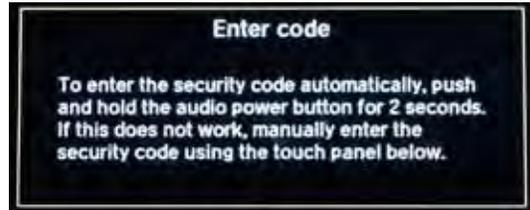
Navigation screen

- When the update is complete, the system will reboot to the HondaLink screen, then the Enter code screen will appear.
- The Enter code message and keypad will appear on the screens, although they may not appear at the same time. **Wait for both screens to appear.** Then, press and hold the VOL button for 2 seconds until you hear the beep.

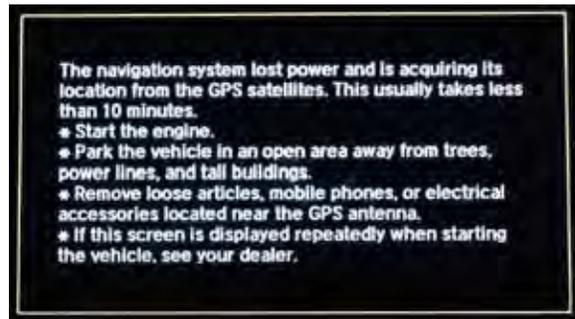
- Remove the USB update device.
- Press the engine start/stop button to select the vehicle ON mode. Once the Enter code screens appear, press and hold the power button for 2 seconds until you hear the beep.
- The navigation screen will show the GPS initialization message.

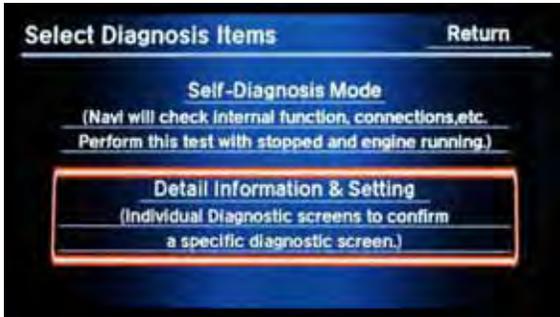
- Press and hold the NAVI, BACK, and MENU buttons until the Select Diagnosis Items screen appears.

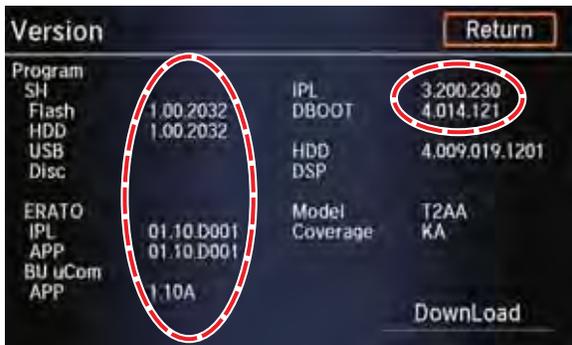
Accord

- Select **Detail Information & Setting**.
- Select **Version**.
- Verify that the software was updated to the new version as shown below.

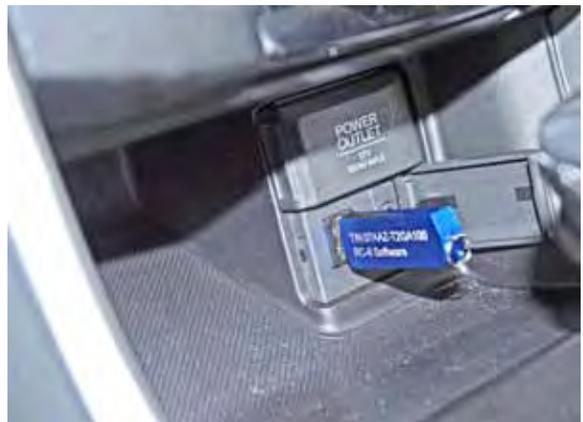
Accord

- Connect a battery charger to the vehicle and leave it connected during the entire update procedure to maintain a steady voltage.
- Press the engine start/stop button to select the vehicle ON mode.
- Wait for the audio system to boot up, then insert the USB update device into the USB port in the center console. See TOOL INFORMATION.

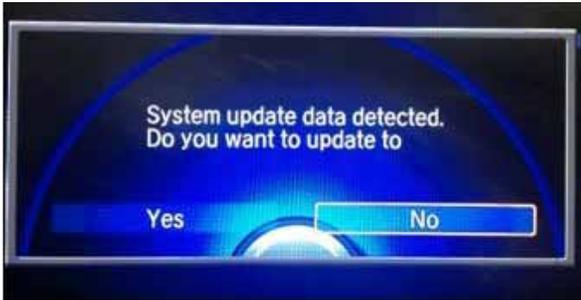
4. When the System update data detected screen appears, select **Yes**.

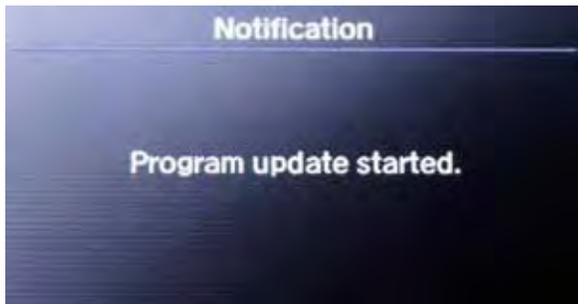
5. Both screens will shut off for about 10 seconds and reboot with the notification shown below on both screens.

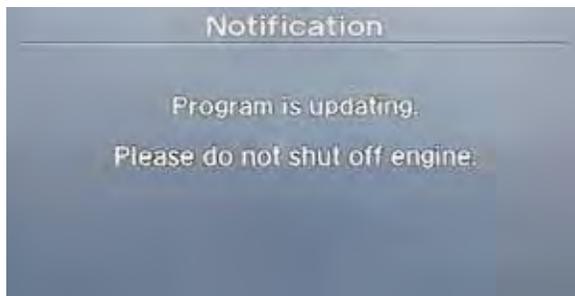
6. The notification below will appear on the upper display screen for the duration of the update process.

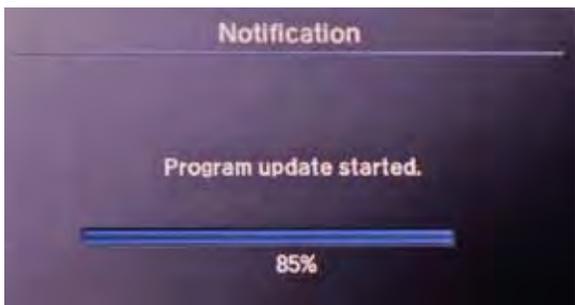
7. The software update will begin. A Notification screen loading bar will display on the touch screen.
NOTE: After the loading bar reaches 100%, it will go back to 0% for the second part of the update.

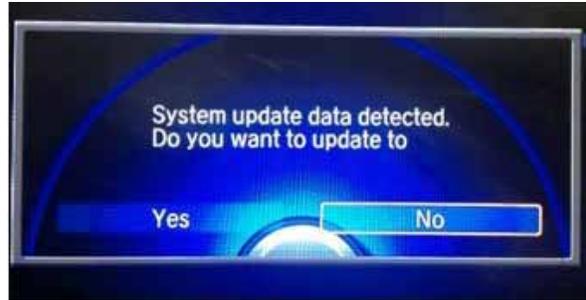
8. When the update is complete, the system will reboot to the H screen, and the System update data detected screen will reappear.

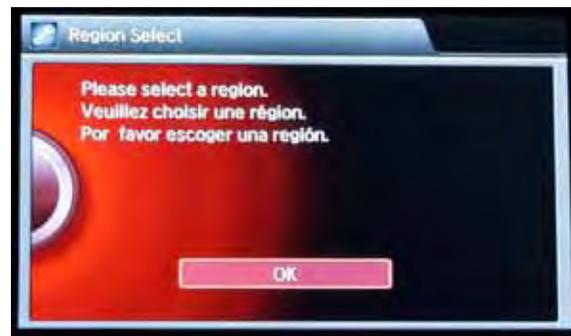
9. Select **No**, then press the engine start/stop button to select the vehicle OFF mode.
10. Remove the USB update device and wait at least 1 minute.
11. Press the engine start/stop button to select the vehicle ON mode.
12. When the Region Select screen appears, select **OK**.

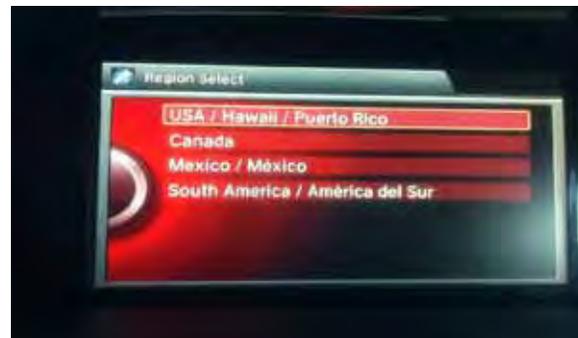
13. Select **USA/Hawaii/Puerto Rico**.

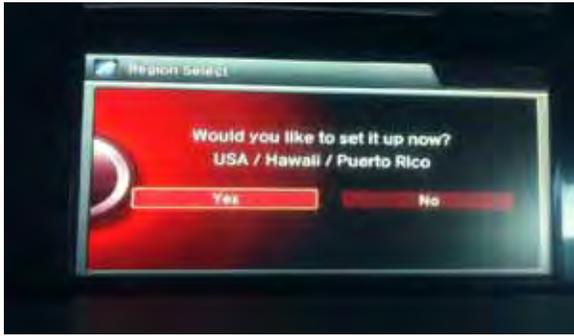
14. Select **Yes**.

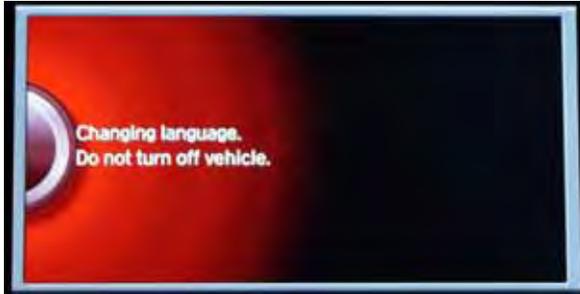
The screen below appears momentarily, then the system reboots to the Enter code screen.

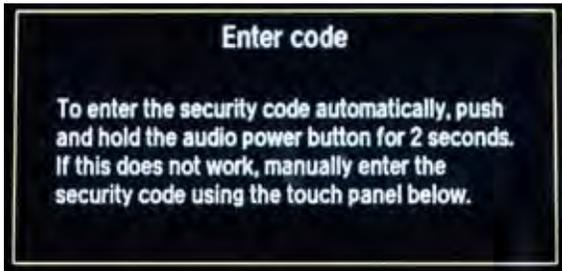
Upper display

15. The Enter code message and keypad will appear on the screens, although they may not appear at the same time. **Wait for both screens to appear.** Then, press and hold the VOL button for 2 seconds until you hear the beep.

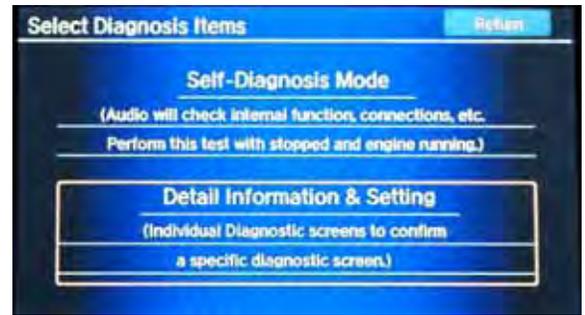
16. Press and hold the DISP, BACK, and VOL buttons until the Select Diagnosis Items screen appears.

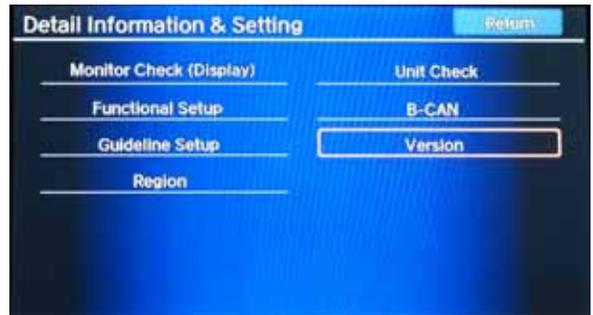
17. Select **Detail Information & Setting**.

18. Select **Version**.

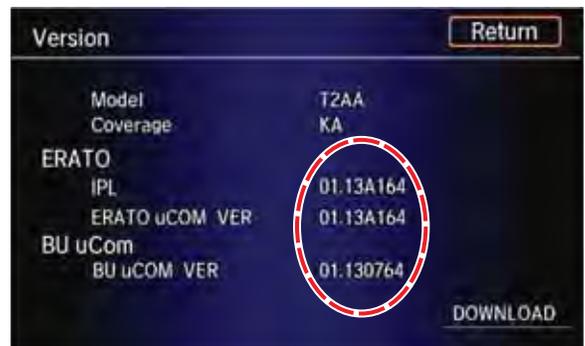
Accord

19. Verify that the software was updated to the new version as shown below.
