# Emissions Service Action

**Code: 23N5**

**Subject: 2012-2014 Passat with 2.0L TDI® Clean Diesel Engine  
ECM Software**

December 16, 2014

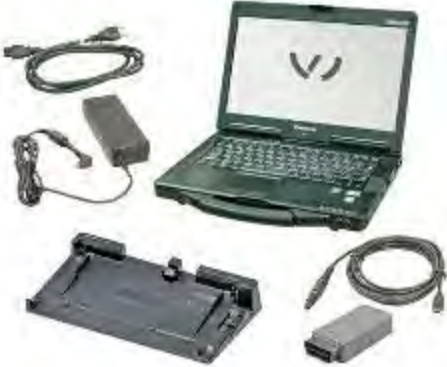
| | <ul style="list-style-type: none"> <li>• VAS 6150C Scan Tool (or equivalent)</li> </ul> |

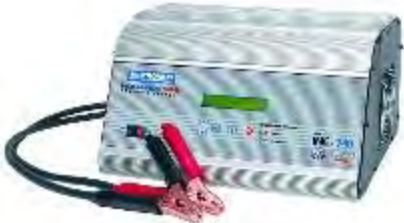
| | <ul style="list-style-type: none"> <li>• INC-940 Battery Charger (or equivalent)</li> </ul> |

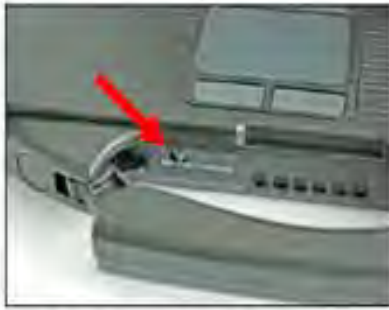
**VAS 6150 & VAS 6150A**  
(Front panel behind handle)

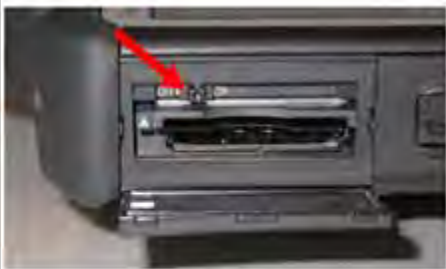
**VAS 6160/-VPC**  
(Upper left side behind SC/EX door)

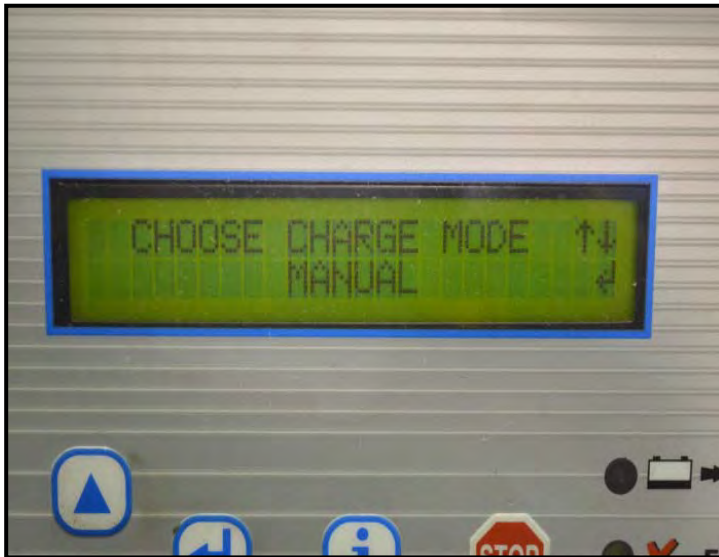
- ⇐ Install the inCharge 940 battery tester onto the vehicle, switch the tester on, then select the “manual” option <as shown>.
- Follow the on screen prompts to charge the battery during the SVM procedure.

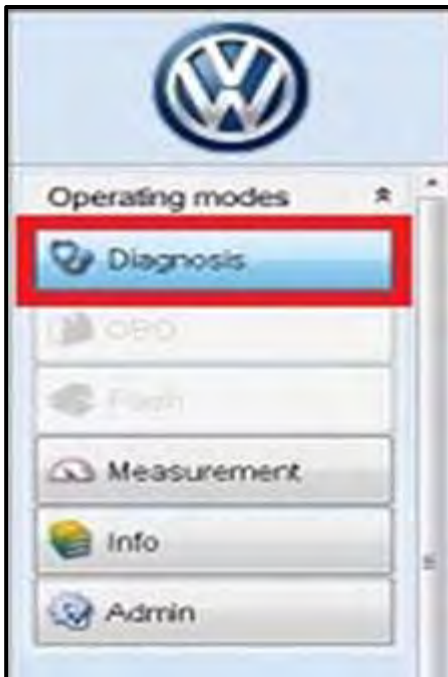
- Switch the ignition on.
- Apply the parking brake.
- Switch the headlights off.
- Attach an appropriate VAS tester to the vehicle.
- Start the ODIS program.
- ⇐ Upon ODIS startup, verify the “Diagnosis” operating mode is selected <as shown>.

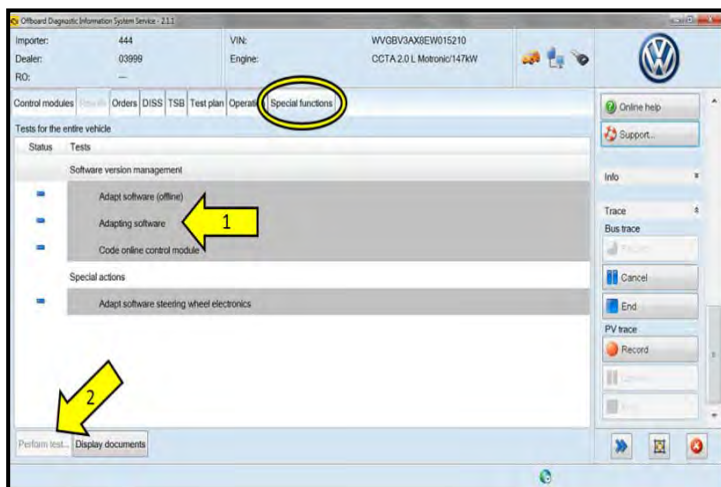
← Once the GFF scan is complete, select “Special functions” <circle>, then “Adapting Software” <arrow 1>, then select “Perform test” <arrow 2>.

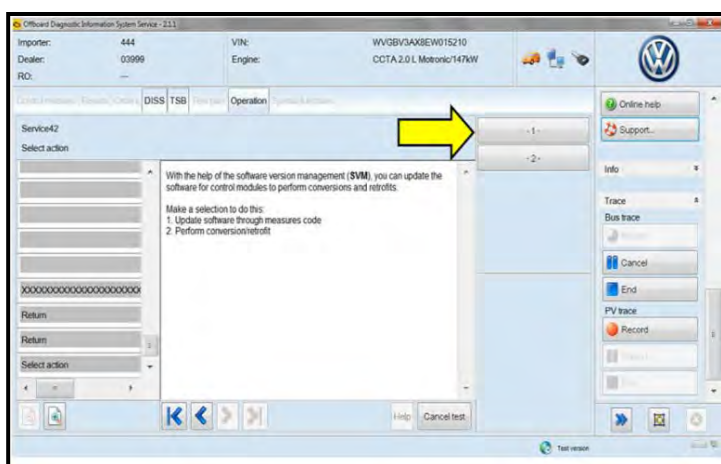
← Select the appropriate option to update **“through measures code”** <arrow>.

⚠ Note: Read this screen carefully. The option to update software through measures code is **NOT** always selection #1 on this screen.

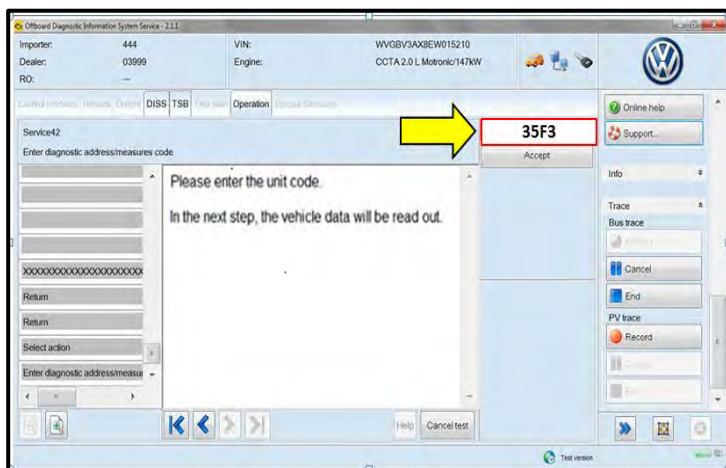
← Enter **“35F3”** <as shown>.

← Select “Accept” <arrow>.

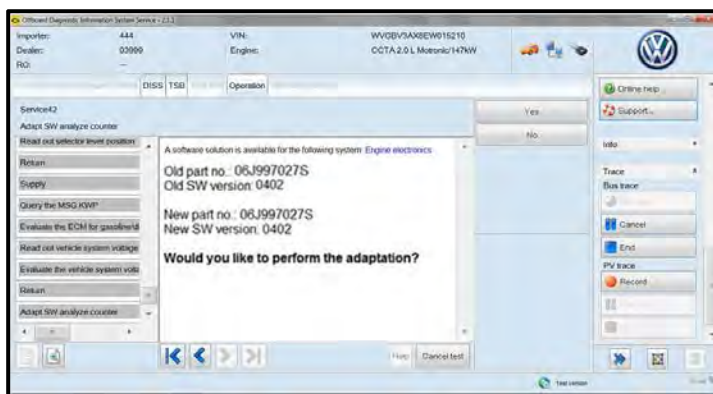
- ⇐ Compare the old and new part number and software version.
- ⇐ If the old and new software versions displayed are the same <as shown>,

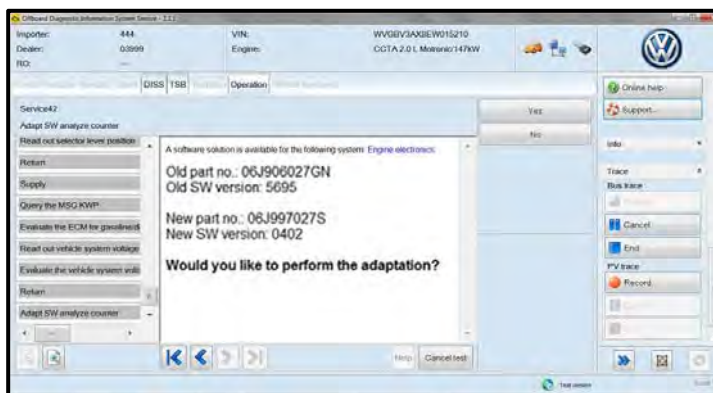
- ⇐ If the old and new software versions displayed are different <as shown>, Select "Yes" and follow the on-screen prompts to complete the test plan.
- Reference the ECM Software Change Table above for affected ECMs.

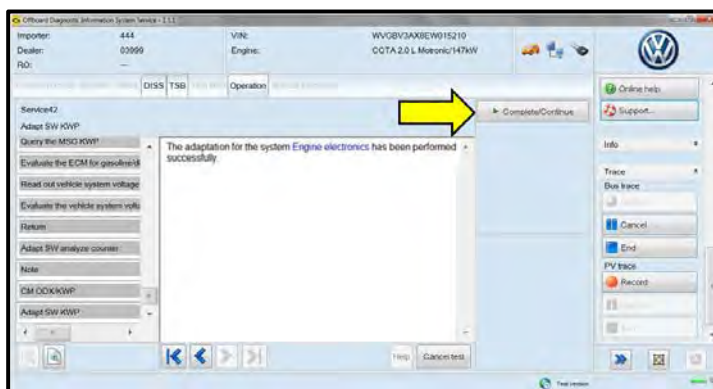
- ⇐ When the SVM update is complete a confirmation message is displayed <as shown>.
- ⇐ Select "Complete/Continue" <arrow>.

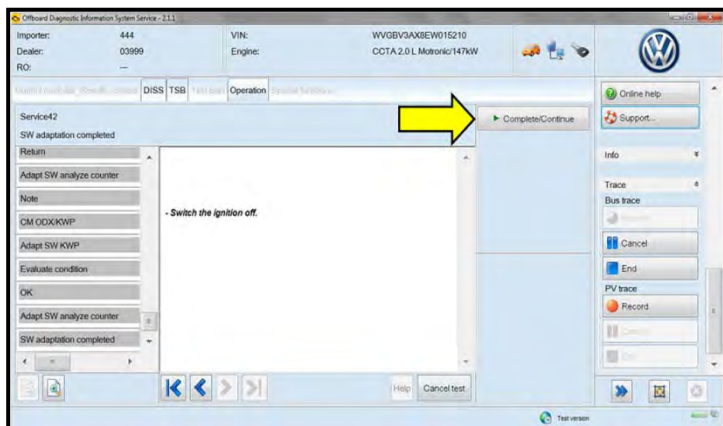
⇐ Switch the ignition off, then select “Complete/Continue” <arrow>.

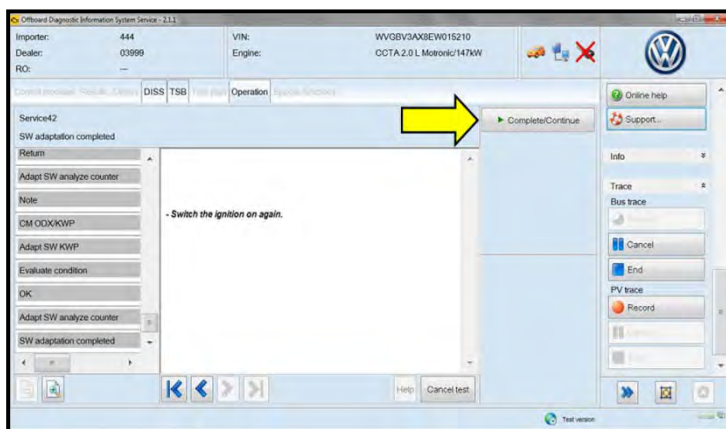
⇐ Switch the ignition on, then select “Complete/Continue” <arrow>.

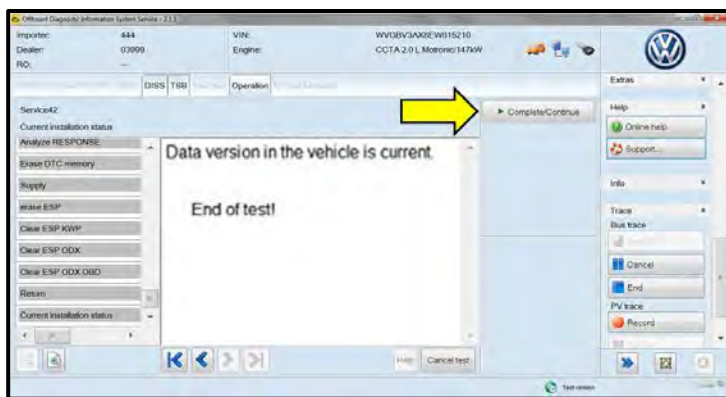
⇐ Select “Complete/Continue” <arrow>.

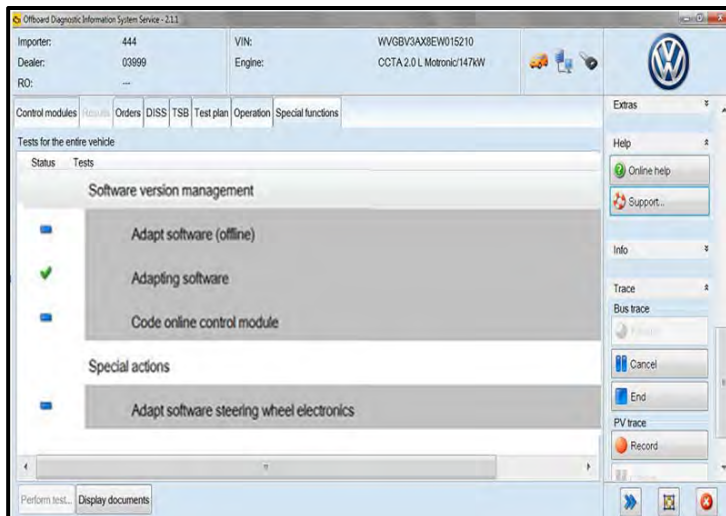
• The green check mark indicates the test plan was successfully carried out.
