SI B11 23 14
Engine

Service Action: Replace the Thermostat (F10)

F10 (5 Series Sedan)

With the N20 engine

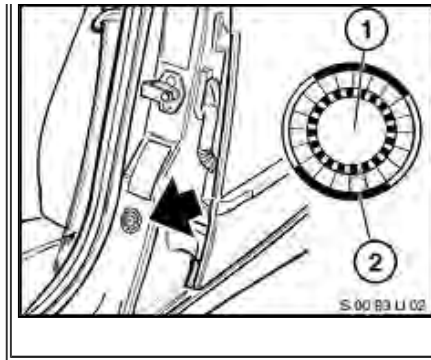
LABEL INSTRUCTIONS

This Service Action has been assigned code number **720**. After the vehicle has been checked and/or corrected, obtain a label (SD 92-453) and:

- A. Emboss your BMW center warranty number in the middle of the label (1);
- B. Punch out code number **720** (2), printed on the label; and
- C. Affix the label to the B-pillar as shown.

First check if a Service Action label with a code number **720** is already attached to the B-pillar.
