SB-10057340-8733

Service Action: Program Control Units (SCR)

MODEL

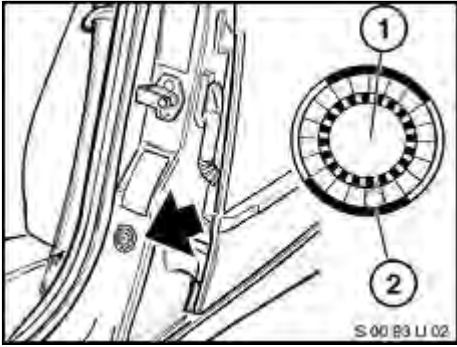
LABEL INSTRUCTIONS

<p>This Service Action has been assigned code number 730. After the vehicle has been checked and/or corrected, obtain a label (SD 92-464) and:</p> <ol style="list-style-type: none"> A. Emboss your BMW center warranty number in the middle of the label (1); B. Punch out code number 730 (2), printed on the label; and C. Affix the label to the B-pillar as shown.
--	---

If the vehicle already has a label from a previous Service Action/Recall Campaign, affix the new label next to the old one. Do not affix one label on top of another one, because a number from an underlying label could appear in the punched-out hole of the new label.
