Technical Service Bulletin

SUBJECT:		No: TSB-15-13-001	
ENGINE STALL (LOW ENGINE SPEED, HIGH AMBIENT TEMPERATURE)		DATE: March, 2015	
		MODEL: 2014-15 Mirage	
CIRCULATE TO:	<input type="checkbox"/> GENERAL MANAGER	<input type="checkbox"/> PARTS MANAGER	<input checked="" type="checkbox"/> TECHNICIAN
<input checked="" type="checkbox"/> SERVICE ADVISOR	<input checked="" type="checkbox"/> SERVICE MANAGER	<input checked="" type="checkbox"/> WARRANTY PROCESSOR	<input type="checkbox"/> SALES MANAGER

PURPOSE

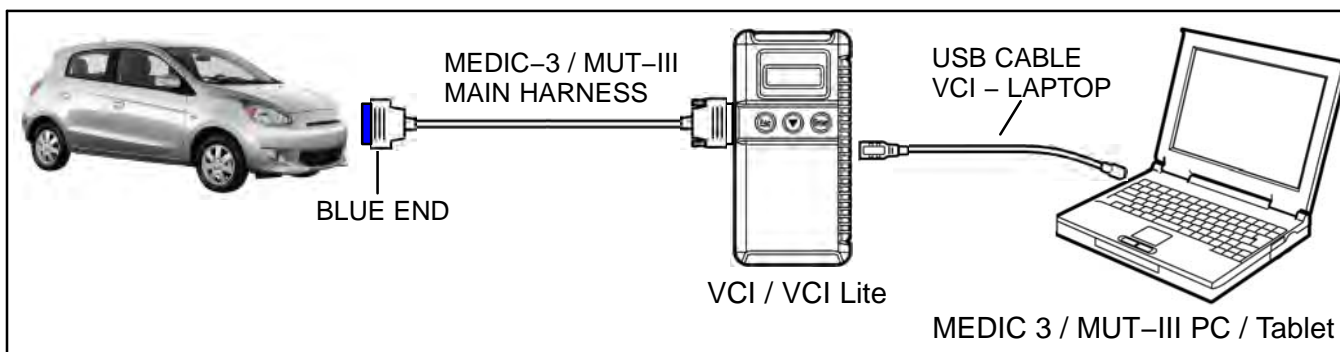
Connect the equipment as follows:

NOTE: VCI and MEDIC 3 Laptop shown for illustration purposes only

- Turn the MEDIC PC/tablet on. If the battery indicator in the lower right hand corner of the screen does not show a full charge, it is recommended that either the battery be charged prior to beginning, or that reprogramming be completed with the A/C power adaptor connected.
- Connect the USB cable to the VCI/VCI Lite.
- When the laptop/tablet displays the MUT-III main screen, connect the USB cable to the device.
- Connect the MUT-III main harness with the blue DLC connection to the VCI/VCI Lite.
- Connect the blue connection of the MUT-III main harness to the vehicle's data link connector.
- Turn the VCI power switch ON . Verify that the indicator lamp in the upper right corner of the screen is green.

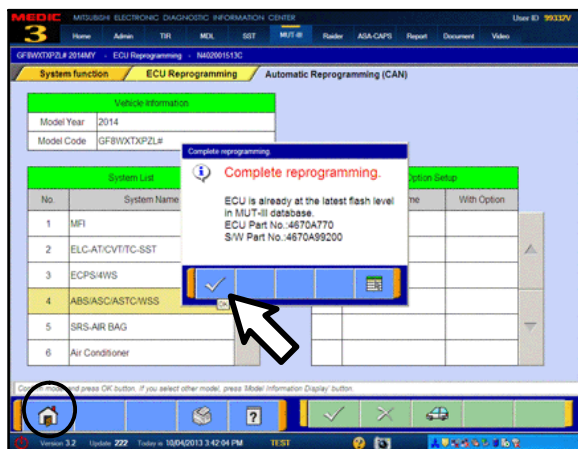
ECM TO LATEST VERSION

If a “Complete Reprogramming” message **does not** appear, continue with step l.

If the message seen at left is displayed, the ECM software is already at the most current level. Do not continue with the reprogramming procedure. This TSB does not apply.

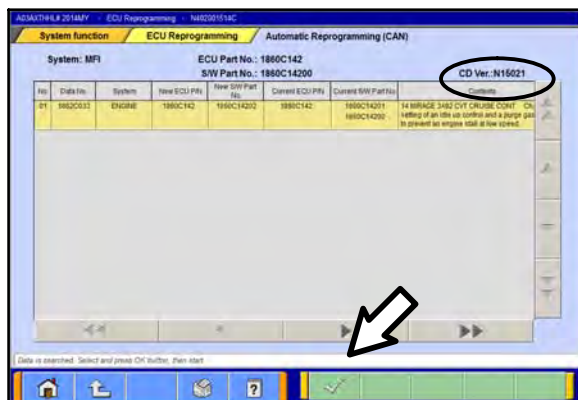
- n. The Automatic Reprogramming (CAN) database screen will display.

Confirm the database number at the top right of the table is N15021 or higher.

If more than one row is displayed in the table, refer to the ECM Reprogramming Chart on Page 2 to select the correct row.

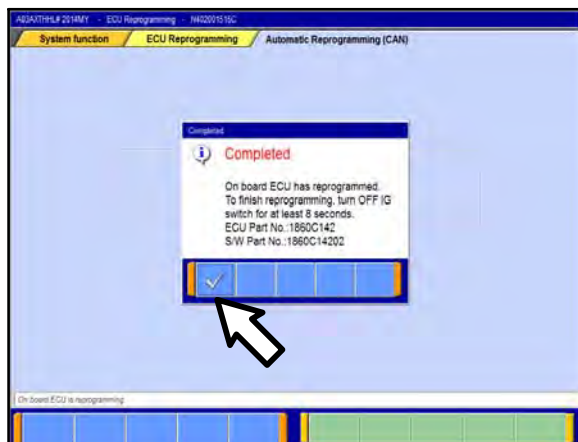
- q. This message will display when ECM reprogramming is successfully completed. Confirm the "New S/W P/N" displayed matches the table at the beginning of this TSB. Then click the check mark to clear the message.
