SI B27 01 15
Intermediate and Special Transmission

Service Action: Replace Park Lock Actuator

I01 (i3)

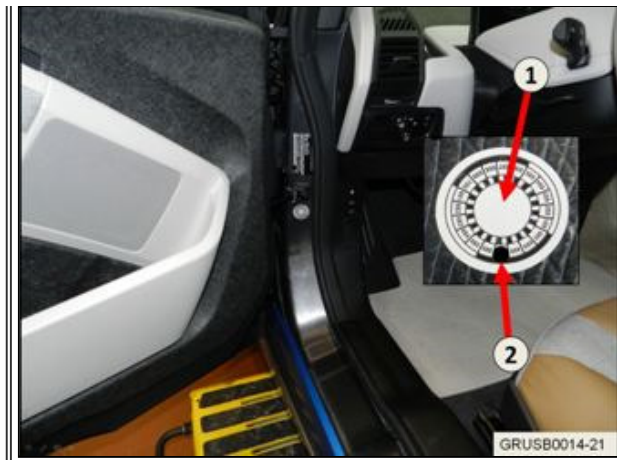
<p>This Service Action has been assigned code number 732. After the vehicle has been checked and/or corrected, obtain a label (SD 92-464) and:</p> <p>A. Emboss your BMW center warranty number in the middle of the label (1);</p>
--	--

- B. Punch out code number **732 (2)**, printed on the label; and
- C. Affix the label to the A-pillar as shown.

If the vehicle already has a label from a previous Service Action/Recall Campaign, affix the new label next to the old one. Do not affix one label on top of another one because a number from an underlying label could appear in the punched-out hole of the new label.
