# Emissions Service Action

## SB-10058669-2682

Subject: **Certain 2010-2014 Volkswagen Vehicles with 2.0L TDI® Clean Diesel Engine  
ECM Software Update**

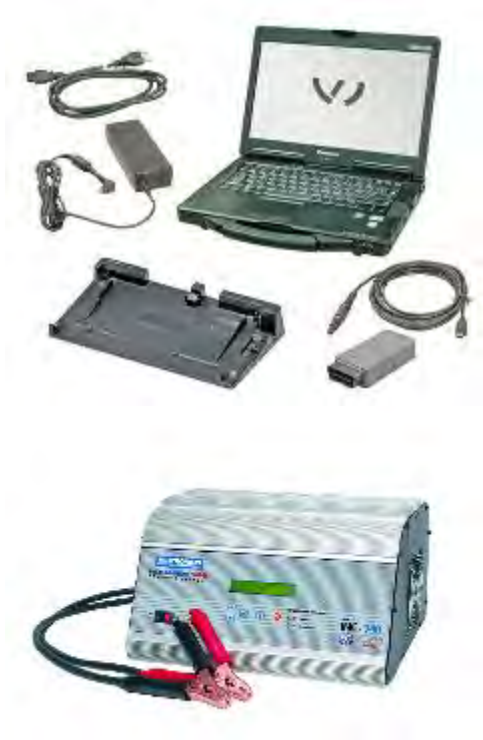
**Required Tools:**

- VAS 6150C Scan Tool (or equivalent)

- INC-940 Battery Charger (or equivalent)

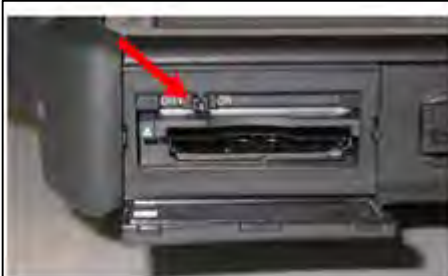
**VAS 6150B**  
(Middle right side behind WIRELESS door)

**VAS 6160/-VPC**  
(Upper left side behind SC/EX door)

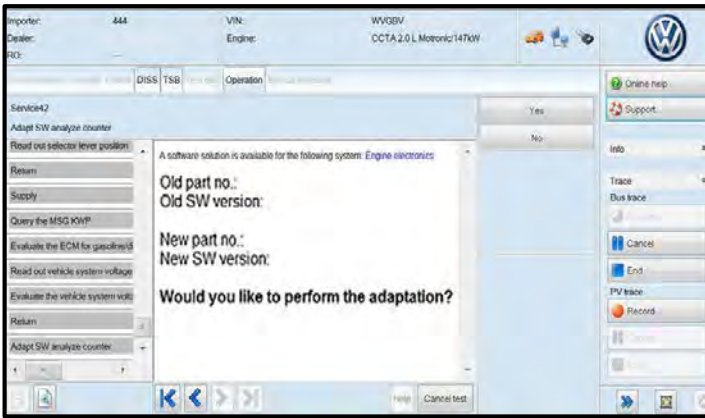
⇐ Compare the old and new part number and software version.

⇐ If the old and new software versions displayed are the same. **Work Complete, proceed to Section C**

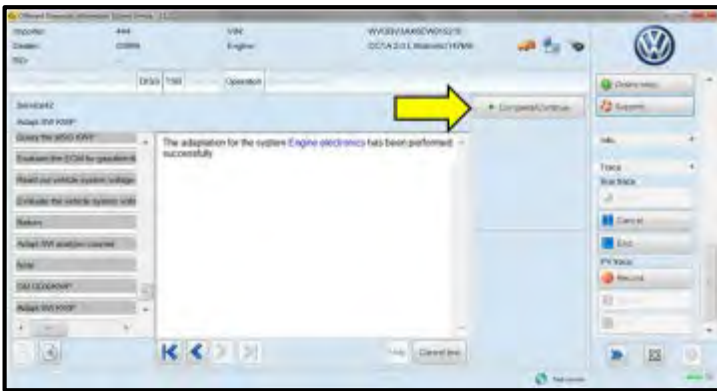
⇐ When the SVM update is complete a confirmation message is displayed <as shown>.

⇐ Select "Complete/Continue" <arrow>.

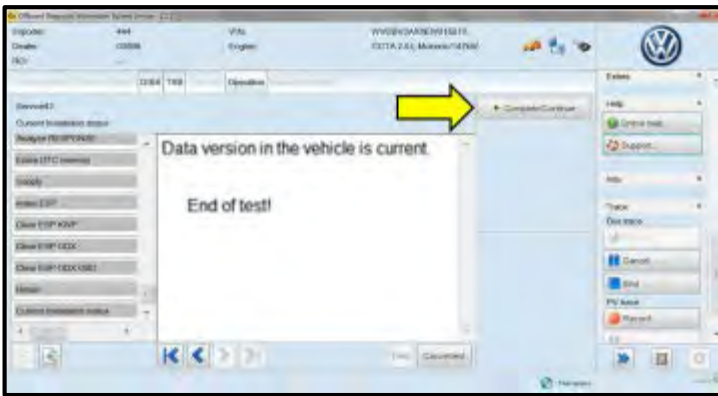
⇐ Select “Complete/Continue” <arrow>.
