**August 21, 2015**

02207 Version 1

## Product Update: Electronic Power Steering (EPS) Software Update

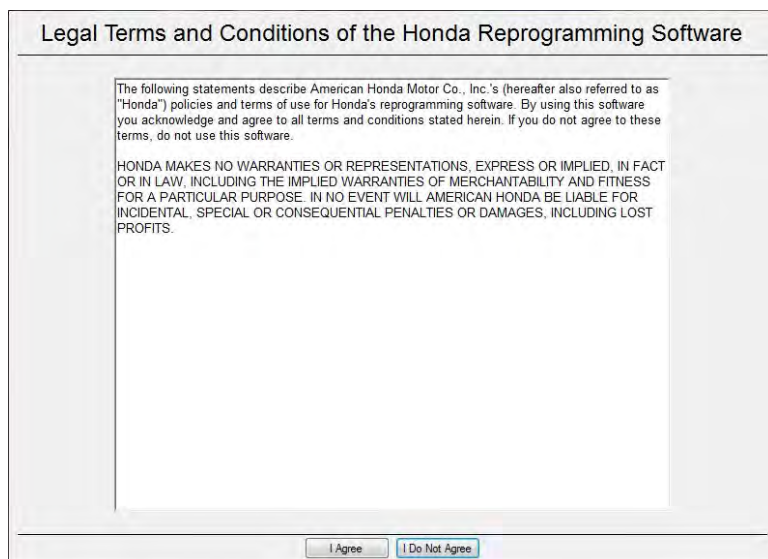
4. Click on the **I Agree** button.

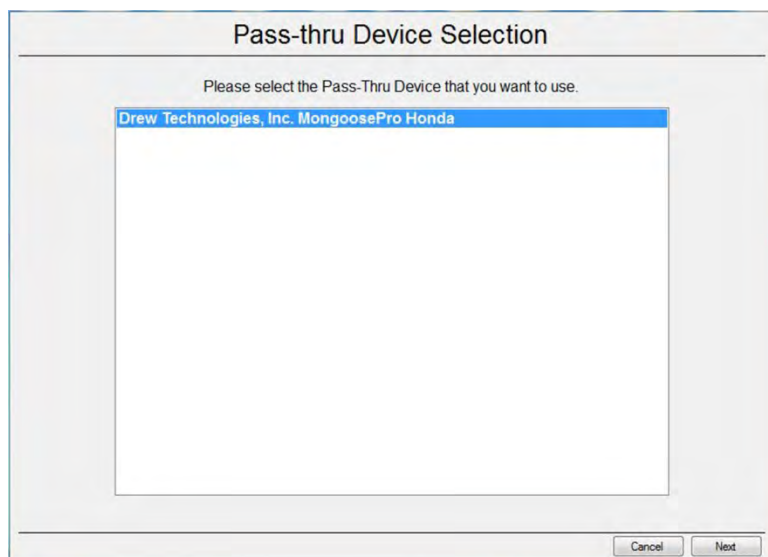
5. Click the **Next** button in the **Pass-thru Device Selection** screen.

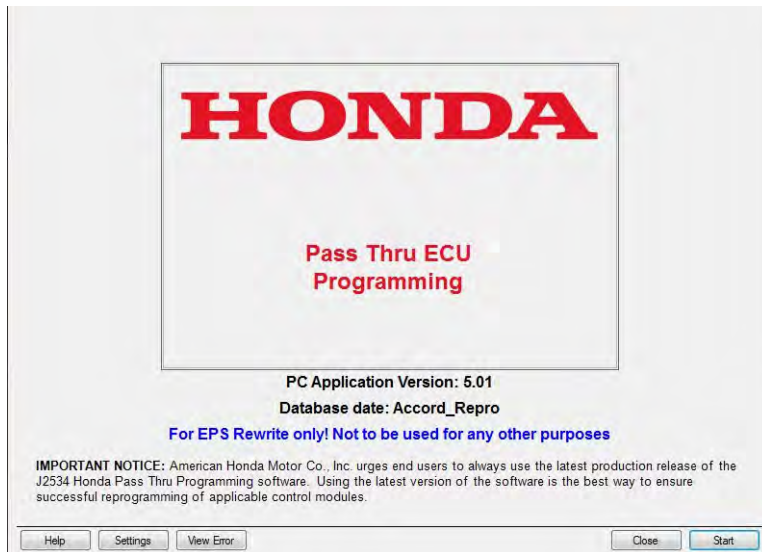
6. Click on the **Start** button.

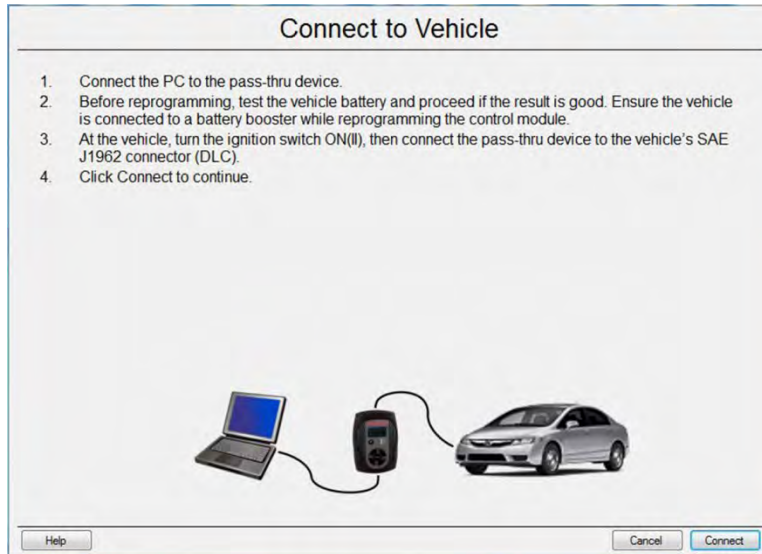
7. Click on the **Connect** button.

**NOTE: Although the MVCI is shown in the screen captures, the Mongoose Pro Honda Interface Tool is actually used.**

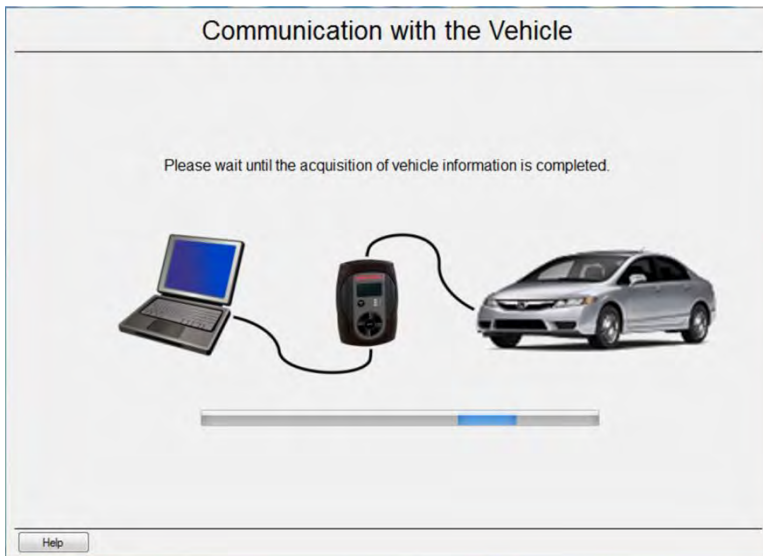
8. You will see the **Communication with the Vehicle** screen.

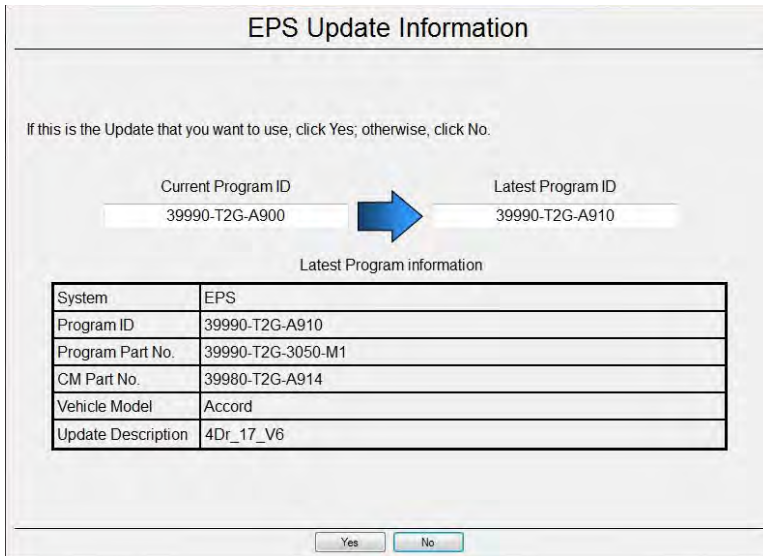
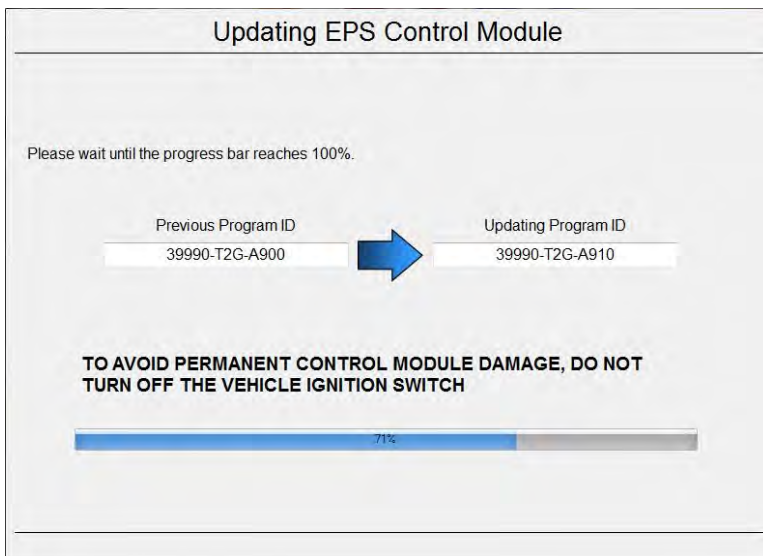
9. Wait for the **EPS Update Information** screen to appear. Select **Yes**. The update will start and the screen will show a loading bar.

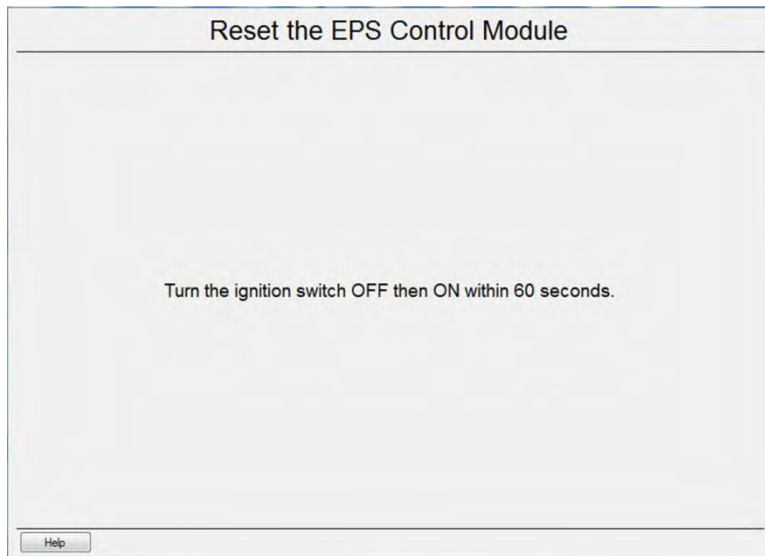
10. Turn the ignition to OFF, then to ON within 60 seconds to complete the updating procedure.

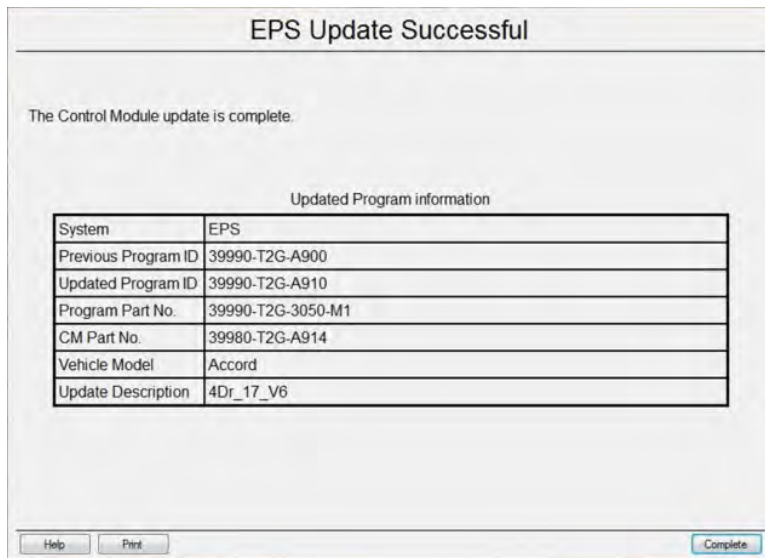
11. The **EPS Update Successful** screen appears. Select **Complete**, then disconnect the Mongoose Pro Honda Interface Tool.
