HYUNDAI NEW THINKING. NEW POSSIBILITIES.	GROUP CAMPAIGN	NUMBER 15-01-024
	DATE MAY 2015	MODEL(S) VARIOUS
Technical Service Bulletin		
SUBJECT: BLUETOOTH AND VOICE RECOGNITION SOFTWARE UPDATE (SERVICE CAMPAIGN TX5)

DESCRIPTION: This bulletin describes the procedure for updating the Bluetooth and Voice Recognition software for certain 2013 Model Year Navigation and Audio systems. This update expands phone compatibility, improves Bluetooth connection, improves voice recognition and fixes the transfer of an active phone call after 14 minutes and 59 seconds from the Radio to the handset (private mode).

Applicable Vehicles:	<p align="center">Non NAVIGATION</p> Certain '13MY Tucson (LM) - pages 2-5 Certain '13MY Santa Fe Sport (AN) – pages 6-10 Certain '13MY Santa Fe Sport (AN) [Color Touchscreen] – pages 11-13 Certain '13MY Sonata (YFa) - pages 6-10 Certain '13MY Elantra (All applicable VINs) [One Knob] – pages 2-5 Certain '13MY Elantra (All applicable VINs) [Two Knob] – pages 6-10
	<p align="center">NAVIGATION</p> Certain '13MY Sonata (YFa) and Elantra (All) - pages 14-19

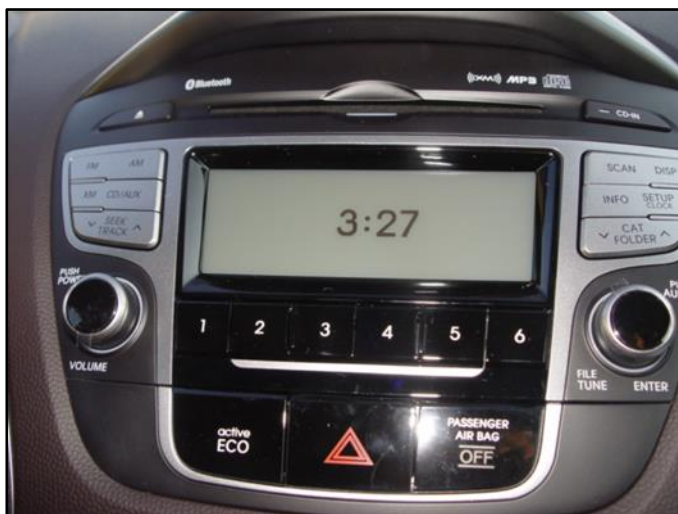
Note: The Elantra [One Knob] and the Tucson (Non Navigation) uses the exact same procedures for updates. Example steps in this section will demonstrate only one of the systems but can be applied to both vehicles.

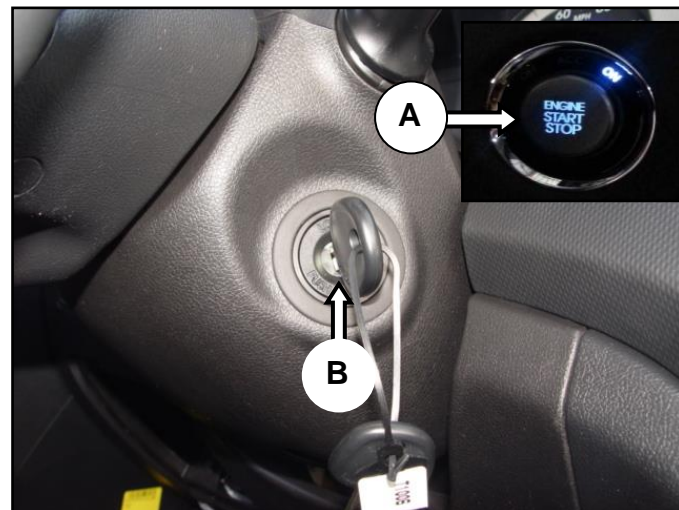
1. Start the vehicle by using the key (B), or with the Start Stop Button (A).

To start the vehicle using the Start/Stop Button, depress the brake and push the Start/Stop Button (A) once.

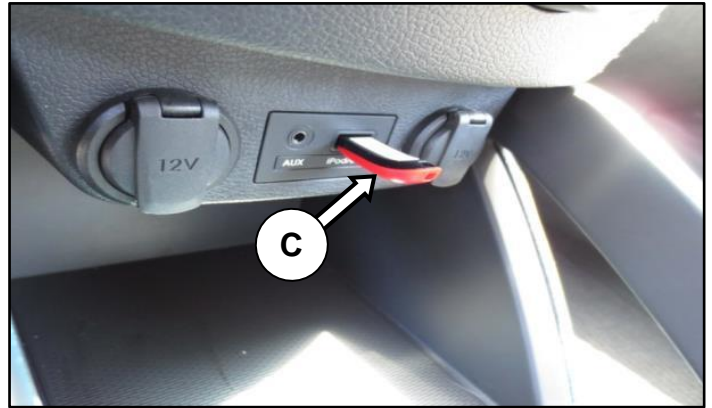
2. After the vehicle has been started, insert the USB update stick into vehicle USB port (C) and allow the music on the USB to play for greater than four seconds.

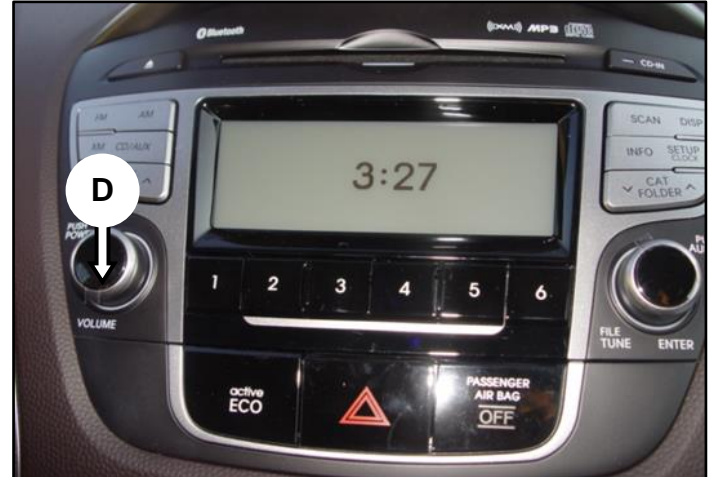
3. Before checking the Software version turn the radio OFF by pressing the power button (D) once.

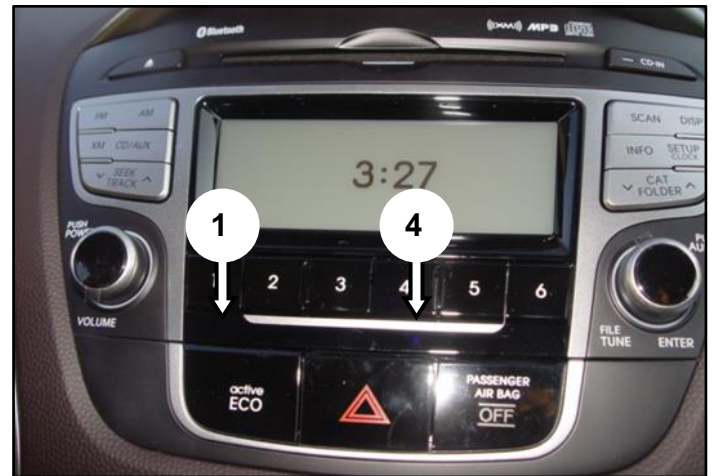
4. With the radio OFF, press and hold both the preset button [1] and [4] simultaneously for 3 seconds.

Next release both buttons then tap button [1] four times.

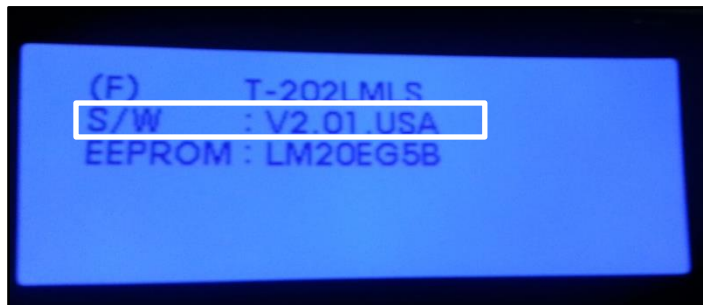
- 5. If the current S/W version is not V4.00.USA or higher end Tucson update procedure here. Software update is not possible.

Tucson update requires a minimum previous/current version V4.00 to start/complete the update.

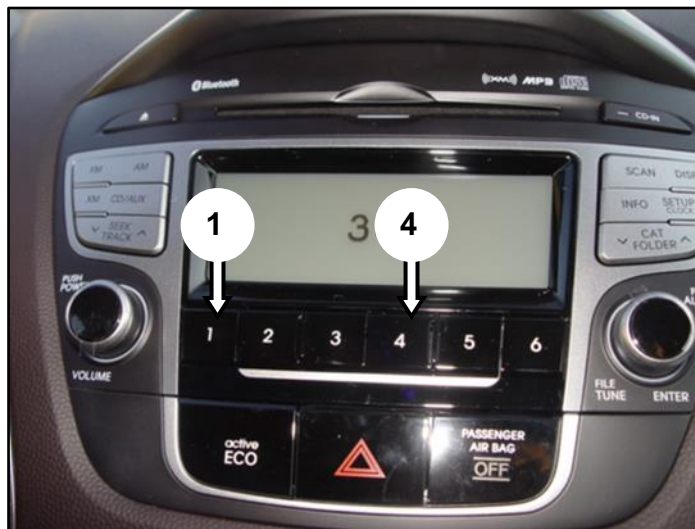
- 6. With the radio OFF, press and hold both the preset button [1] and [4] simultaneously for 3 seconds.

Next release both buttons then tap button [1] four times.

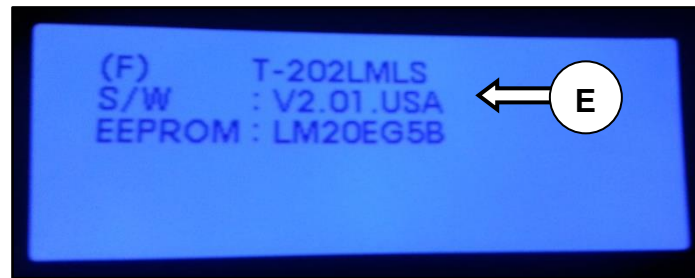
- 7a. Next press preset button [1] when the version information screen (E) is displayed.

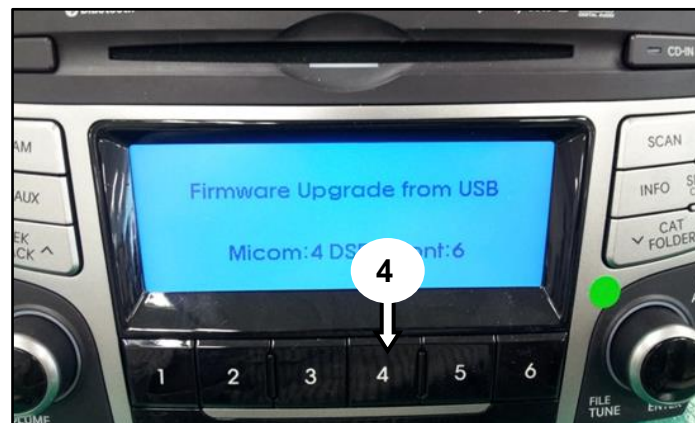
- 7b. Press preset button [4] Micom to start the update.

Do not interrupt the update while in progress. Any interruptions like ignition OFF or USB removal can result in the head unit being permanently disabled.

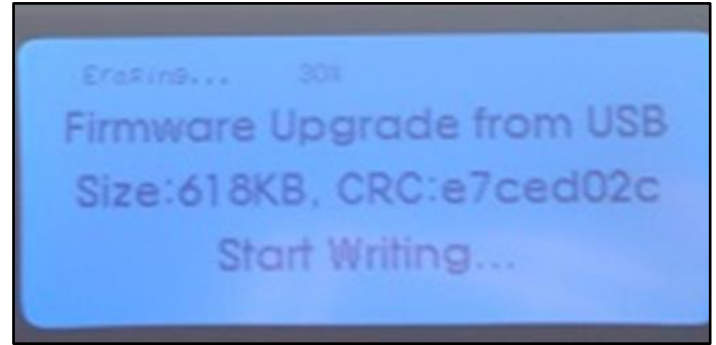
8. The update will take approximately 3 minutes.

If the audio unit does not turn off within 5 seconds of resetting, the update has failed.

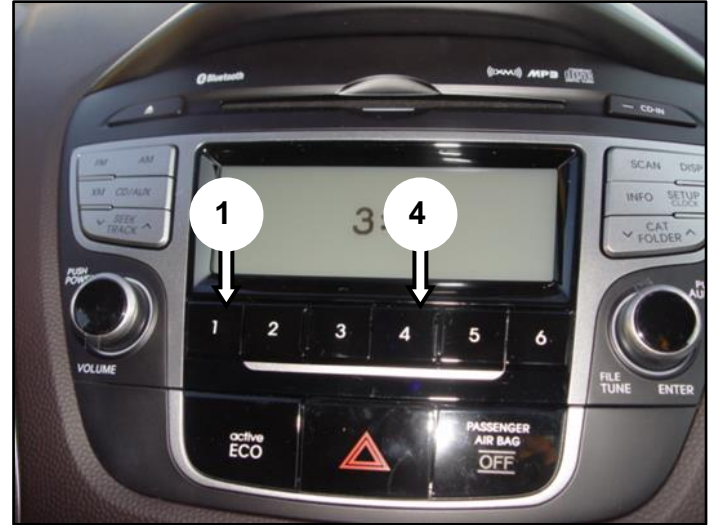
9. Update version confirmation.

With the radio OFF, press and hold both the preset button [1] and [4] simultaneously for 3 seconds.

10. Updated Tucson S/W version should now be: **V7.01.USA**

11. Updated Elantra S/W version should now be: **V8.00.USA**

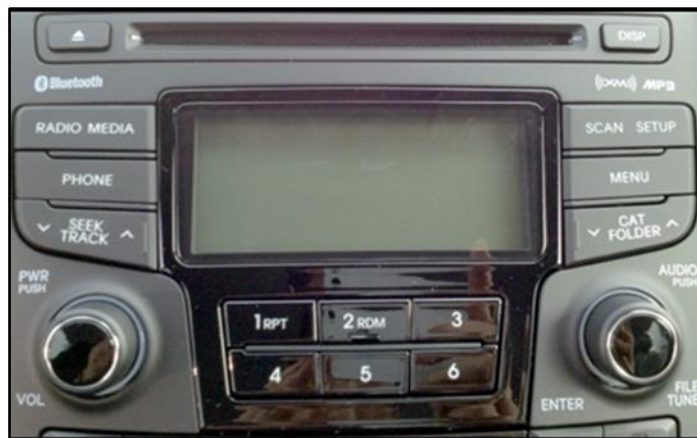
1. Sonata (YFa) Non Navigation Bluetooth and Voice Recognition Update.

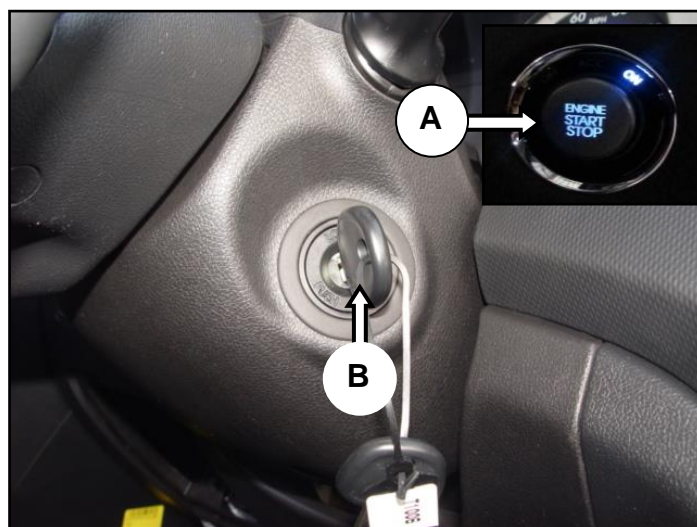
2. Start the vehicle by using the key (B), or with the Start Stop Button (A).

To start the vehicle using the Start/Stop Button, depress the brake and push the Start/Stop Button (A) once.

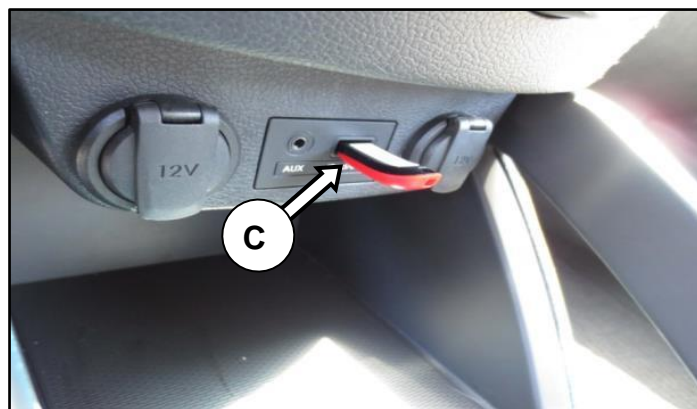
3. After the vehicle has been started, insert the USB update stick into vehicle USB port (C) and allow the music on the USB to play for greater than four seconds.

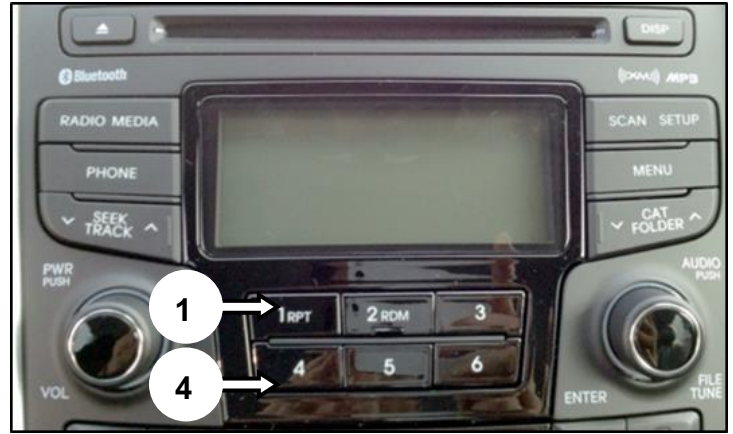
4. With the radio OFF, press and hold both the preset button [1] and [4] simultaneously for 3 seconds.

Next release both buttons then tap preset button [1] four times.

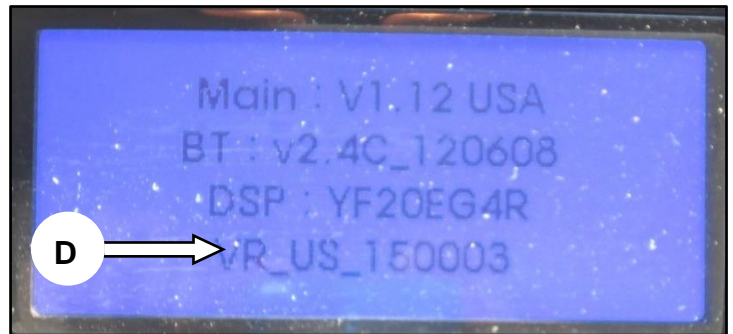
5. If the **VR US** version is **170013** or higher do not attempt update. End update procedure here, head unit is already updated and does not require further updates.

If **VR US** version is lower [D], continue to the steps below.

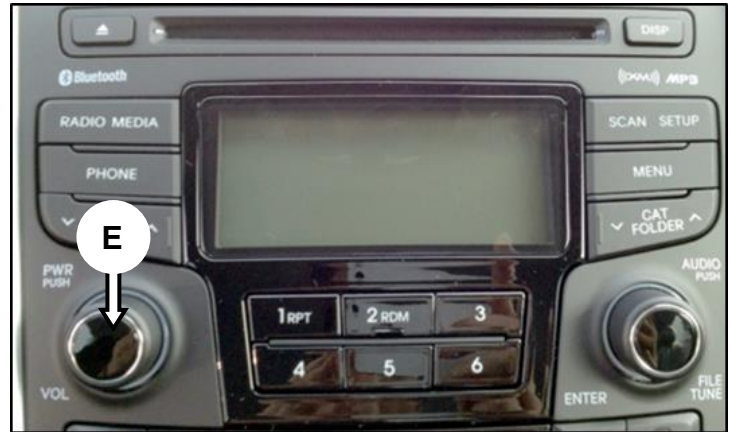
6. After the **VR US** version has been verified lower than **170013** turn the radio OFF by pushing the power button [E] and repeat step (4).

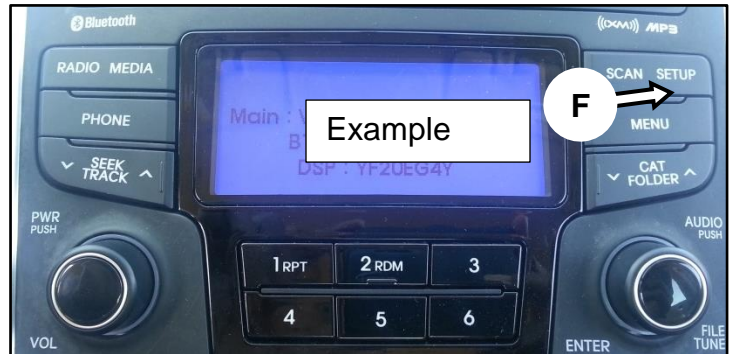
7. After the engineering menu is displayed, press the "SETUP" hard button [F] on the right side of the radio.

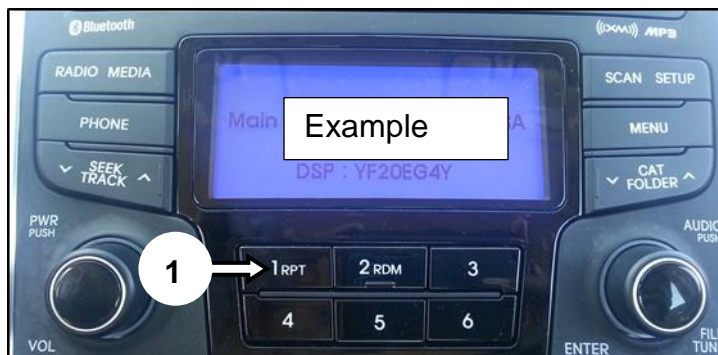
8. Next press preset button [1].

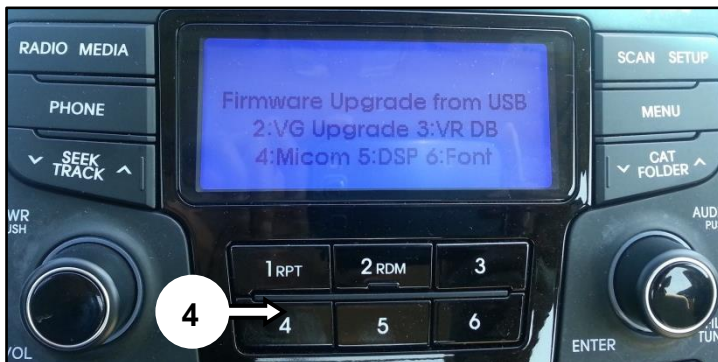
9. Next press preset button [4] to start the update.

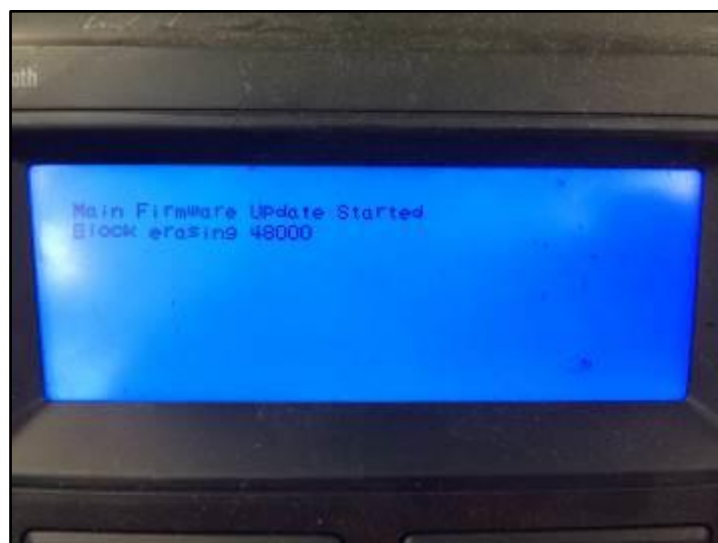
10. The Micom Firmware Update will take approximately 20 to 25 minutes.

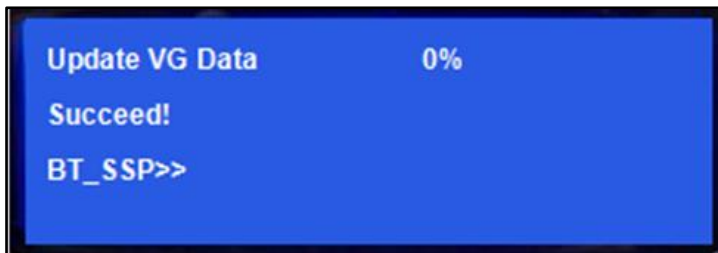
11. Update performs in the order below :

BT → VG → VR → MAIN → DSP → FONT

BT_SSP >>
 BT_SSP >> VG >>
 BT_SSP >> VG >> VR >>
 BT_SSP >> VG >> VR >> MAIN >>
 BT_SSP >> VG >> VR >> MAIN >> DSP >> FONT >> Finish

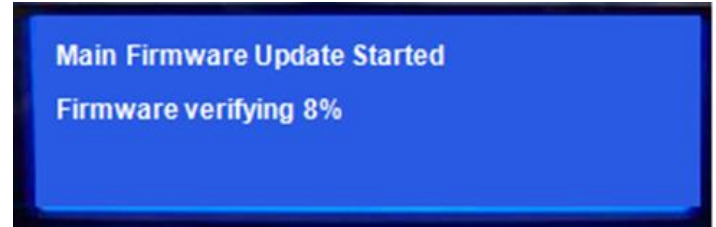
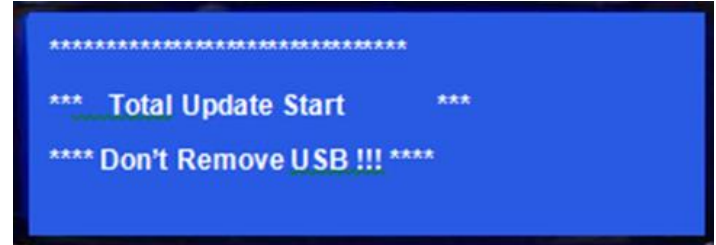
- 12. The Radio will automatically reset and then turn off after the update is complete.

If the audio unit does not turn off within 10 seconds of resetting, the update has failed.

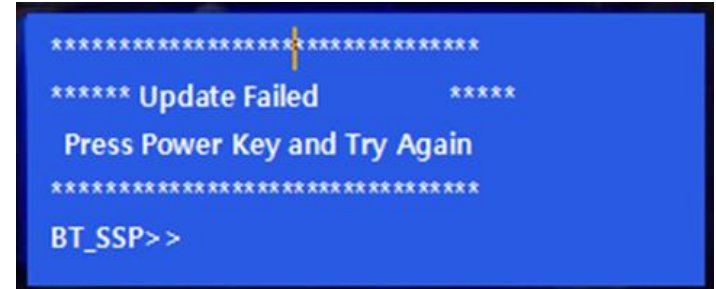
- 13. If the Update Failed message shown to the right is ever displayed during the update, the contents of the USB may have become damaged.

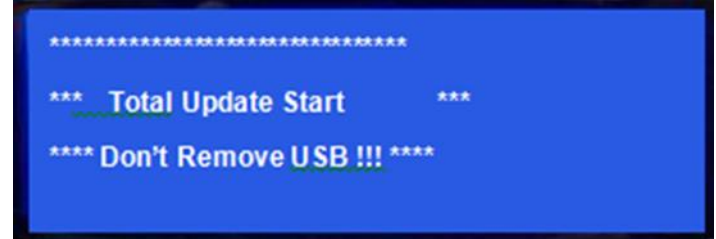
- 14. If the update was successful, the sample message shown to the right will be displayed.

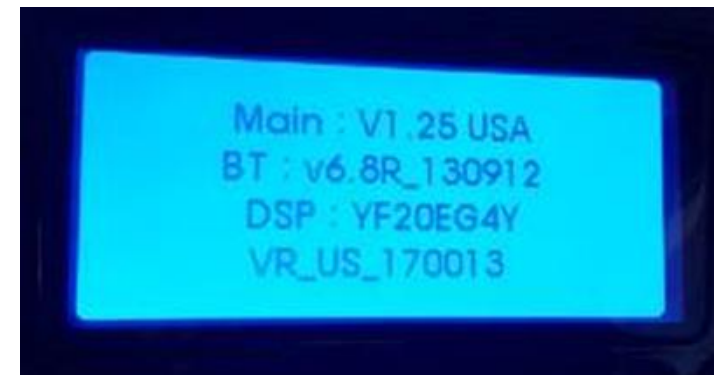
Sonata (YFa).

- 15. After removing the USB update stick, confirm that the software is updated using step (4) above.

Main V1.25
BT: V6.8R
VR_US_170013

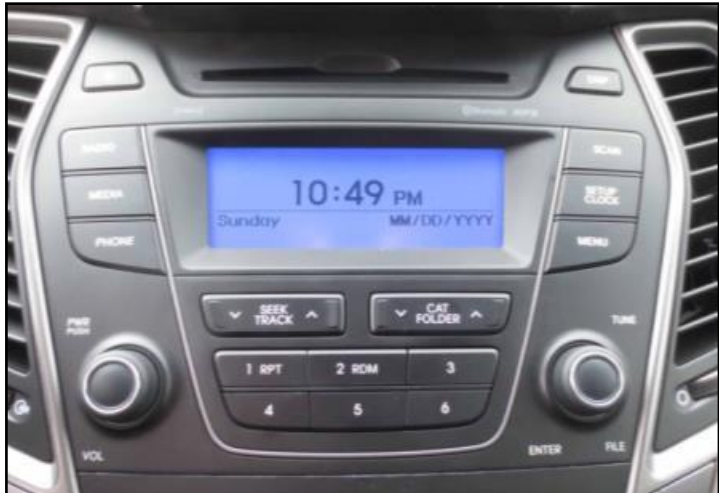
16. Santa Fe Sport (AN).

Software version after update is complete:

Main V1.28
BT: V6.8R
VR_US_170013

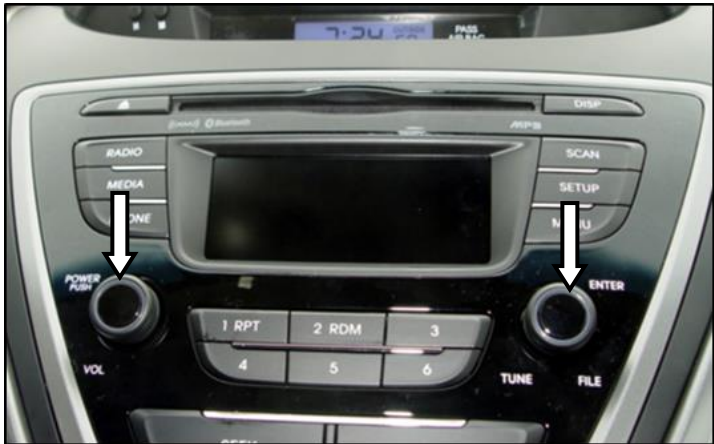
17. Elantra (MD)

Software version after update is complete:

Main V1.14
BT: V6.8R
VR_US_170013

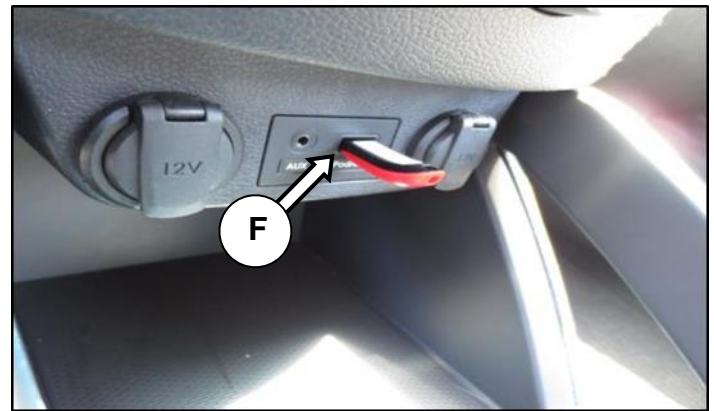
2. With the vehicle's engine running and the radio in the **OFF** state, insert the USB stick (F).

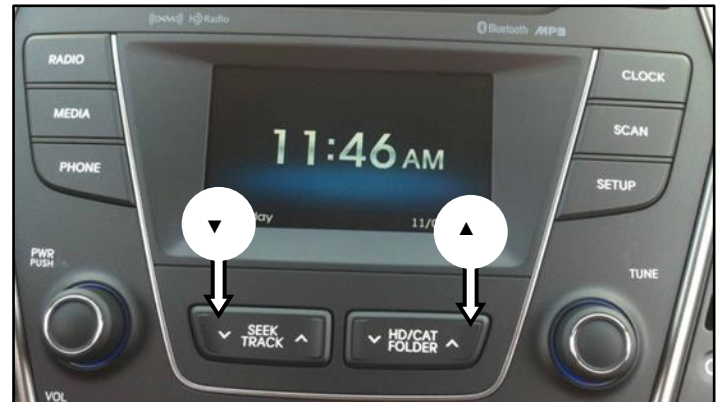
3. Before conducting the update, confirm the current S/W version.

With the radio **OFF**, Press the 'SEEK(▼)' button and the 'HD/CAT FOLDER(▲)' button for 2 seconds simultaneously then release both buttons and then tap the 'SEEK(▼)' button 4 times.

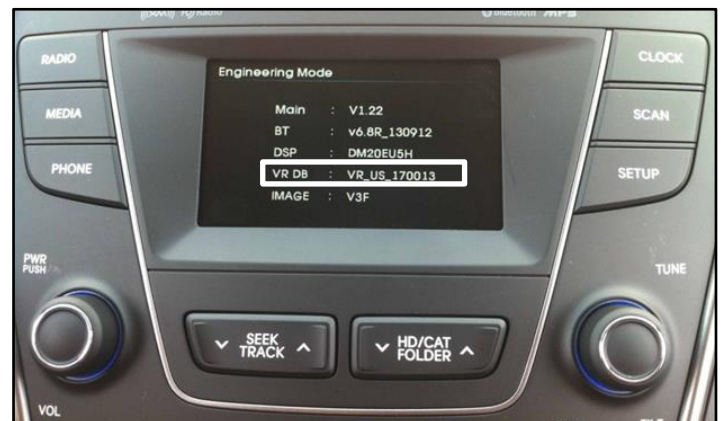
4. If the **VR DB:** is **VR_US_170013** do not attempt to update. No update is needed, end update procedures here.

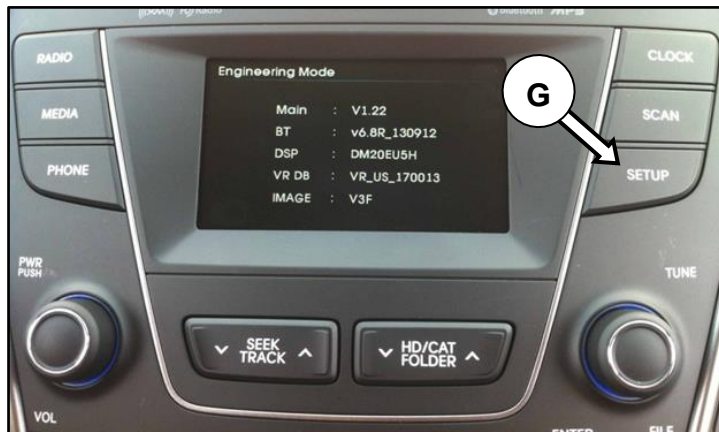
- 5. While inside the 'Engineering Mode', press the **'SETUP'** button (G).

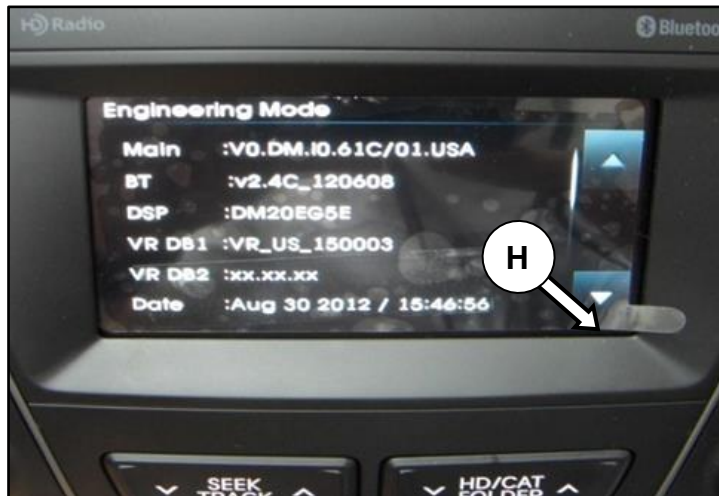
- 6. Touch '▼' soft key (H) on the display screen until **"Firmware Update by USB"** is displayed on the screen.

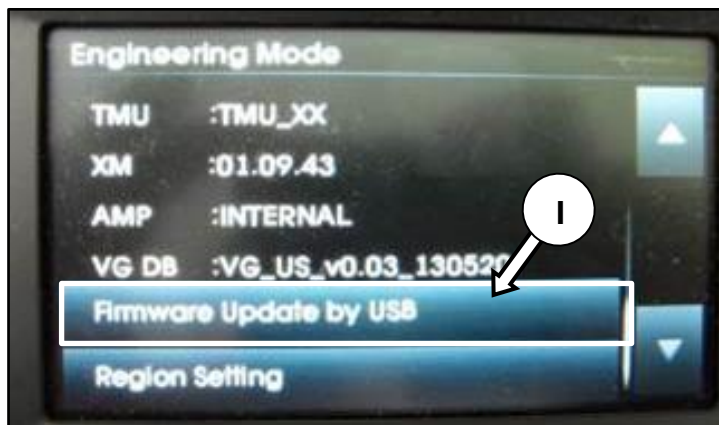
- 7. Touch **"Firmware Update by USB"**.

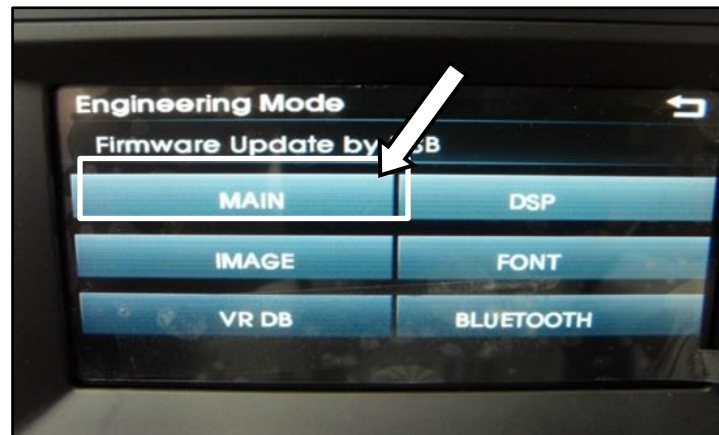
- 8. Touch 'MAIN' on the display screen to start the upgrade of the main operating software.

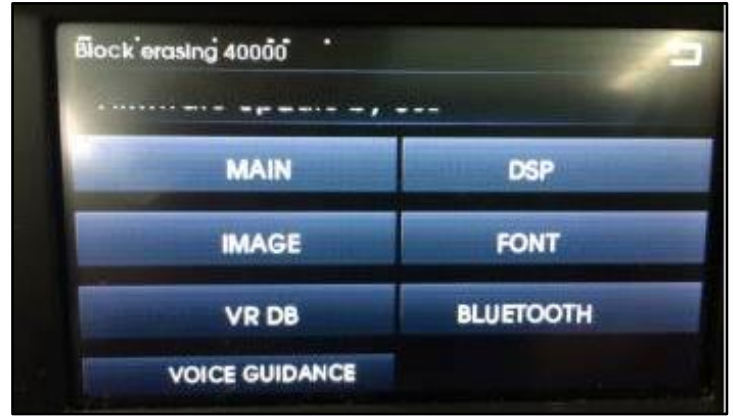
- 8a. The update will take approximately 5 minutes.

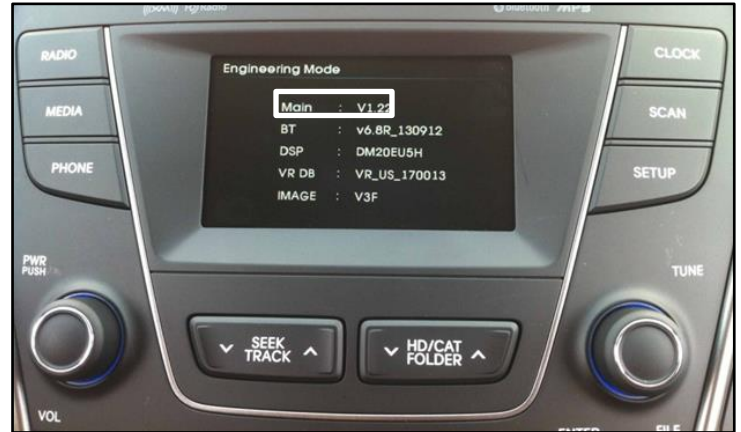
- 9. After the MAIN software update is complete, verify that the software version has been updated successfully.

Software version after update is complete:
Main: V1.28

If the Main version is not **V1.28** conduct update steps (3) – (9) again.

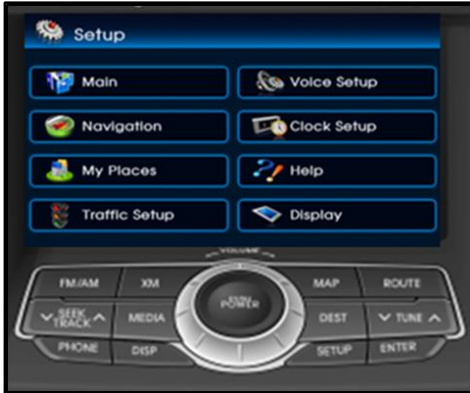
1. Sonata (YFa)

- 1a. The Sonata and Elantra Navigation system use the exact same procedures for updates; example steps in this section will demonstrate only one of the systems but can be applied to both vehicles.
- 2. With the vehicle's engine running and the radio ON, insert the USB stick (J).

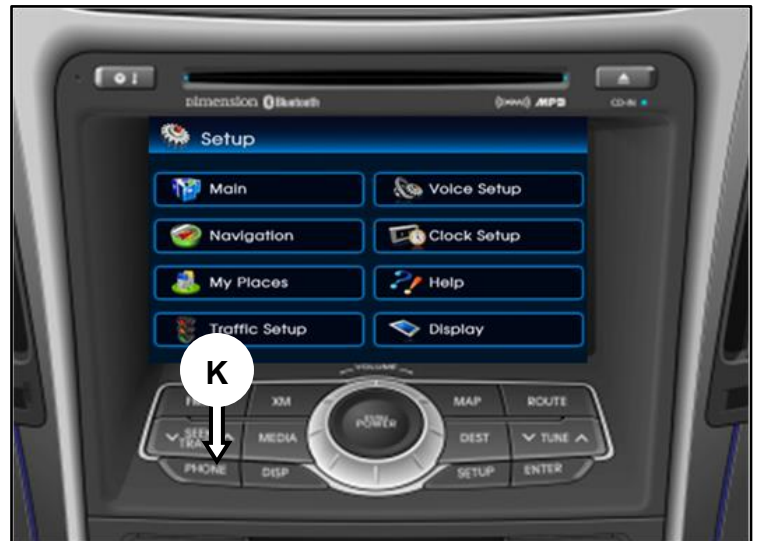
Sonata (YFa)

- 3. After pressing 'Agree' on the disclaimer screen, press the Phone button (K).

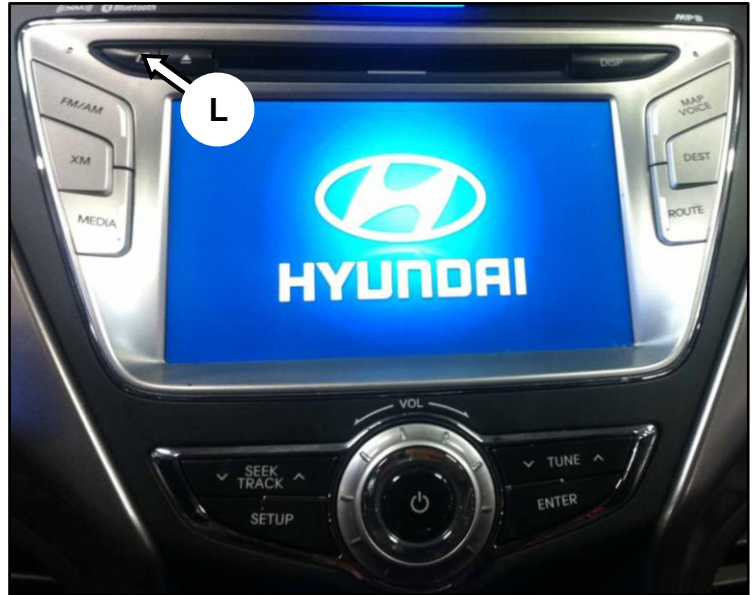
Elantra (ALL)

4. After pressing 'Agree' on the disclaimer screen, press the Phone button (K). Press the Phone button (L).

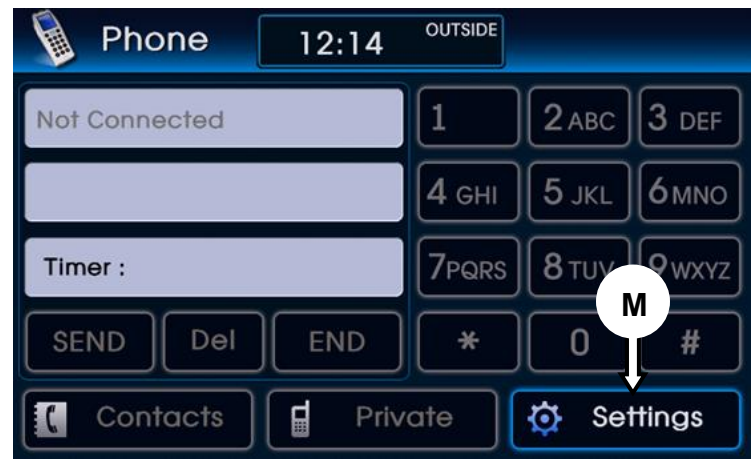
5. Touch 'Settings' (M) on the display.

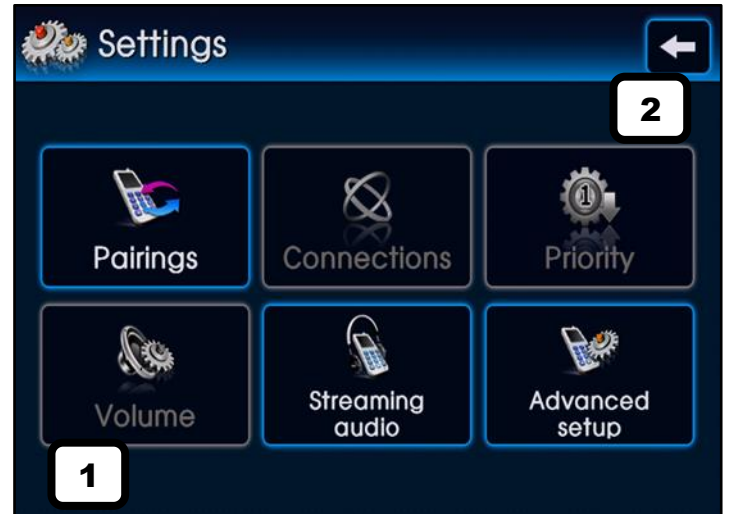
6. To enter the Engineering menu tap area 1 first, then tap area 2.

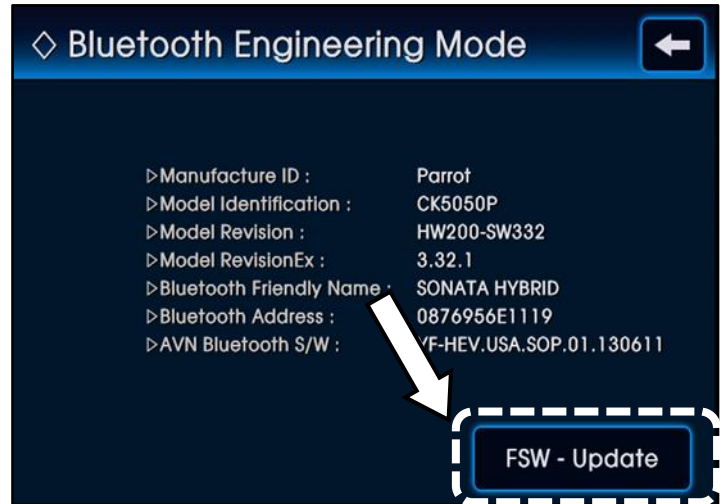
7. Press 'FSW-Update' to start the update.

NOTICE Do not interrupt the update while in progress. Any interruptions like ignition OFF or USB removal can result in the head unit being permanently disabled.

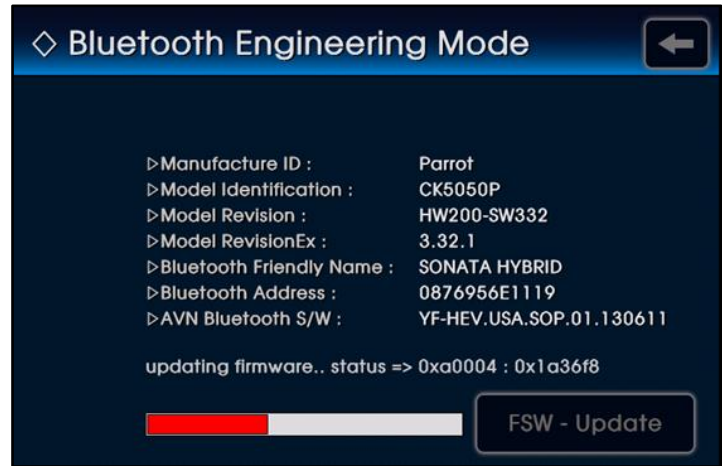
7a. The update will take approximately 5-9 minutes.

When complete, the red progress indicator will turn grey.

To continue to the last update steps, you will need to turn the ignition OFF for 15 seconds then turn it back ON.

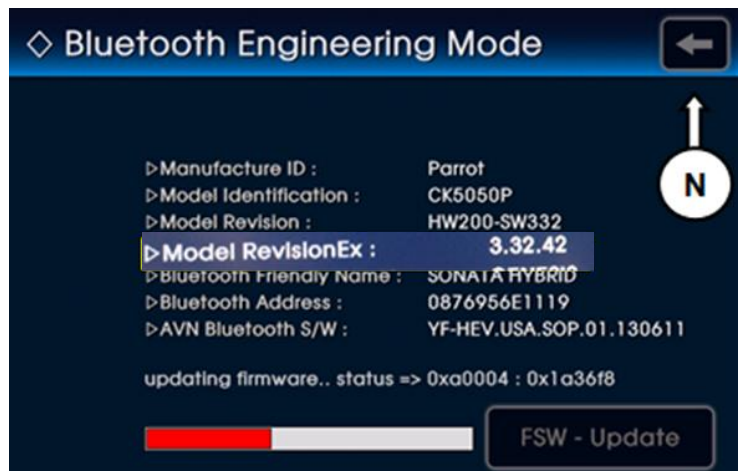
8. Repeat steps 4-6 to enter the Engineering Menu to verify that the Model RevisionEx: was updated to 3.32.42

Press the Back button (N) if the version was updated successfully.

If it was not updated, retry update steps (3) – (7a).

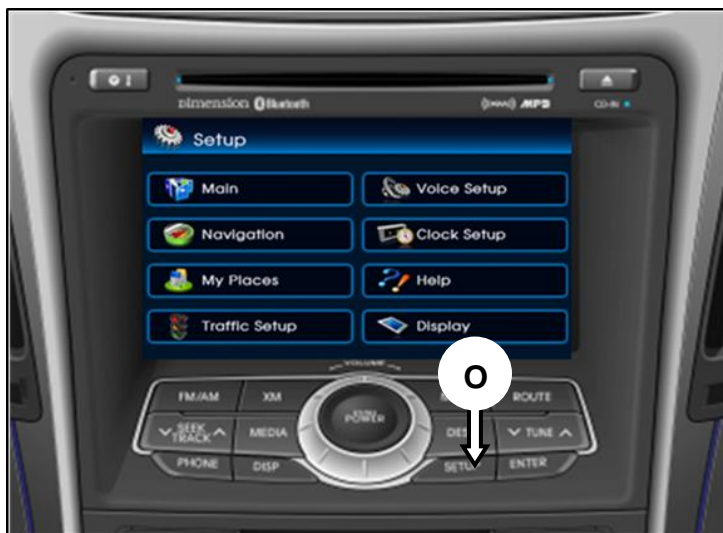
9. Next press the Setup button (O).

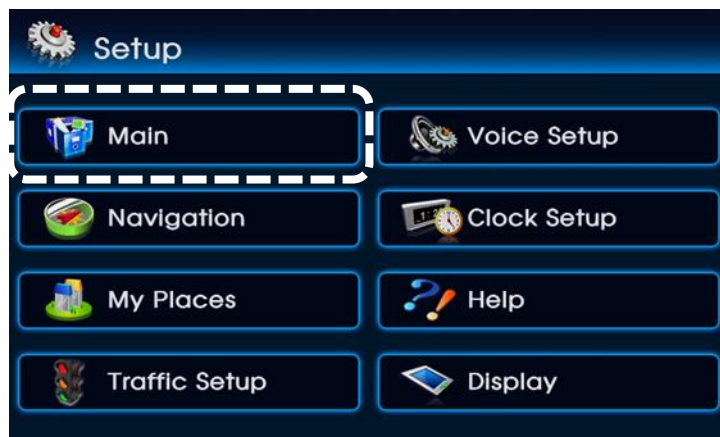
10. Touch 'Main' on the display.

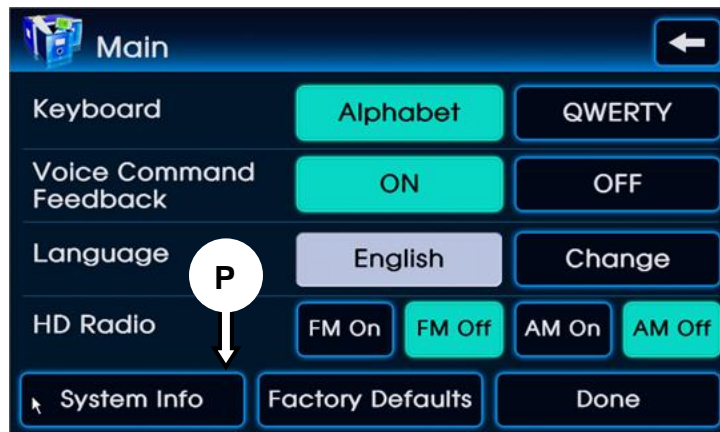
11. Touch 'System Info' (P) on the display.

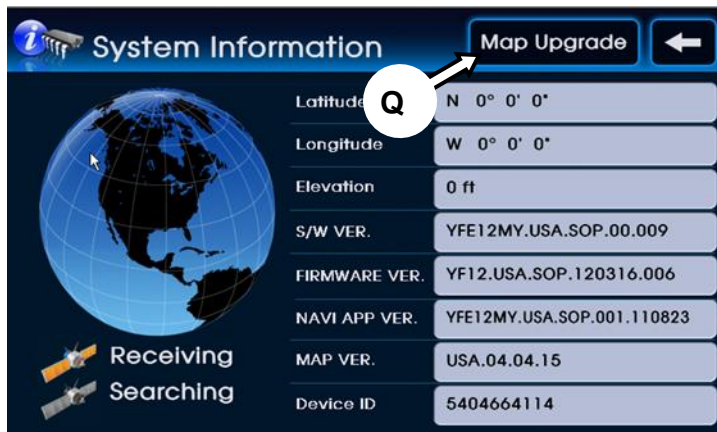
12. Touch 'Map Upgrade' (Q) on the display.

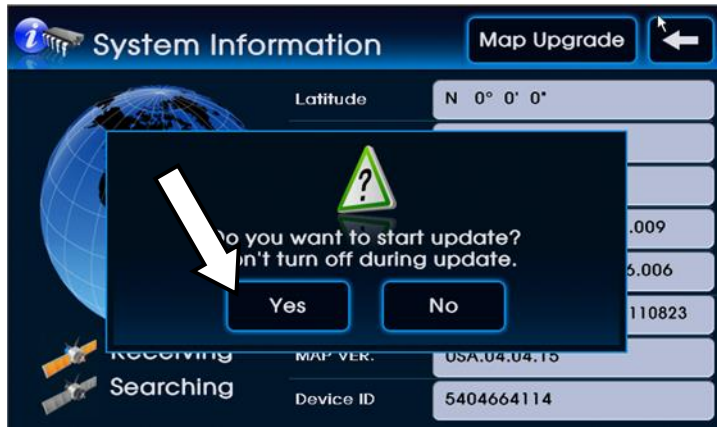
13. Touch 'Yes' on the pop up.

Do not interrupt the update while in progress. Any interruptions like ignition OFF or USB removal can result in the head unit being permanently disabled.

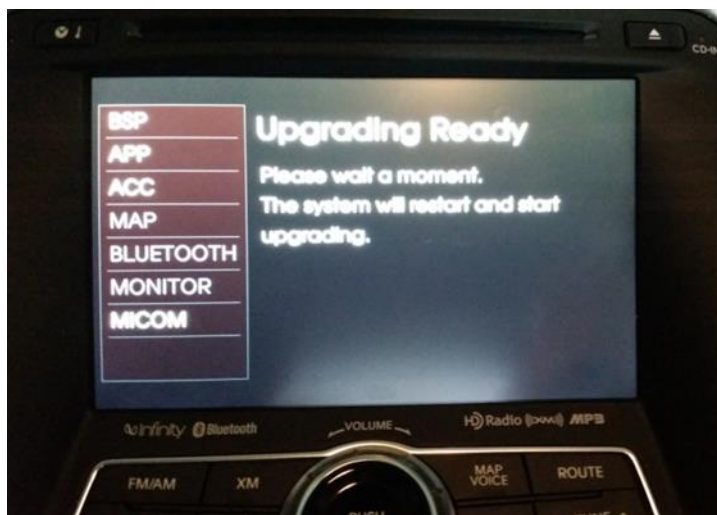
13a. Update preparation status will be shown before the update begins.

The navigation may reboot before the update starts.

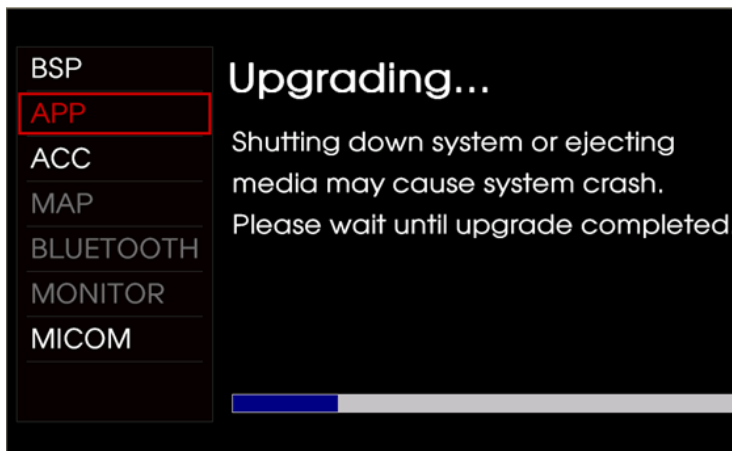
14. The update will take approximate 8 minutes.

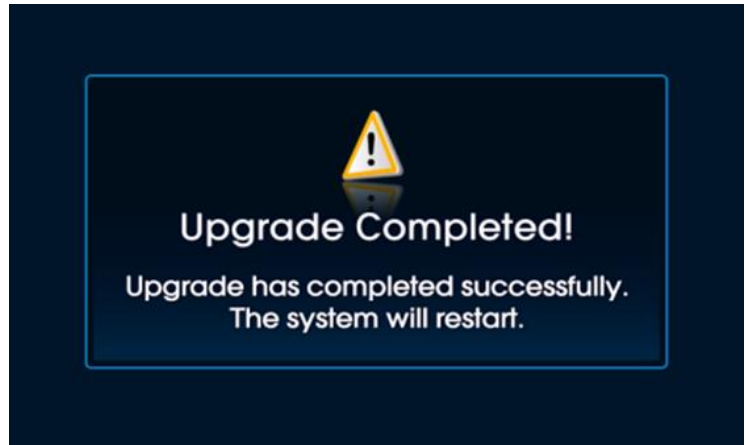
14a. The navigation system will restart when the update is complete.

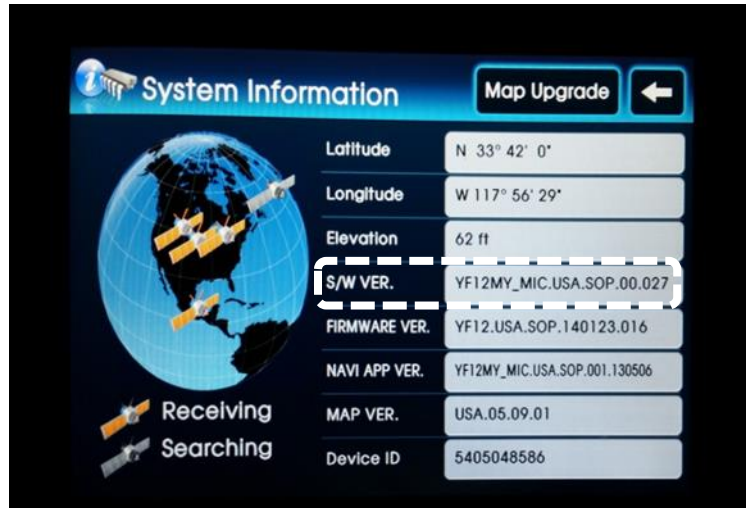
15. Follow (9) – (12) steps to verify the software was updated.

Sonata version after update is complete:

YF12MY_MIC.USA.SOP.00.027

Elantra version after update is complete:

MD_nd.USA.SOP.01.030
