PRODUCT CAMPAIGN BULLETIN

NUMBER: WQS-54
DATE: June 30, 2015
NHTSA ID: 15V-366

SUBJECT: WQS-54 Driver Assist System (EyeSight) Delay in Warning Indicator

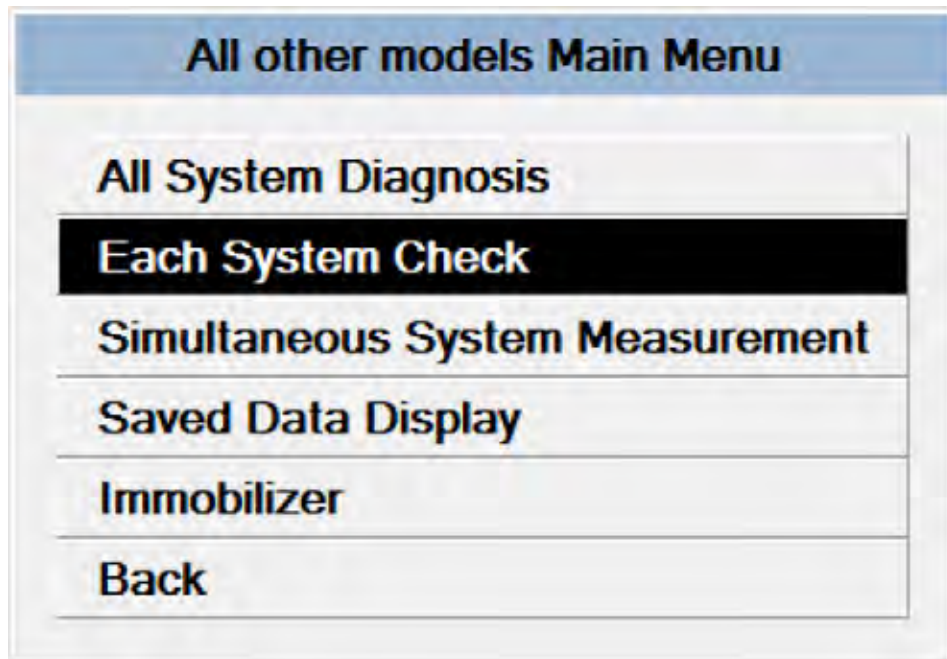
Select “Each System Check”

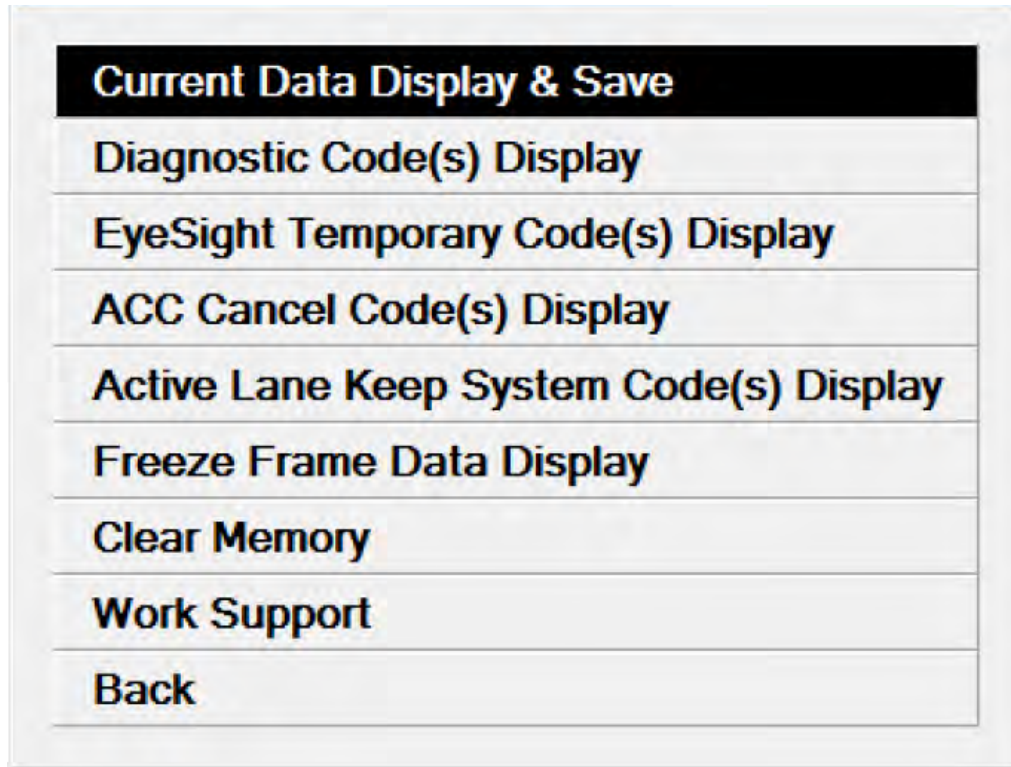
Select “Current Data Display & Save”

Verify the value of “Control Software Version”
