MODEL
2016MY
Sedona (YP)

TECHNICAL SERVICE BULLETIN

SUBJECT: SERVICE ACTION: TCM SHIFT LOGIC IMPROVEMENT (SA 208)

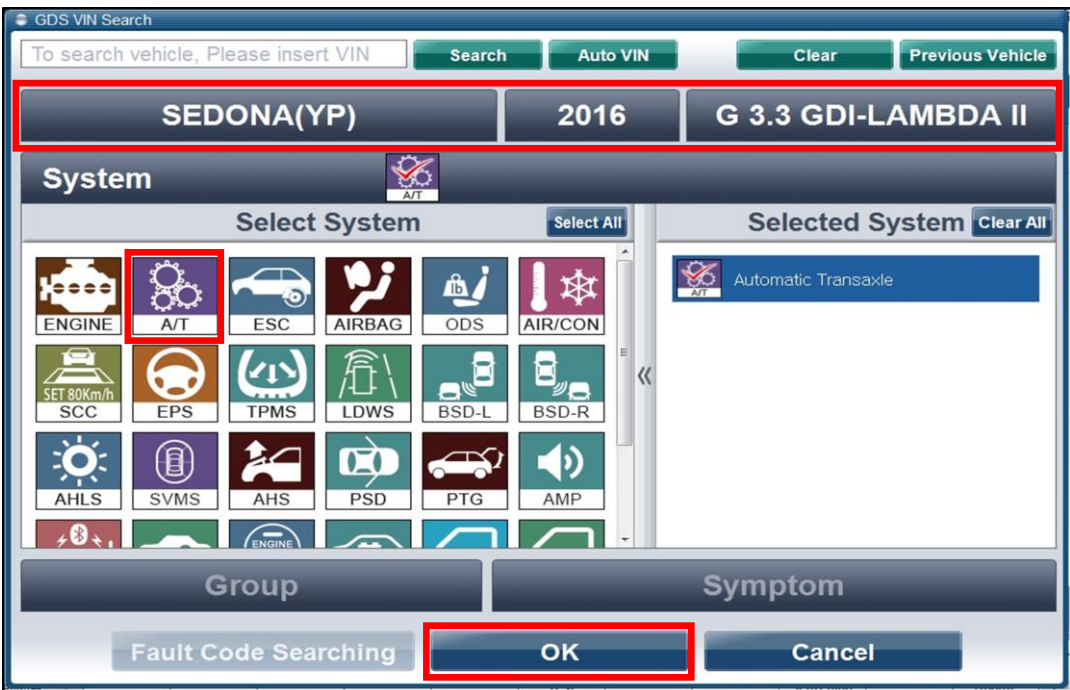
- With the ignition key ON, turn ON the VCI and GDS. Access the GDS vehicle identification number (VIN) screen and configure the vehicle using the **VIN AUTO DETECT** Function.
- Select **A/T** system and click **OK**.

- Select **ECU Upgrade** from the bottom right-hand corner. Next select **Auto Mode**, and then **A/T**. Perform the upgrade in accordance with normal GDS ECM upgrade procedures.

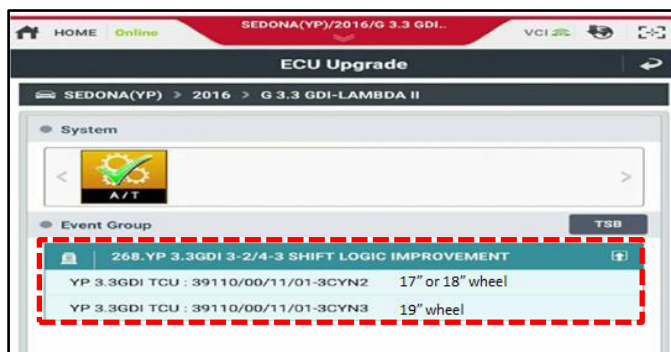
1. Within the ECM Upgrade screen, select **Manual Mode** in the left column, select **A/T** and then select **Upgrade Event #268**. Select the appropriate control unit part number by referring to the ROM ID Information Table on Page 3, and click **OK**.

2. Enter the password from the table above, and click **OK**.
3. Upgrade will begin and the progress of the upgrade will appear on the bar graph.
