GROUP FUE	MODEL 2015MY K900 (KH)
	NUMBER 029	DATE October 2015
TECHNICAL SERVICE BULLETIN		
SUBJECT: SERVICE ACTION: REAR OXYGEN (O₂) SENSOR LOGIC IMPROVEMENT (SA199)

This bulletin provides information related to the ECM software upgrade of some 2015MY K900 (KH) vehicles, produced from December 13, 2013 through December 15, 2014, to improve rear Oxygen (O₂) Sensor logic. To apply the improved logic, the ECM should be reprogrammed using the GDS/KDS download, as described in this bulletin. For confirmation that the latest reflash has been done to a vehicle you are working on, verify ROM ID using the tables in this TSB.

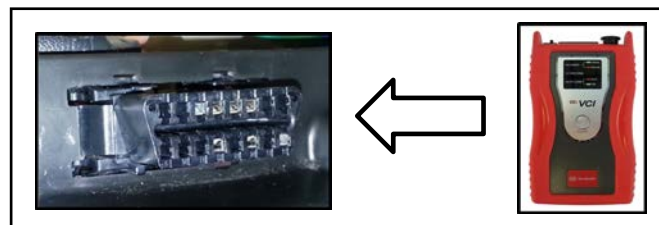
3. Connect the Main 16-pin DLC cable (GHDM – 241000) to the VCI.

4. Connect the Main 16-pin DLC cable (GHDM – 241000) to the OBD-II connector, located under the driver's side of the instrument panel.

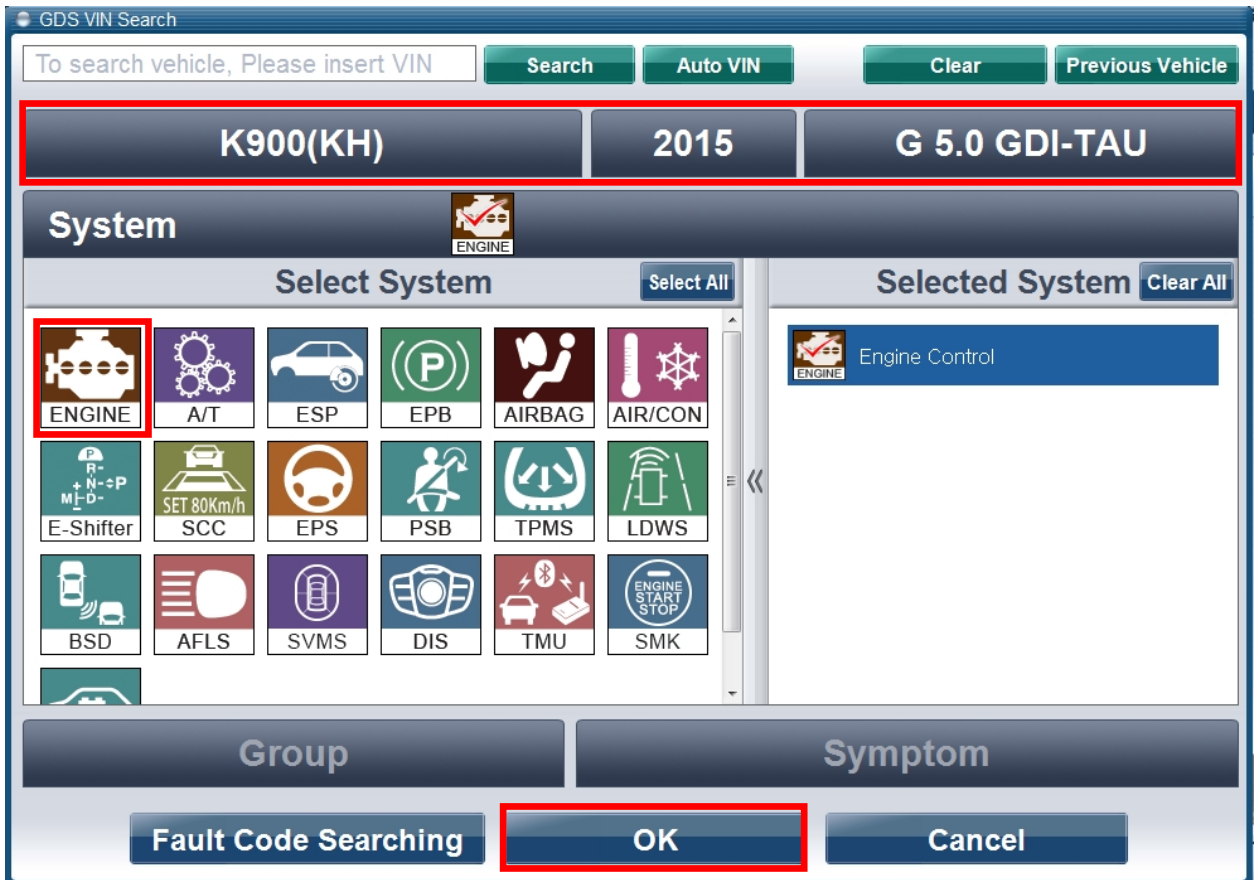
5. With the ignition key ON, turn ON the VCI and GDS. Access the GDS vehicle identification number (VIN) screen and configure the vehicle using the **VIN AUTO DETECT** Function.
6. Select **ENGINE** system and click **OK**.

Display screen above is for demonstration only purposes and will vary depending on model.

7. Select **ECU Upgrade** from the bottom right-hand corner. Next select **Auto Mode**, and then **Engine**. Perform the ECM upgrade in accordance with normal GDS ECM upgrade procedures.
