GROUP Electrical	MODEL 2015MY Cadenza (VG)
	NUMBER 088	DATE August 2015
TECHNICAL SERVICE BULLETIN		
SUBJECT: VOICE RECOGNITION ENGINE SOFTWARE UPGRADE

This bulletin provides the procedure for upgrading the navigation system software on some 2015MY Cadenza (VG) vehicles, produced from April 15, 2014 through June 16, 2014 to improve the performance of the Voice Recognition (VR) engine. Possible customer concerns include:

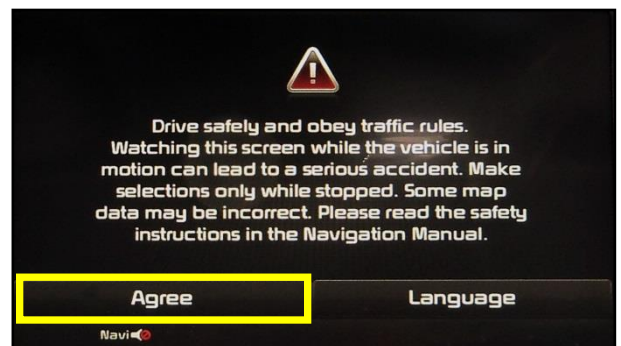
1. Start the vehicle or connect the Midtronics GR8-1299 charger.
2. Touch the **Agree** icon on the screen.

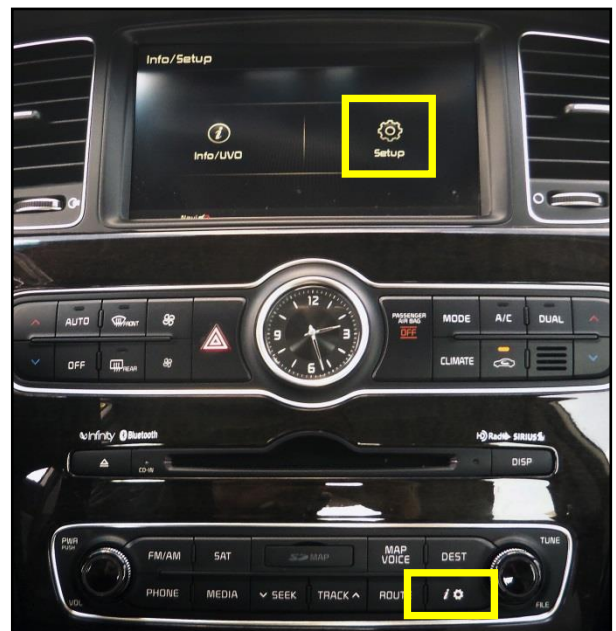
3. Press the

button and then touch the **Setup** icon on the screen.

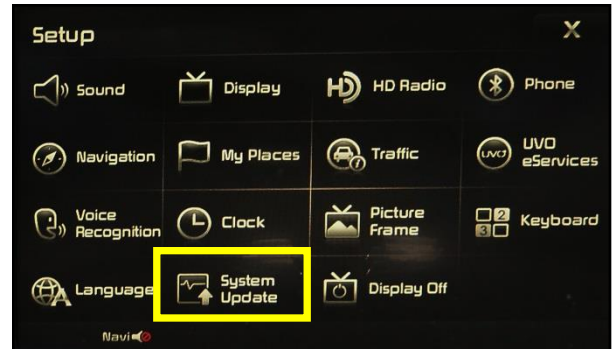
4. Touch the **System Update** icon.

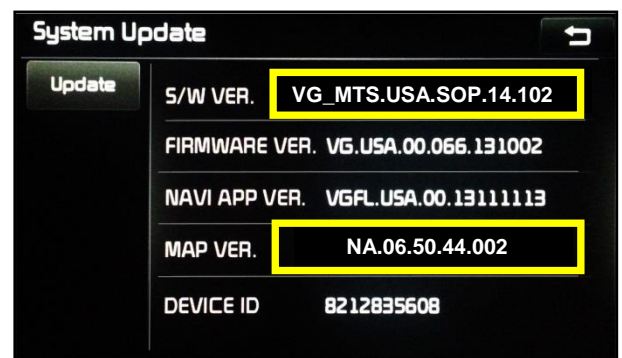
5. Compare the original Software Version (S/W) to the versions shown in the table shown below.

ORIGINAL S/W VERSION
VG_MTS.USA.SOP.14.102
MAP VERSION
NA.06.50.44.002

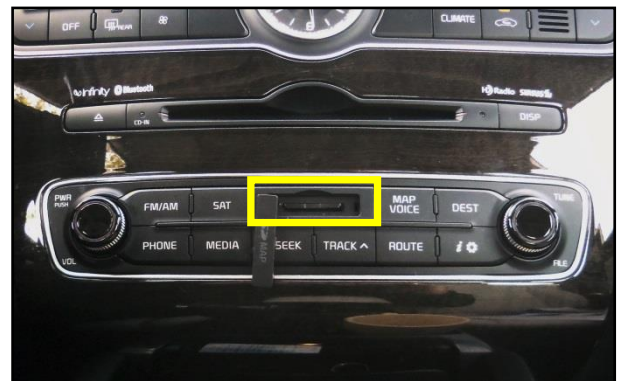
6. Remove the map SD Card from the slot and insert the upgrade SD Card. The AVN system will be restarted automatically after five (5) seconds.

- If the upgrade screen does not display automatically, press

> Setup > System Update > Update.
- Do NOT turn the vehicle OFF while the update is in progress.

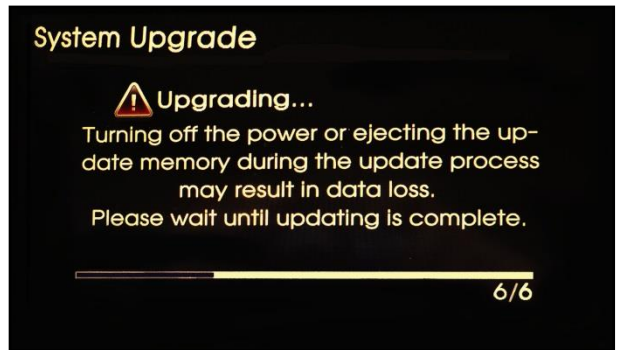
7. The upgrade screen will be displayed and the system will install 6 updates.
NOTE: if the update fails to start, proceed to step 8 and perform a “Forced Update”. If the update starts, proceed to step 9.

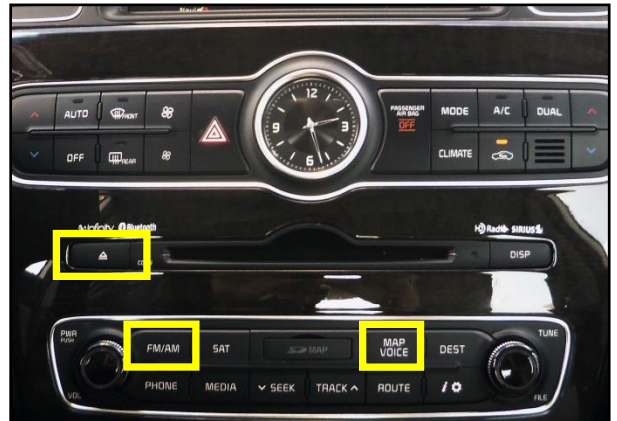
8. To perform a “Forced Update”, press and hold the CD EJECT + FM/AM + MAP VOICE buttons, at the same time, for approximately twenty (20) seconds. Release the buttons once the Kia logo is displayed on the screen. After the Kia logo screen, the upgrade screen will be displayed and the system will install 6 updates

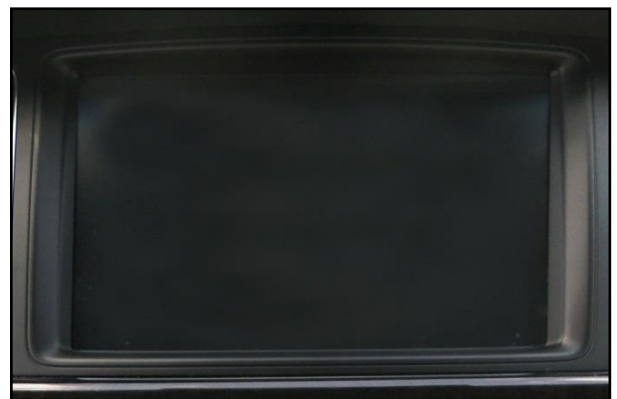
9. If the update is completed successfully, the display will turn off. Once the Kia logo is displayed on the screen, cycle power to the navigation system by pressing the ON/OFF button.

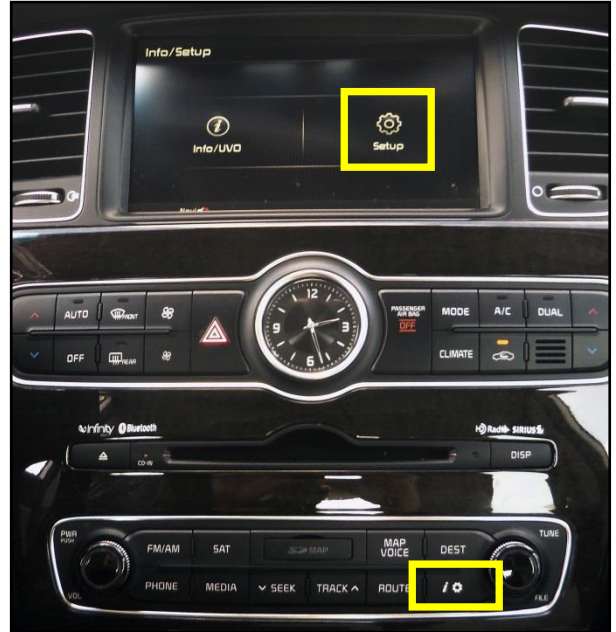
- Remove the upgrade SD Card and reinstall the map SD Card. Allow the system to reboot and press the

Button. Then, touch the **Setup** button on the screen.

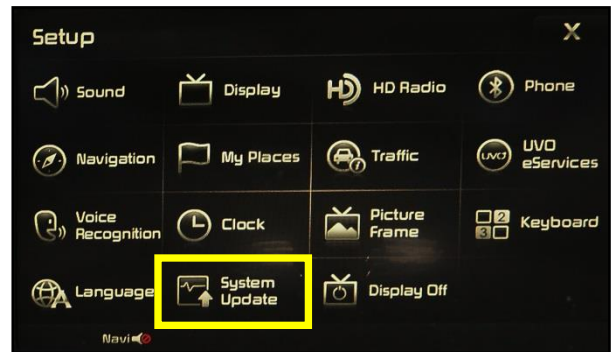
- Touch the **System Update** button on the screen.

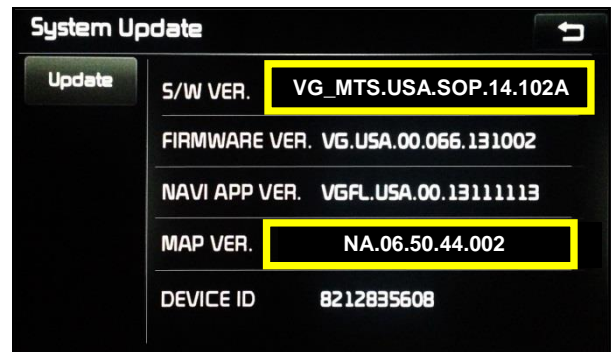
- Confirm the upgraded software version matches the applicable information shown in the table below:

NEW S/W VERSION
VG_MTS.USA.SOP.14.102A
MAP VERSION
NA.06.50.44.002
