GROUP Service Campaign	MODEL 2012~2014MY Sorento (XMa) 2012~2013MY Optima (TF/QF) 2012~2013MY Sportage (SL)
	NUMBER SC 114 (Rev 1, 02/27/2015)	DATE February 2015
VOLUNTARY SERVICE CAMPAIGN		
SUBJECT: ECM UPGRADE –MIL ON WITH DTC P0087 (SC114)

This bulletin provides information related to an ECM software update for the Engine Control Unit (ECU) in certain 2012~2014MY Sorento, 2012~2013MY Optima, and 2012~2013MY Sportage vehicles equipped with the 2.4L and 2.0L Turbo GDI engines. The subject vehicle's engines are equipped with a Gasoline Direct Injection (GDI) system that utilizes a Flow Control Valve (FCV) to control the supply of fuel. The FCV needle may experience excessive wear, eventually resulting in impairment of fuel flow. If that happens, and to protect the engine, the ECU may reduce engine acceleration while illuminating the "Check Engine" or Malfunction Indicator Lamp (MIL). The ECU update will improve the durability and operation of the FCV needle.

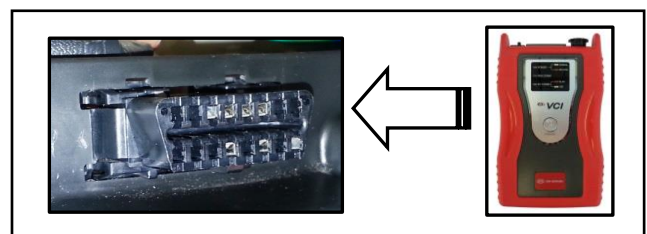
3. Connect the Main 16-pin DLC cable (GHDM – 241000) to the VCI.

4. Connect the Main 16-pin DLC cable (GHDM – 241000) to the OBD-II connector, located under the driver's side of the instrument panel.

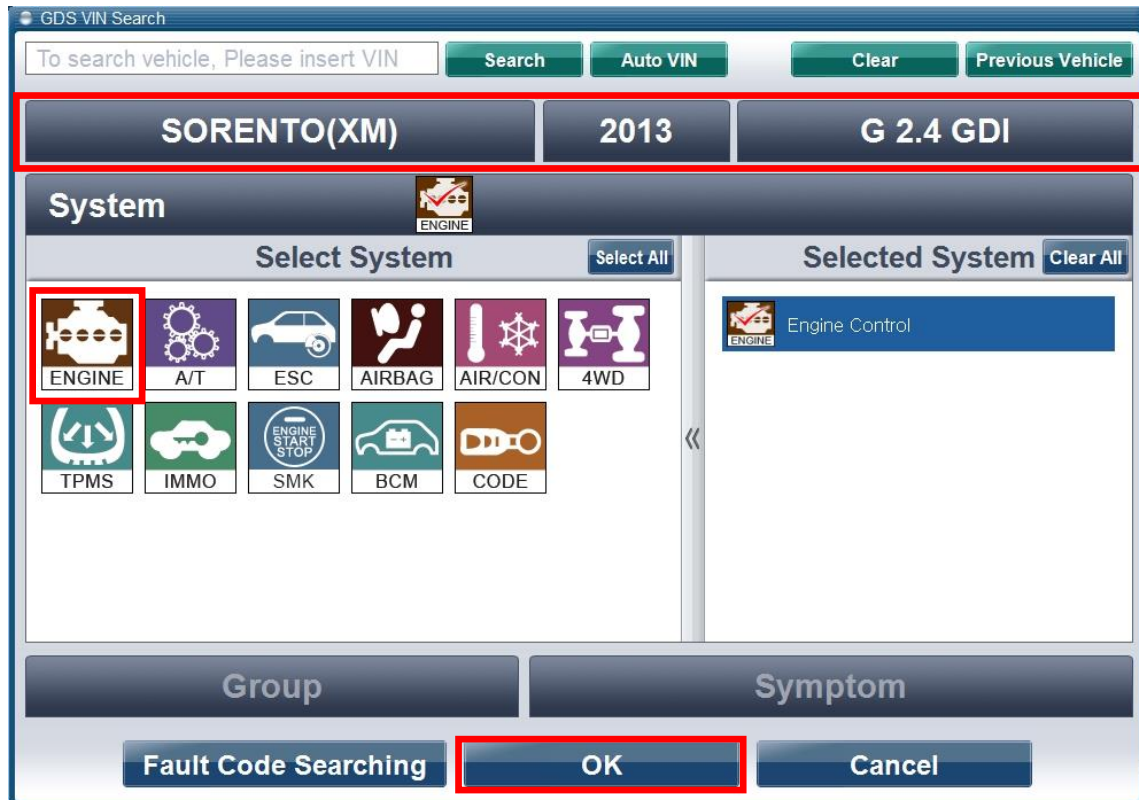
5. With the ignition key ON, turn ON the VCI and GDS. Access the GDS vehicle identification number (VIN) screen and configure the vehicle using the **VIN AUTO DETECT** Function.
6. Select **ENGINE** system and click **OK**.

Image shown is for demonstration ONLY purposes and will vary by model.

7. Select ECU Upgrade from the bottom right-hand corner. Next select Auto Mode, and then Engine. Perform the ECM upgrade in accordance with normal GDS ECM upgrade procedures.
