MODEL
**2014~2015MY
Sorento (XMa)
w/3.3L GDI**

TECHNICAL SERVICE BULLETIN

SUBJECT: ECM UPGRADE – SORENTO (XMa) 3.3 GDI MIL ON
WITH DTCs P2096, P2098

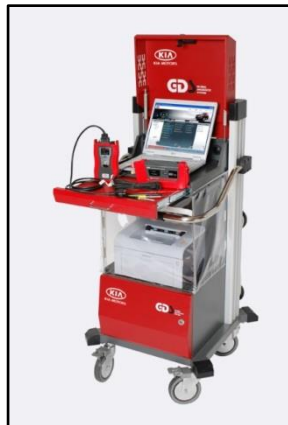
Global Diagnostic System (GDS)

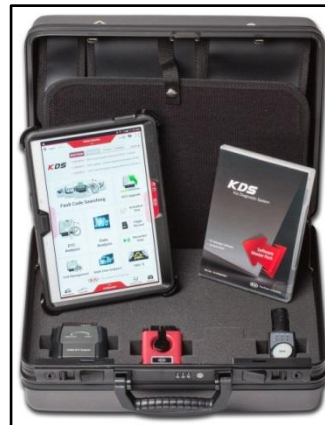
Kia Diagnostic System (KDS)

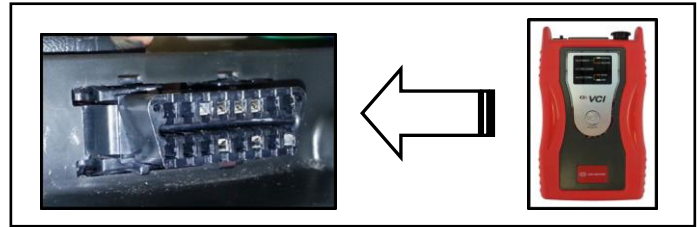
- Connect the Main 16-pin DLC cable (GHDM – 241000) to the OBD-II connector, located under the driver's side of the instrument panel.

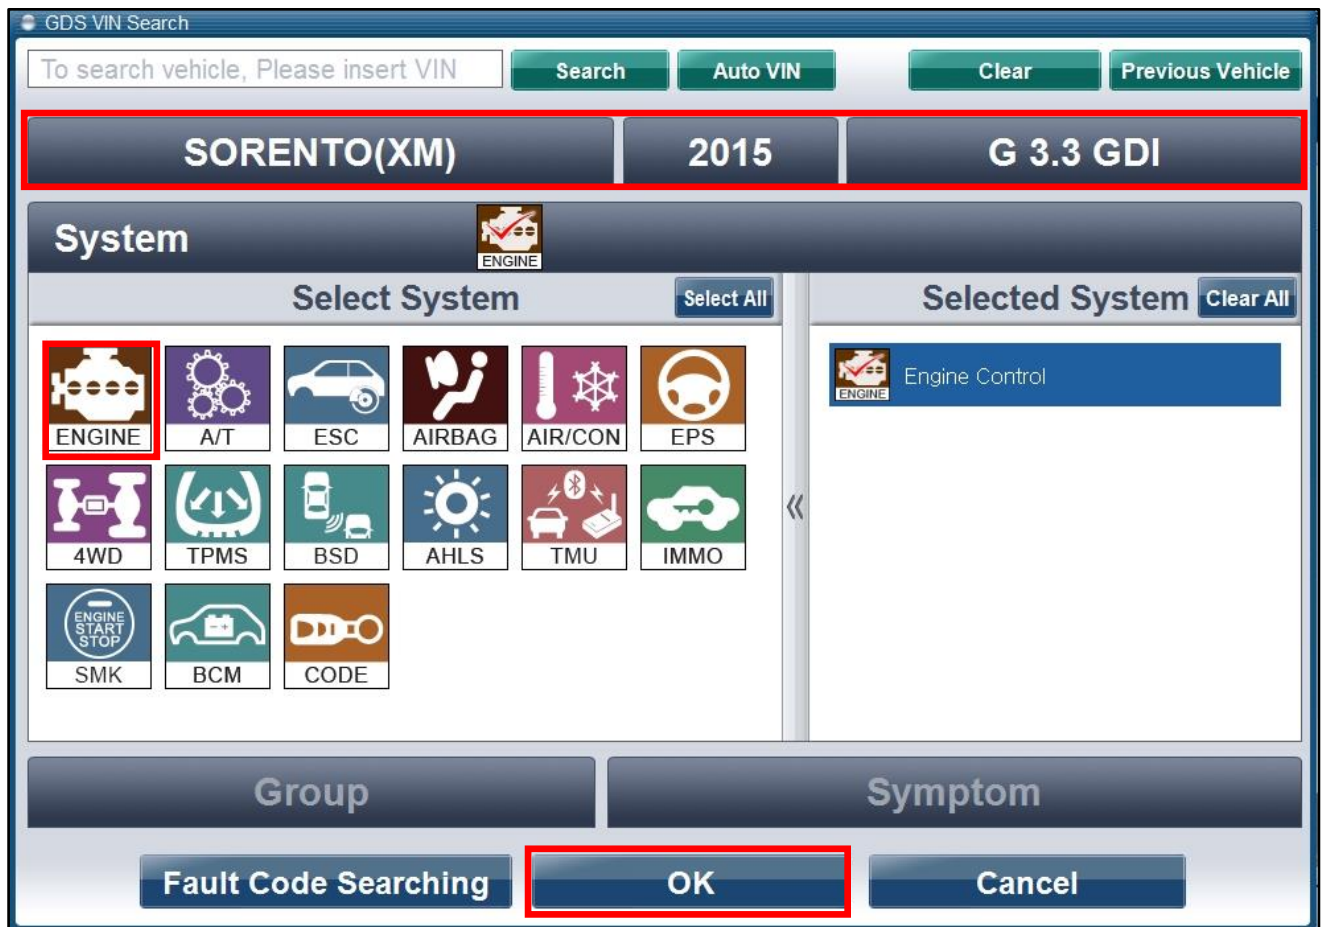
- With the ignition key ON, turn ON the VCI and GDS. Access the GDS vehicle identification number (VIN) screen and configure the vehicle using the **VIN AUTO DETECT** Function.

- Once back at the GDS Main Screen, select **ECU Upgrade** from the bottom right-hand corner. Next select **Auto Mode**, and then **Engine**. Perform the ECM upgrade in accordance with normal GDS ECM upgrade procedures.
