GROUP ENG	MODEL 2012~2013MY Rio (UB) w/1.6 GDi 2012MY~2013MY Soul (AM) w/1.6 GDi
	NUMBER 146	DATE March 2015
TECHNICAL SERVICE BULLETIN		
SUBJECT: ECM UPGRADE – RIO, SOUL MIL ON WITH DTC(S) P0456/P0461/P050A/P2188/P2192/P0128/P0326/P0441

This bulletin provides information related to the ECM software upgrade for some 2012~2013MY Rio (UB) and some 2012~2013 Soul (AM) vehicles which may experience a malfunction indicator lamp (MIL) illuminated with the Electronic Control Module (ECM) system-related DTCs; P0456, P0461, P050A, P2188, P2192, P0128, P0326, P0441. To correct this condition, the ECM should be reprogrammed using the GDS download as described in this bulletin. Before performing this procedure, verify the VIN falls within the production ranges by consulting the table on page 10. For confirmation that the latest reflash has been done to a vehicle you are working on, verify ROM ID using the tables in this TSB.

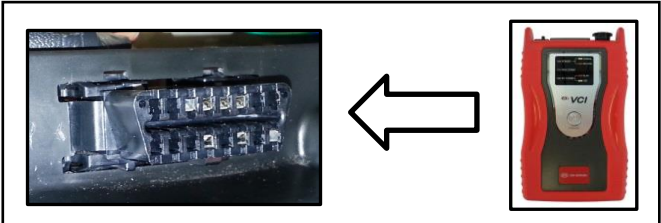
3. Connect the Main 16-pin DLC cable (GHDM – 241000) to the VCI.

4. Connect the Main 16-pin DLC cable (GHDM – 241000) to the OBD-II connector, located under the driver's side of the instrument panel.

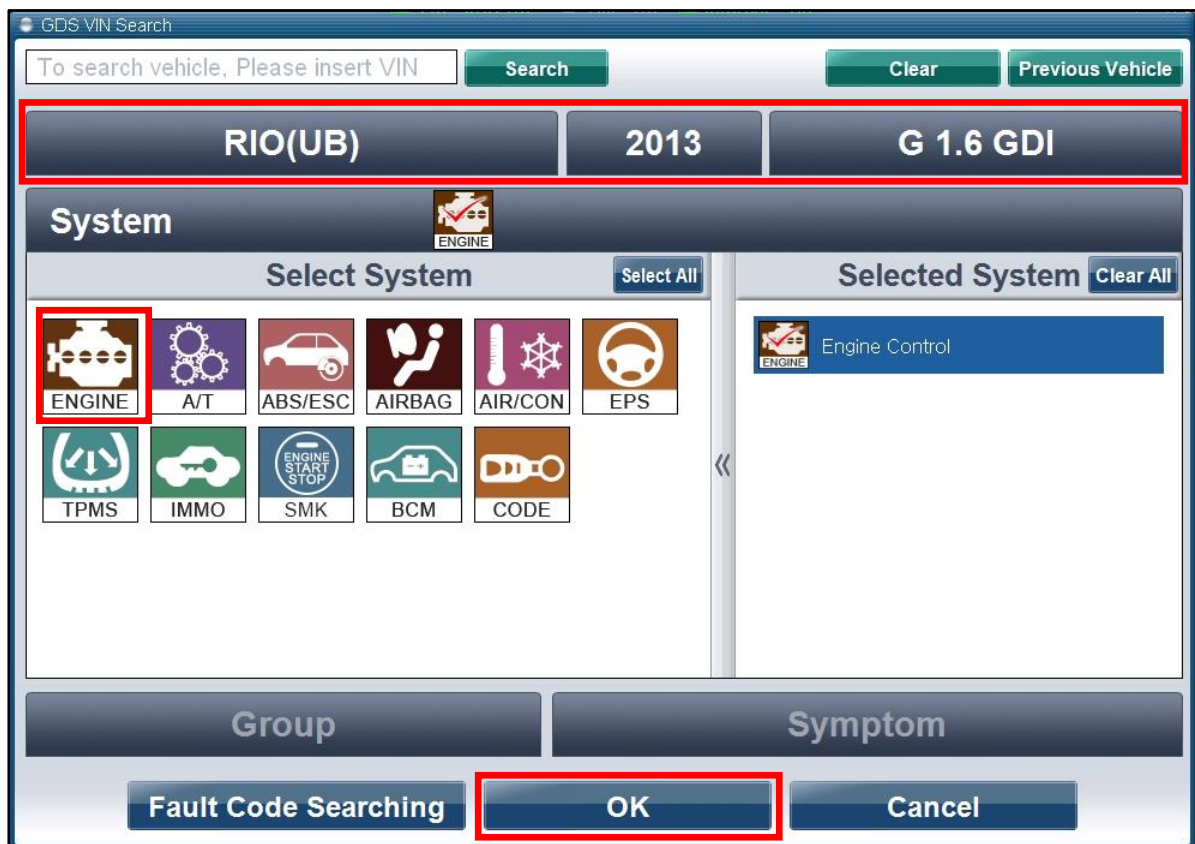
6. Select **ENGINE** system and click **OK**.

Display screen above is for demonstration only purposes and will vary depending on model.
