GROUP
Engine
NUMBER
131 (REV 1, 11/06/2014)

MODEL
2012-2013MY
Rio 1.6L GDI (UB)
DATE
April 2013

TECHNICAL SERVICE BULLETIN

SUBJECT: ECM UPGRADE – KNOCK IMPROVEMENT

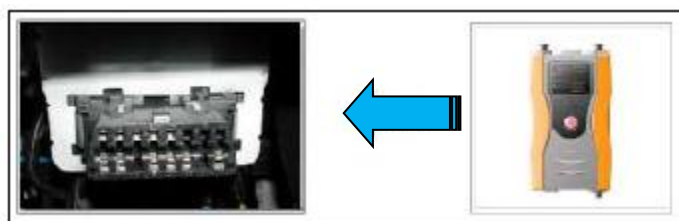
- Connect the Main 16-pin DLC cable (GHDM – 241000) to the VCI.

- Connect the Main 16-pin DLC cable (GHDM – 241000) to the OBD-II connector, located under the driver's side of the instrument panel.
