Navigation System Firmware Improvement (Generation 6)

Service Category Audio/Visual/Telematics

Section Navigation/Multi Info Display

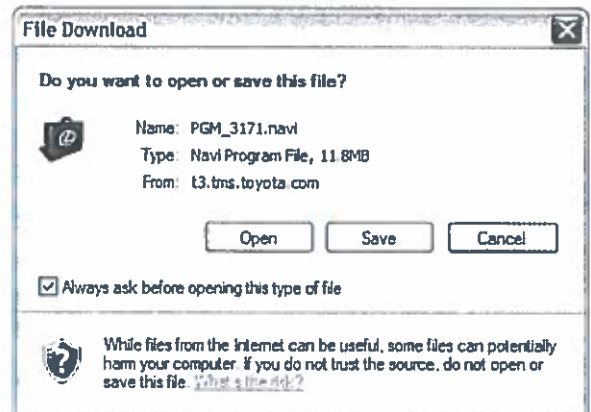
Figure 1.

The file is large and may take up to 10 minutes to download.

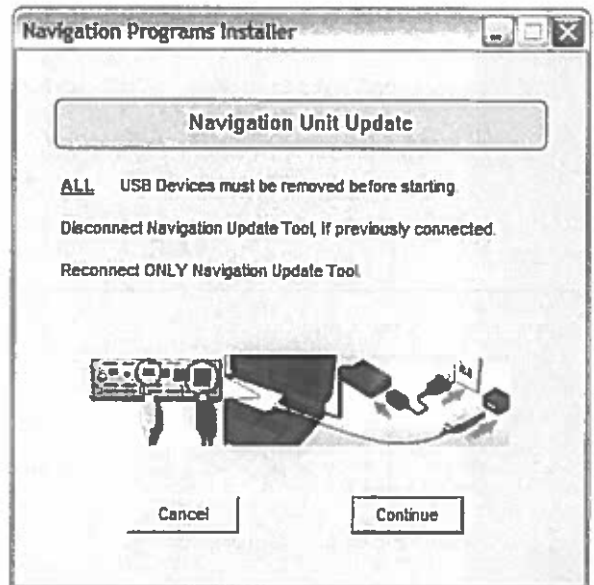
Figure 2.

7. Verify that both the transfer mode display light (green) and power supply display light (blue) are lit, then click *Continue*.

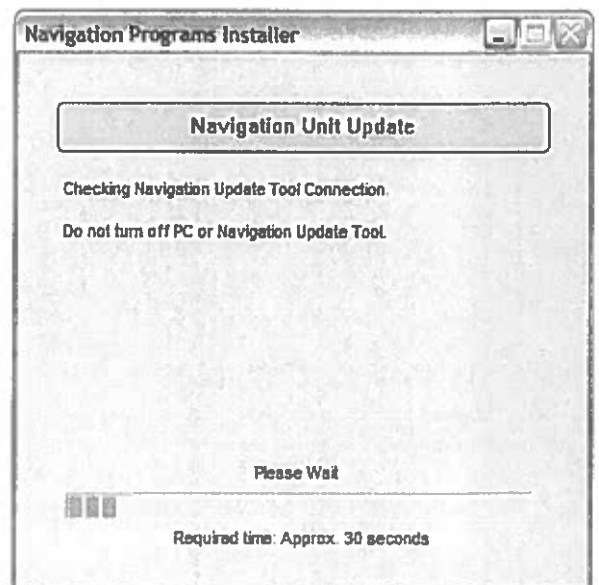
Figure 3.

8. The software will perform a connection check with the Navigation Update Tool. In the event an error is shown, please recheck the USB connection.

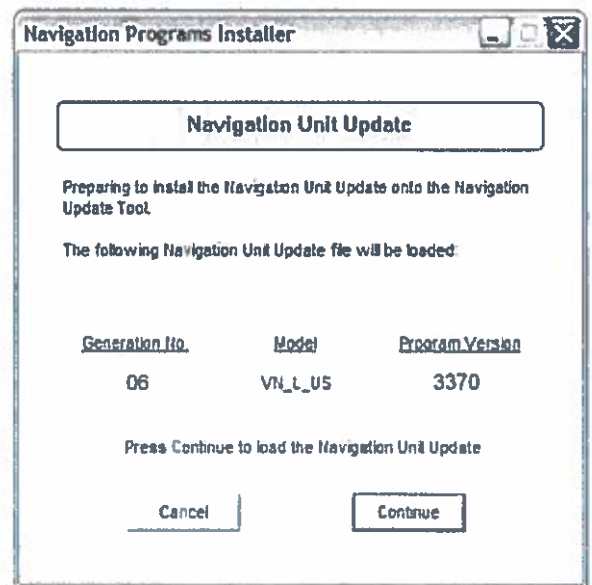
Figure 4.

- Navigation Firmware is ready to be loaded onto the Navigation Update Tool, click *Continue*.

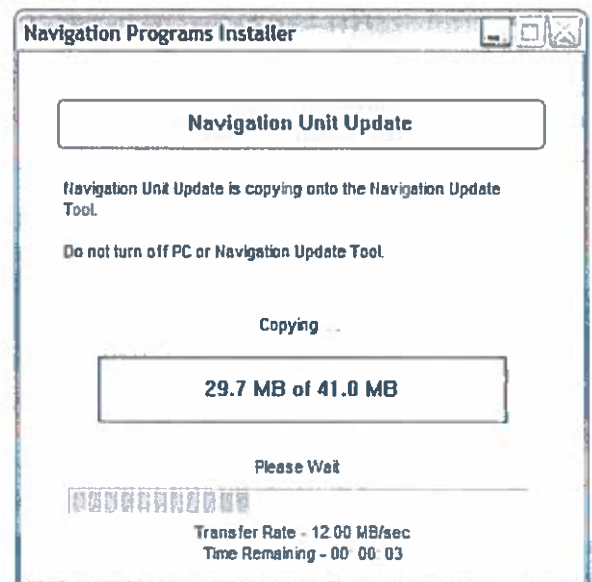
Figure 5.

- Navigation Firmware will now load onto the Navigation Update Tool.

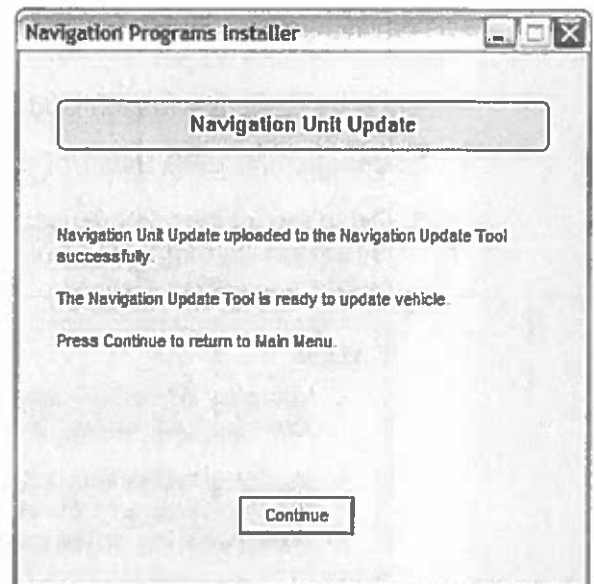
Figure 6.

11. Once the Navigation Firmware is successfully loaded onto the Navigation Update Tool, click *Continue* to finish the installer.

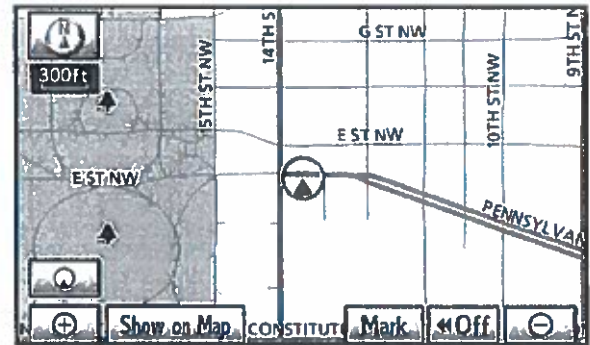
Figure 8.

4. Select *Show on Map*.

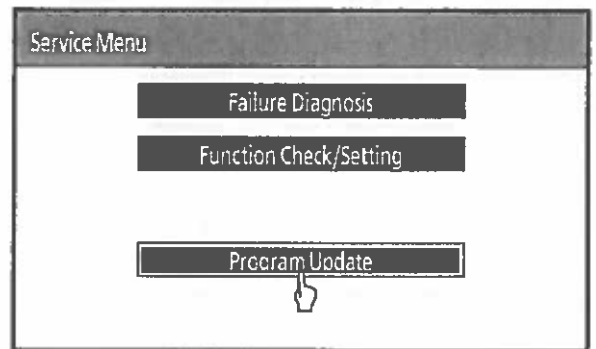
Figure 9.

6. Select *Program Update* from the Service Menu.

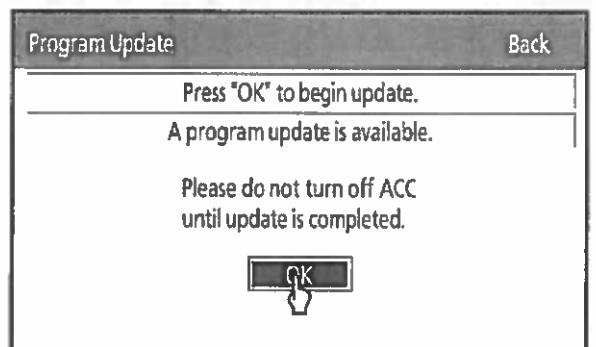
Figure 10.

7. Select *OK*.

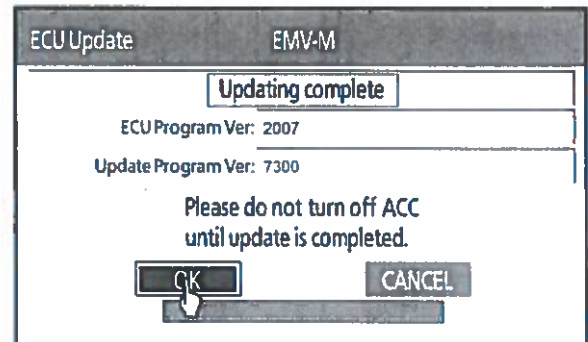
Figure 14.

- After about 1 minute, if the update was successful the display will indicate "*Updating complete*" at the top of the screen. Select *OK* to continue.
