# Technical Service Bulletin

<b>SUBJECT:</b> <b>ENGINE STALL (LOW ENGINE SPEED, HIGH AMBIENT TEMPERATURE)</b>			No: <b>TSB-15-13-001</b>
			DATE: <b>March, 2015</b>
			MODEL: <b>2014-15 Mirage</b>
<b>CIRCULATE TO:</b>	<input type="checkbox"/> GENERAL MANAGER	<input type="checkbox"/> PARTS MANAGER	<input checked="" type="checkbox"/> TECHNICIAN
<input checked="" type="checkbox"/> SERVICE ADVISOR	<input checked="" type="checkbox"/> SERVICE MANAGER	<input checked="" type="checkbox"/> WARRANTY PROCESSOR	<input type="checkbox"/> SALES MANAGER

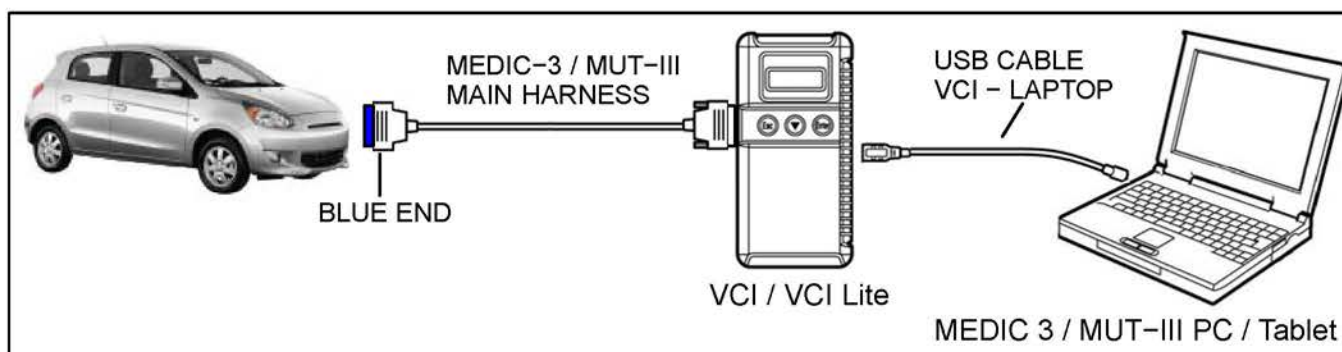
Connect the equipment as follows:

**NOTE:** VCI and MEDIC 3 Laptop shown for illustration purposes only

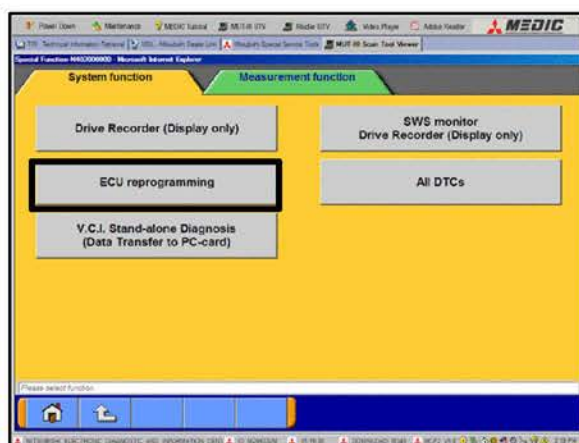
d. Select "ECU Reprogramming."

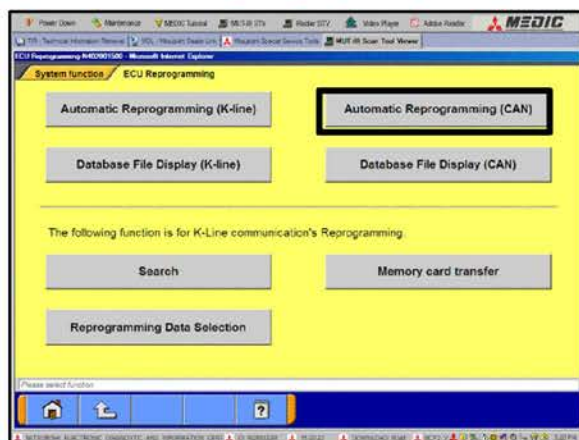
e. Select "Automatic Reprogramming (CAN)."

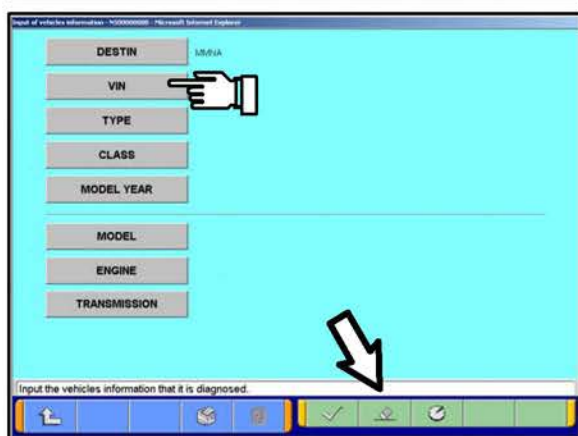
f. Click the car icon at the bottom of the page.

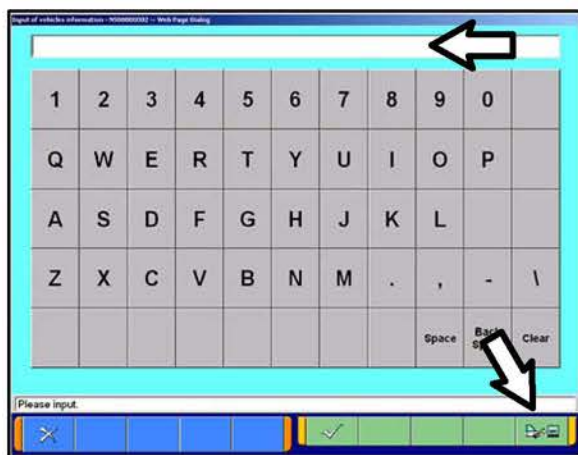
g. If the VIN or vehicle description displayed does not match the vehicle you are working on, click the eraser icon at the bottom of the page to erase vehicle data.

Then click the VIN button.

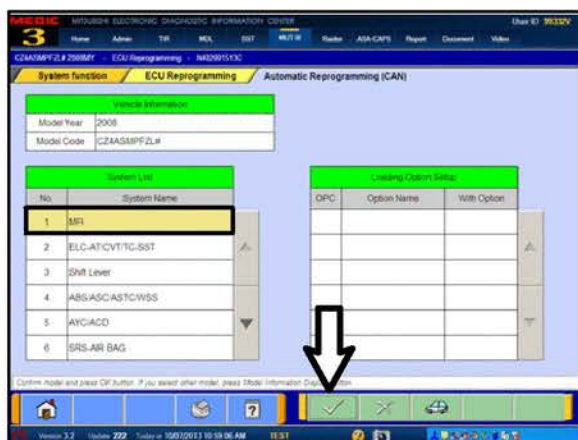
k. Confirm all data matches the vehicle and click the check mark at the bottom of the page.

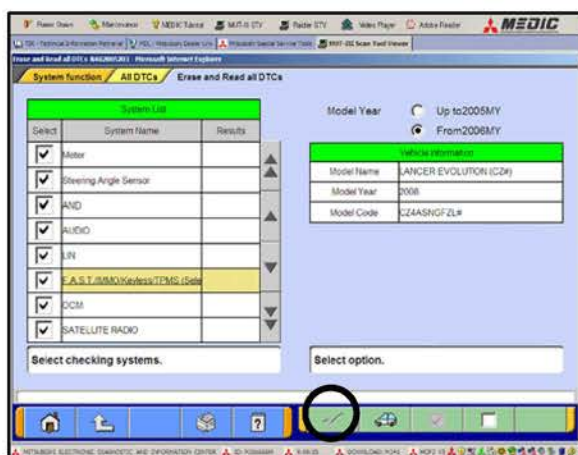
3. Using MUT-III, check and erase ALL DTCs from all systems as follows.

- Select "Special Function."
- Select "All DTCs," then select "ERASE AND READ ALL DTCs."

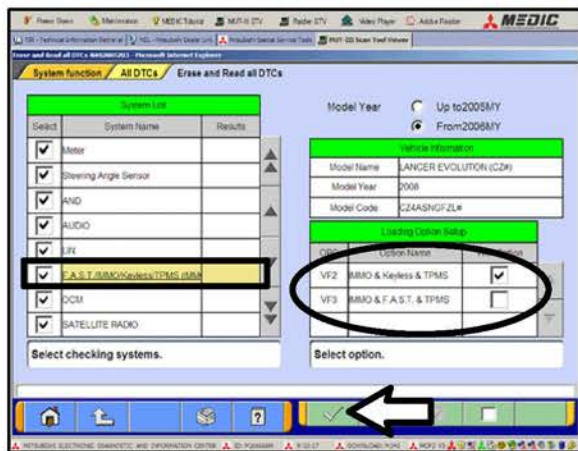
- The "System List" on the left side of the screen will have all selections checked. Do not change these selections. DTCs may be set if the vehicle is equipped with options that are unchecked.
- If the check mark at the bottom of the screen is highlighted, click it and move ahead to step 4. If not, continue with sub step e.

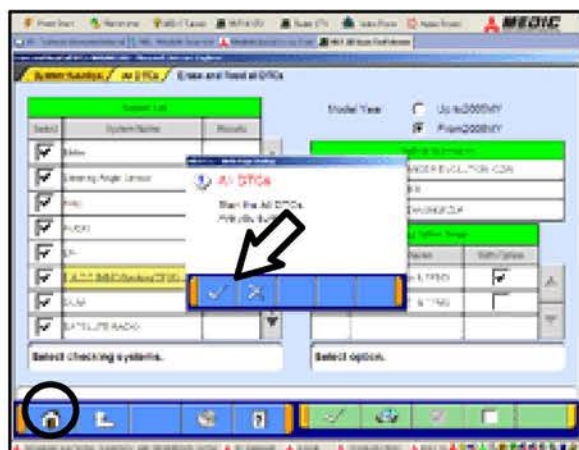
- In the left column, scroll to and click FAST/IMMOB/KEYLESS/TPMS. In the right column, check the correct option code (VF#) from the Loading Options Setup list. This will activate the check mark at the bottom of the page.
  - Vehicles with regular keyless entry (buttons on a multi-function key), select VF2.
  - Vehicles with F.A.S.T. Key, select VF3.
- Click the check mark to continue.
