Technical Service Bulletin

SUBJECT:		No: TSB-15-13-002	
ECM REPROGRAMMING FOR FALSE MIL ILLUMINATION WITH DTC P2097 – REVISED		DATE: March, 2015	
		MODEL: See Below	
CIRCULATE TO:	<input type="checkbox"/> GENERAL MANAGER	<input checked="" type="checkbox"/> PARTS MANAGER	<input checked="" type="checkbox"/> TECHNICIAN
<input checked="" type="checkbox"/> SERVICE ADVISOR	<input checked="" type="checkbox"/> SERVICE MANAGER	<input checked="" type="checkbox"/> WARRANTY PROCESSOR	<input type="checkbox"/> SALES MANAGER

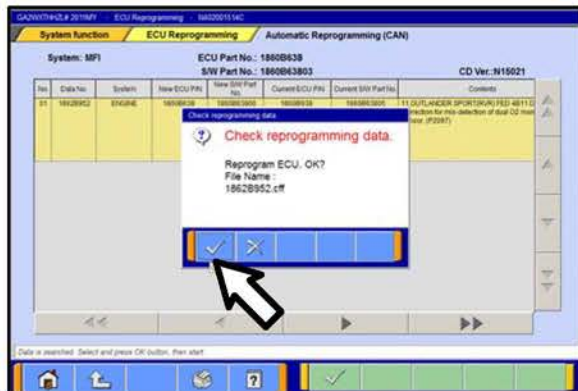
I. The Automatic Reprogramming (CAN) database screen will display.

Confirm the database number at the top right of the table is **N15021** or higher.

If more than one row is displayed in the table, refer to the ECM Reprogramming Chart on Page 2 to select the correct row.

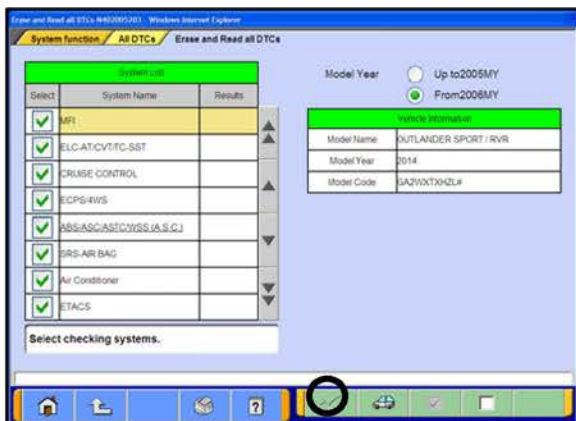
- c. The “System List” on the left side of the screen will have all selections checked. Do not change these selections. DTCs may be set if the vehicle is equipped with options that are unchecked.
- d. If the check mark at the bottom of the screen is highlighted, click it and move ahead to step 4. If not, continue with sub-step e.

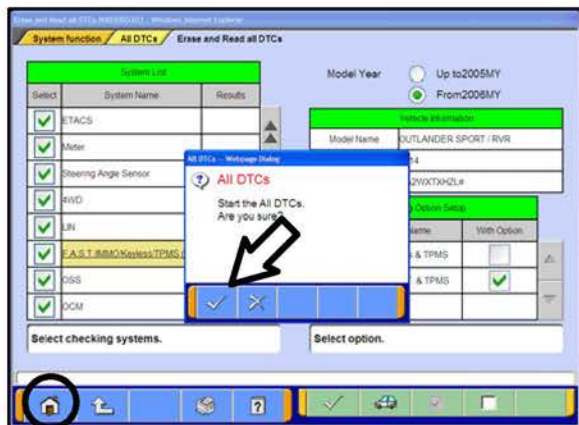
- e. In the left column, scroll to and click FAST/IMMO/KEYLESS/TPMS. In the right column, check the correct option code (VF#) from the Loading Options Setup list. This will activate the check mark at the bottom of the page.
 - Vehicles with regular keyless entry (buttons on a multi-function key), select VF2.
 - Vehicles with F.A.S.T. Key, select VF3.
- d. If the check mark at the bottom of the screen is highlighted, click it and move ahead to step 4. If not, continue with sub-step f.
- f. In the left column, scroll to and select METER. A chart will display. Check the correct display type for the vehicle.
Click the check mark to continue.
