Subject: MAZDA CONNECT FUNCTIONALITY CONCERNS	Bulletin No: 09-022/15
	Last Issued: 06/10/2015

DESCRIPTION

REPAIR PROCEDURE

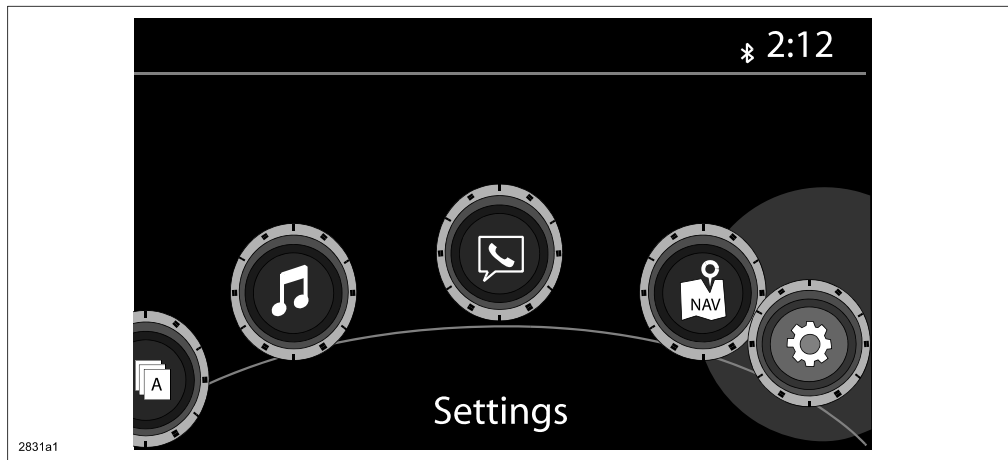
1. Select "Settings" from the Home screen to check the software version.

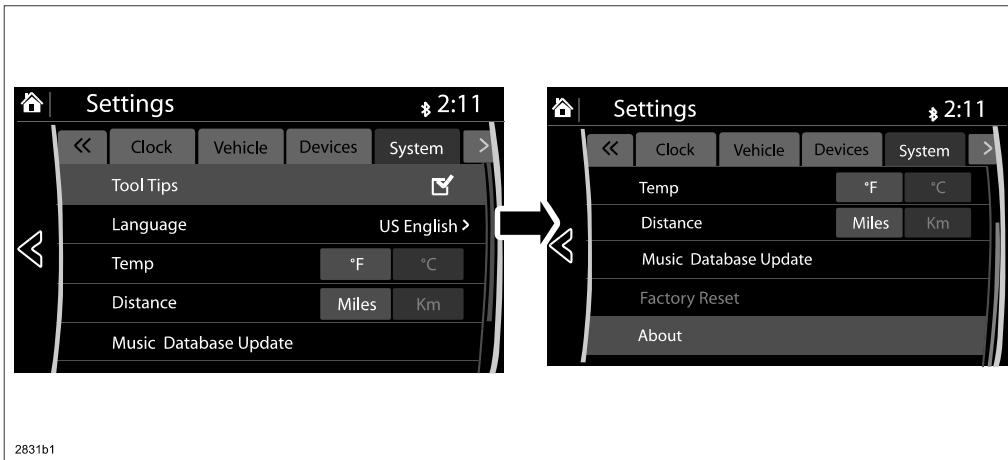
2. Select "System" and scroll down to the "About" option.

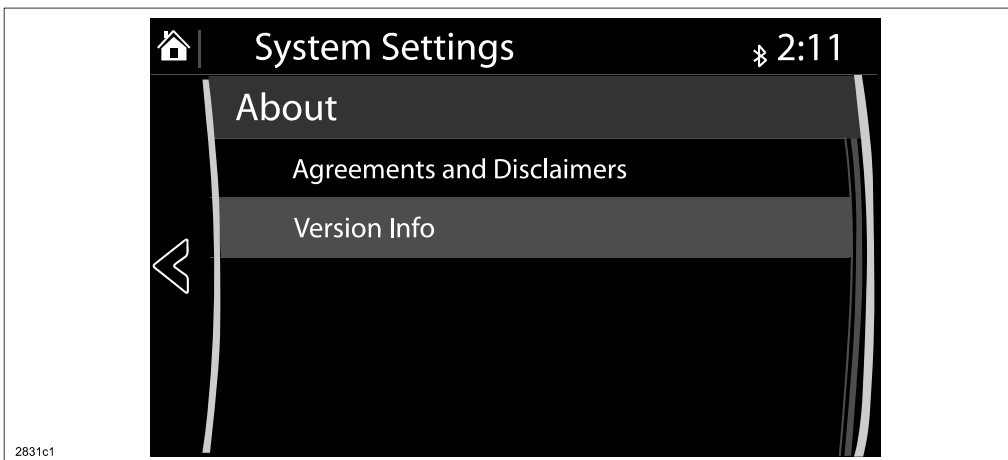
3. Select "Version Info" from the "About" screen.

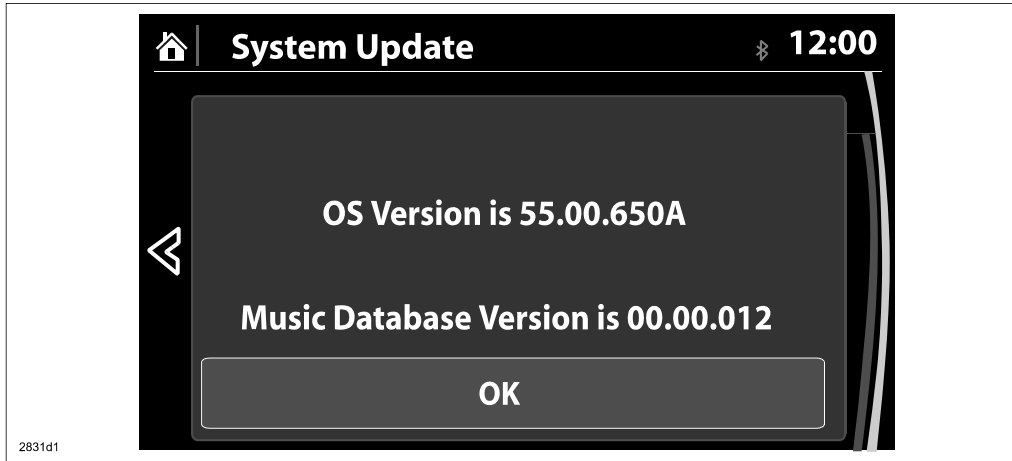
4. Make sure the software version is 55.00.650A or later, then select OK. If it is not 55.00.650A or later, update the system using a USB memory stick with the latest software according to the “Reflash Procedure.” If needed, refer to “Downloading Update Software to a USB Memory Stick (for additional USB memory sticks)” below.

27. Turn the ignition switch OFF, and then turn the ignition to ACC again.
28. Check the software version to make sure it is the same as on the USB memory stick. See MAZDA CONNECT Software Version Verification Procedure.
29. Turn the ignition switch OFF, then remove the USB memory stick from the USB port.

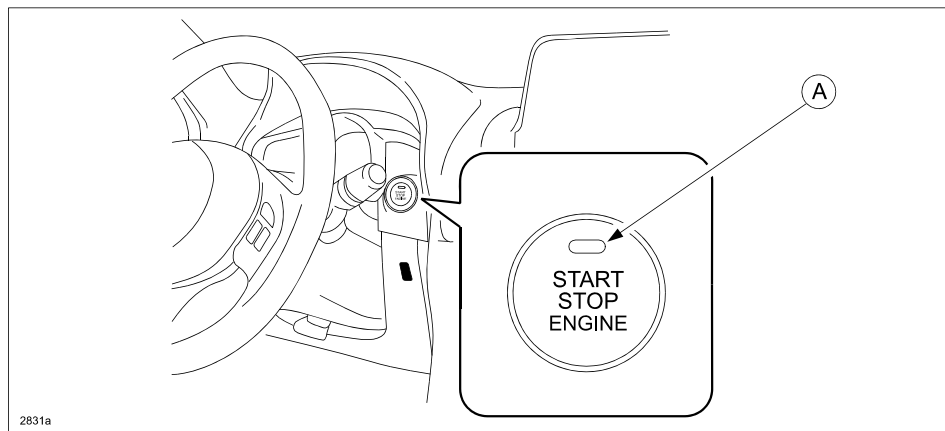
4. Install the ROOM FUSE and AUDIO FUSE to the fuse block in the engine compartment (if not installed).
5. Connect battery charger (charge current maintained about 7A) to the vehicle to stabilize voltage fluctuation.
6. Press the START/STOP ENGINE push button 1 time without depressing the clutch pedal (manual transaxle) or the brake pedal (automatic transaxle), to switch the ignition position to ACC. Confirm that the push button start indicator light (A) is illuminated (amber) and the display in the instrument cluster is OFF (ignition position is in ACC).

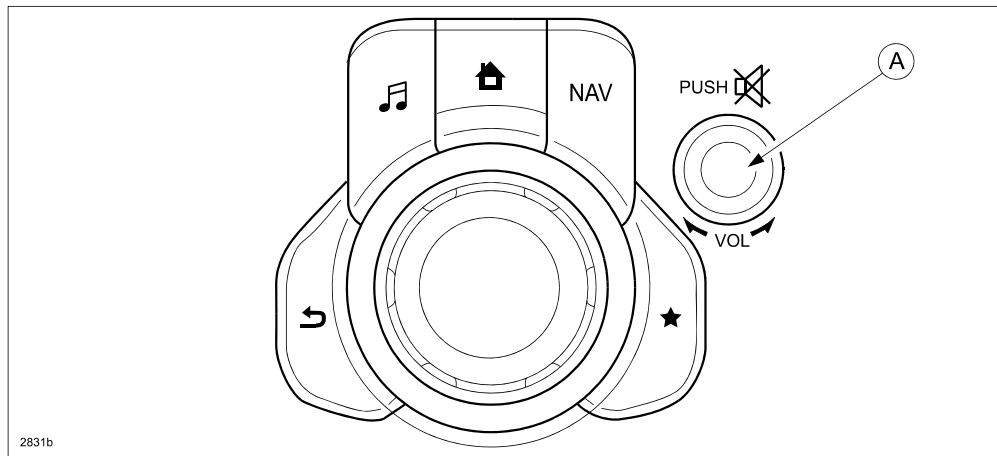
7. Verify that there is a sound coming from the speakers. If sound cannot be heard, turn the volume dial (A) to turn the volume up, or make sure that MUTE is not on.

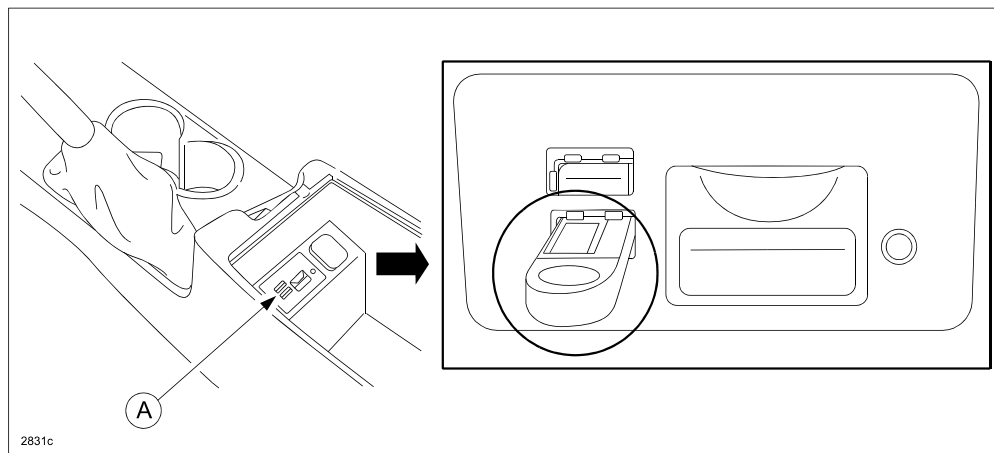
8. Connect the prepared USB memory stick to the either one of the two USB port (A).

NOTE: There should only be the prepared USB memory stick inserted in one of the USB ports. Nothing should be inserted in the other USB port during the re-flashing process.

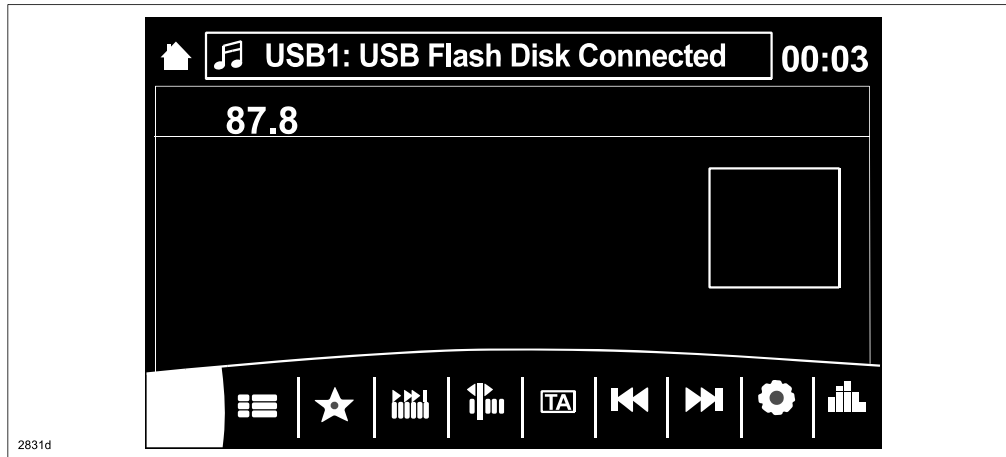
9. When the USB memory stick is recognized, the following message will appear briefly on the screen.

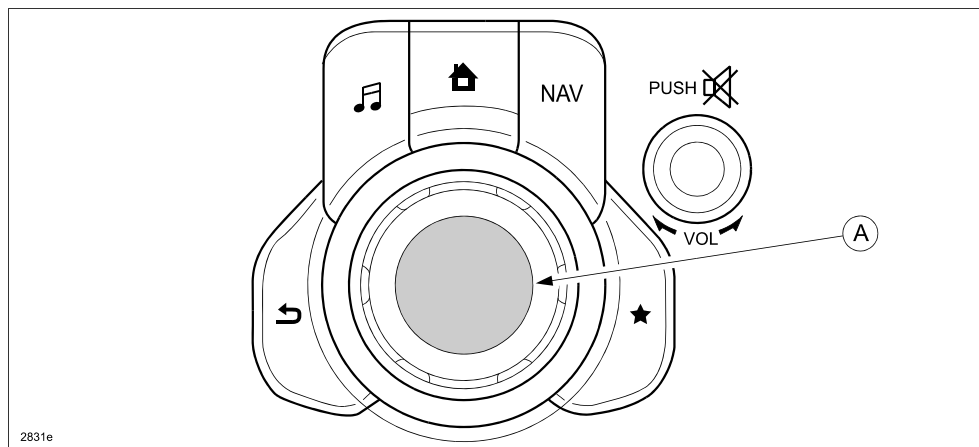
- It takes approx. 5 seconds before the USB memory stick is recognized.
- If the USB memory stick is not recognized, perform the following:
 - (1) Select "Setting".
 - (2) Select "System".
 - (3) Select "Factory Reset".
 - (4) Push the commander switch knob (A) to "Enter".

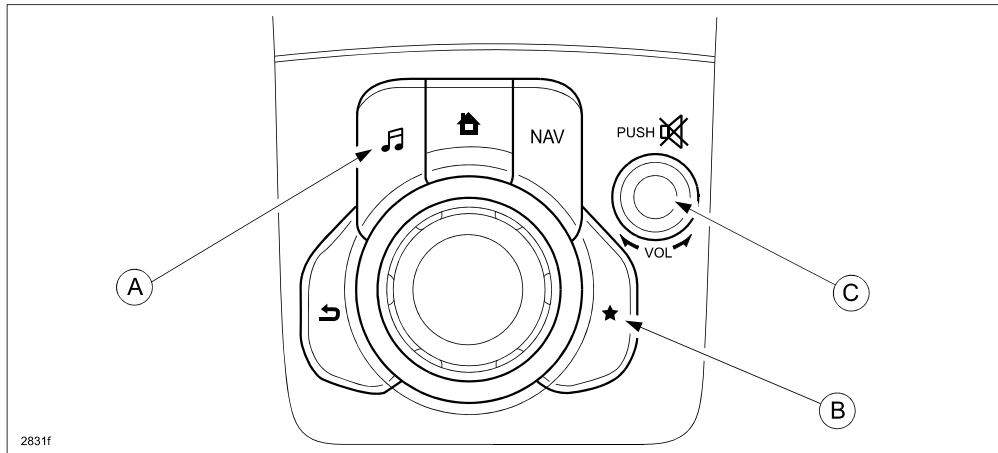
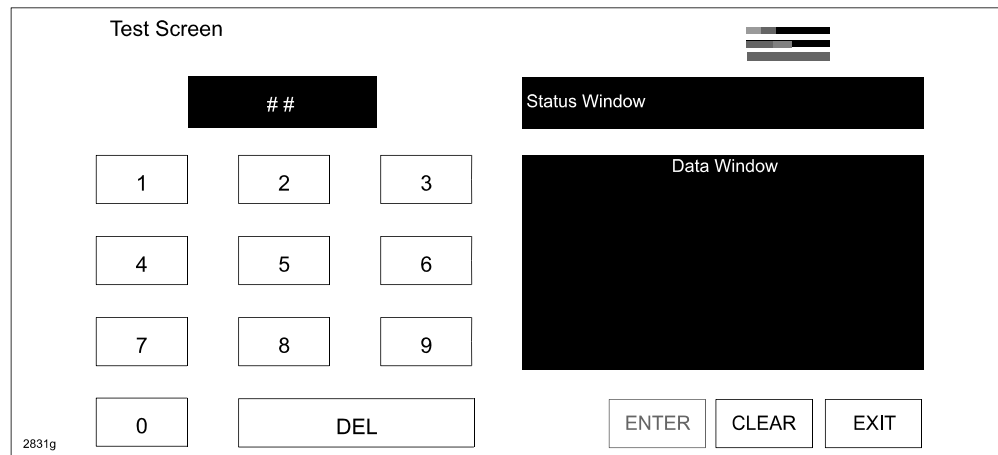
10. Press the three buttons (Music (A) + Favorites (B) + Volume Mute(C)) on the commander switch at the same time for 2-5 seconds and the Diagnostic Test Screen will appear.

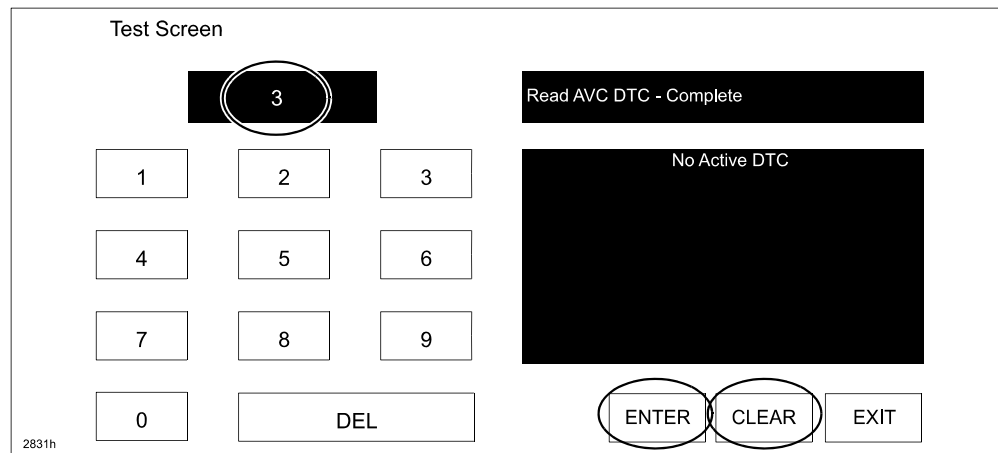
11. On the test screen, input '3' and then select "ENTER" to verify whether any DTCs (in the CMU) are active. Select "CLEAR" to go next step.

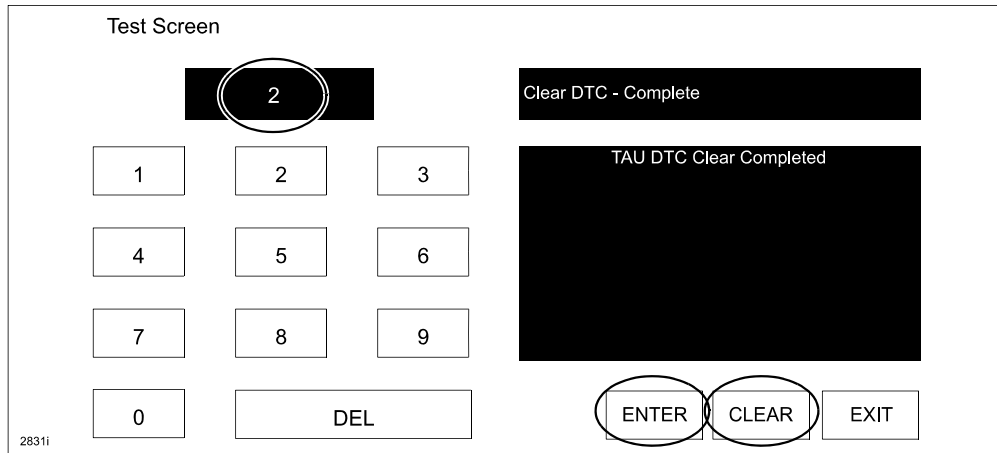
12. If any DTCs are present, input '2' on the test screen and then select "ENTER". This will internally clear all the earlier set DTCs (in the CMU). Select "CLEAR" to go to next step.

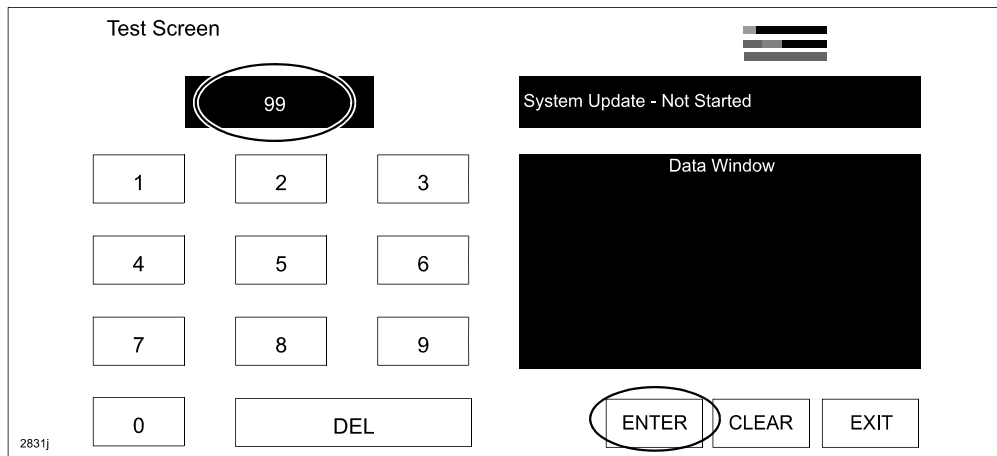
13. Use the touchscreen or the commander switch to input '99' and then select "ENTER" on the Test screen.

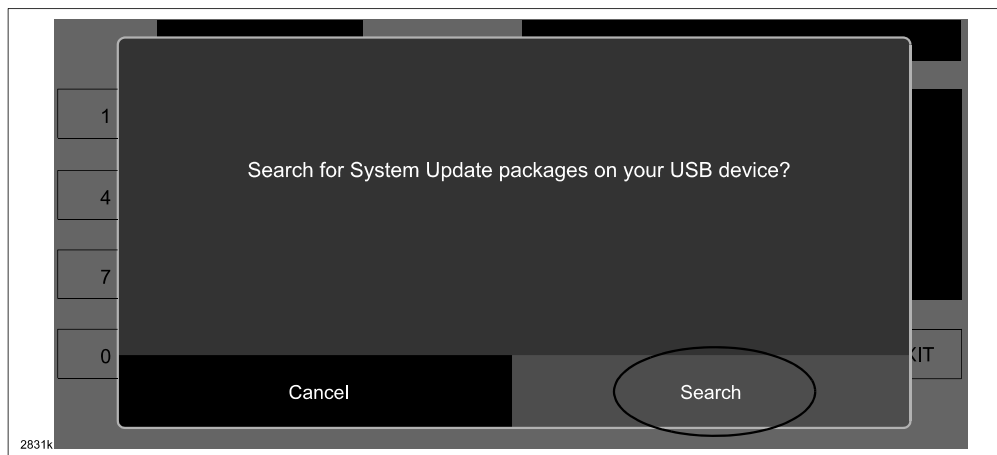
14. Select "Search" on the screen below.

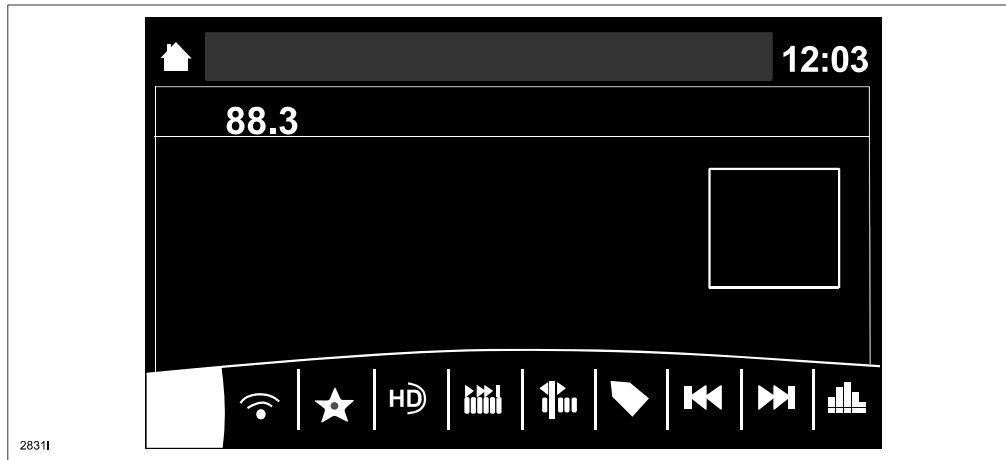
NOTE: If the following screen is displayed, perform the following.

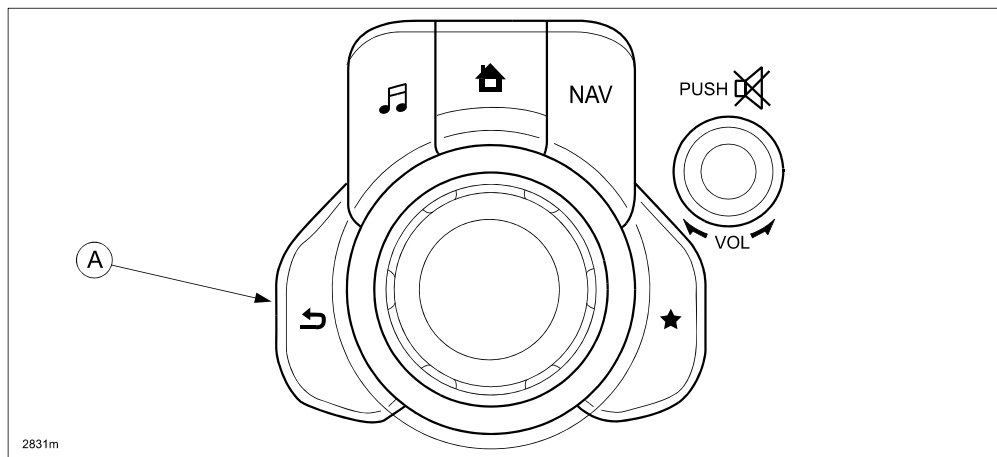
(1) Press the “Return” button (A) on the commander switch.

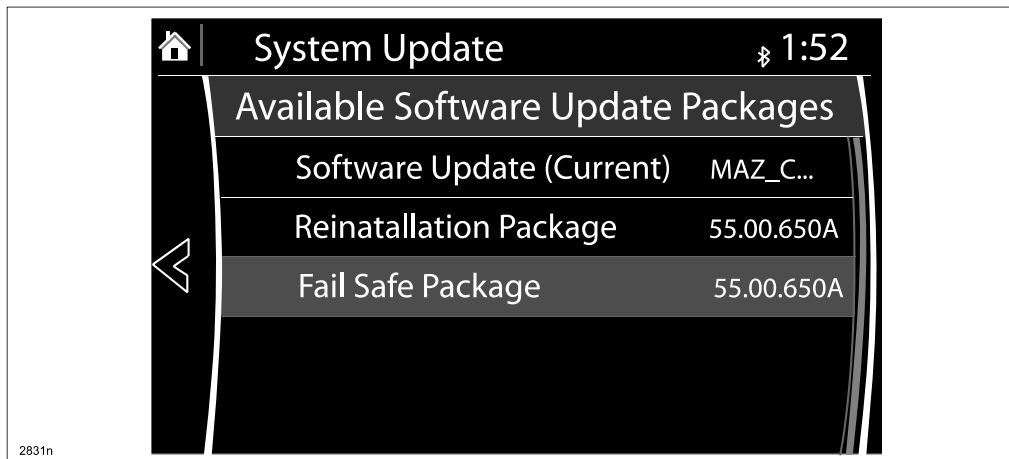
(2) Verify that the screen changes back to the screen below.

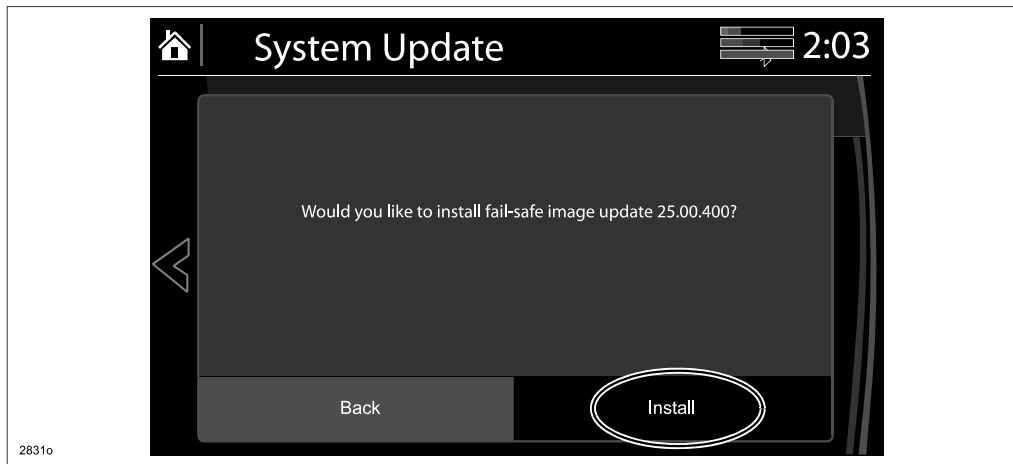
15. Select “Fail Safe Package” first using the touch screen.

CAUTION: Always do the “Fail Safe Package” first, followed by “Reinstallation Package”.

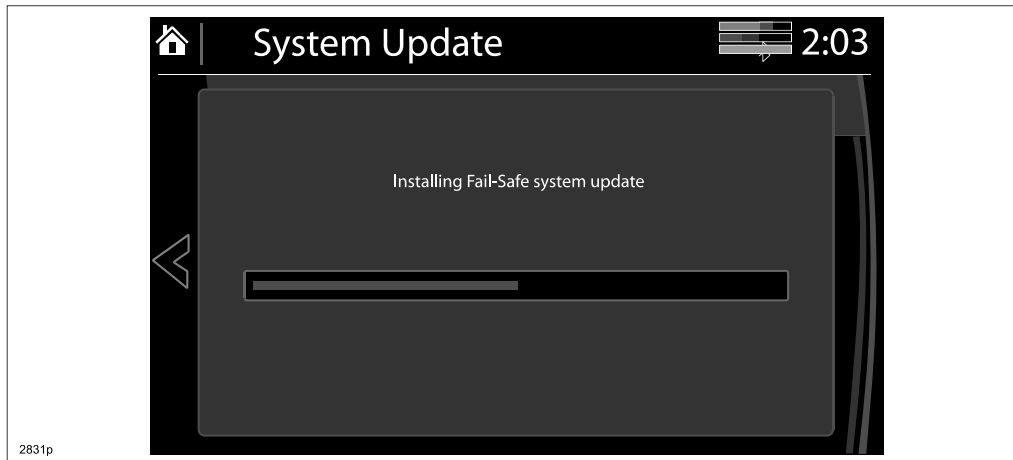
16. Select “Install” on the screen below and the Failsafe installation process will start.

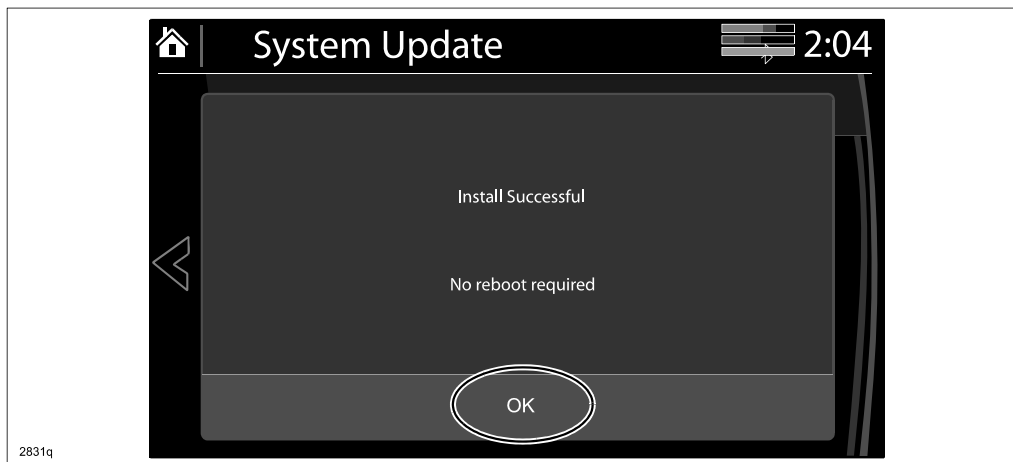
17. After the Failsafe installation process is completed, select “OK”.

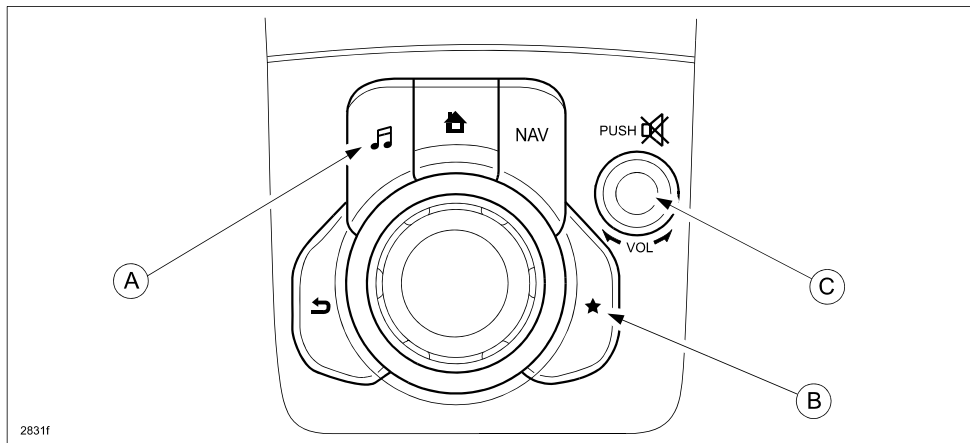
19. Press the three buttons (Music (A) + Favorites (B) + Volume Mute(C)) on the commander switch at the same time for 2-5 seconds to open the Diagnostics Test screen again.

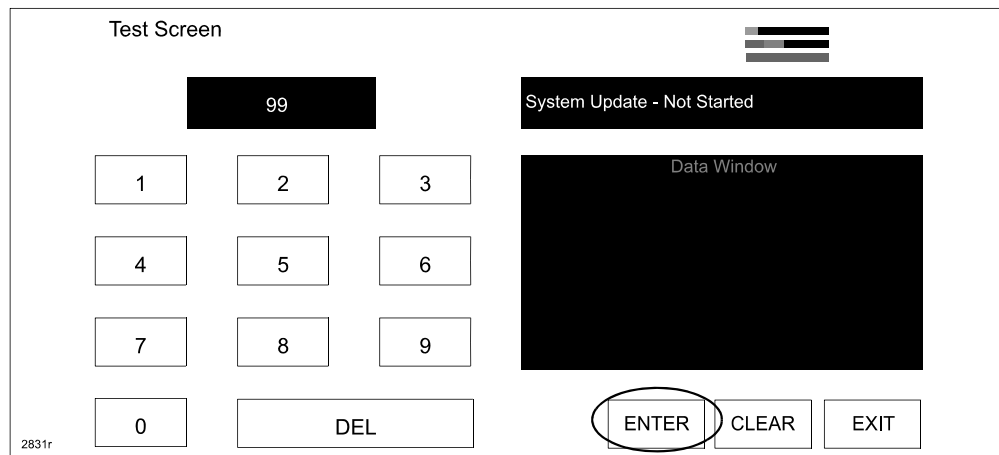
20. Use the touchscreen or the commander switch to input '99' and then select "ENTER" on the Test screen.

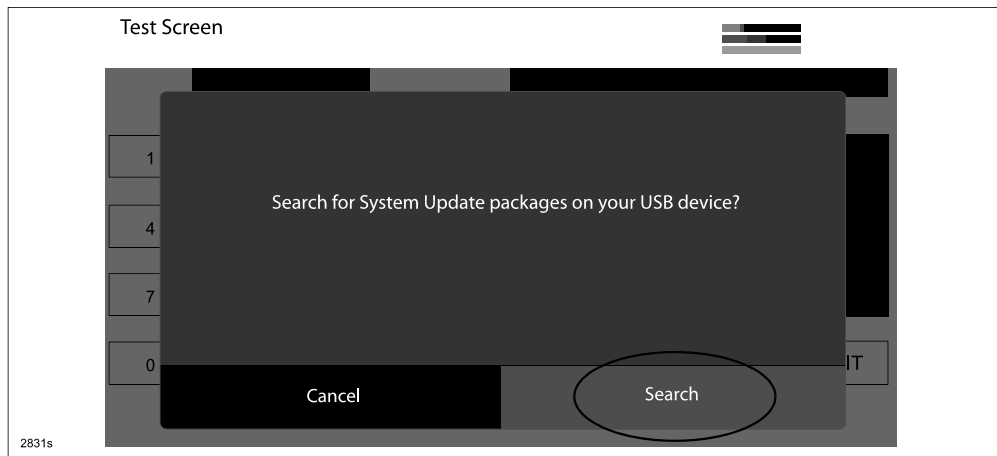
21. Select "Search" on the screen below.

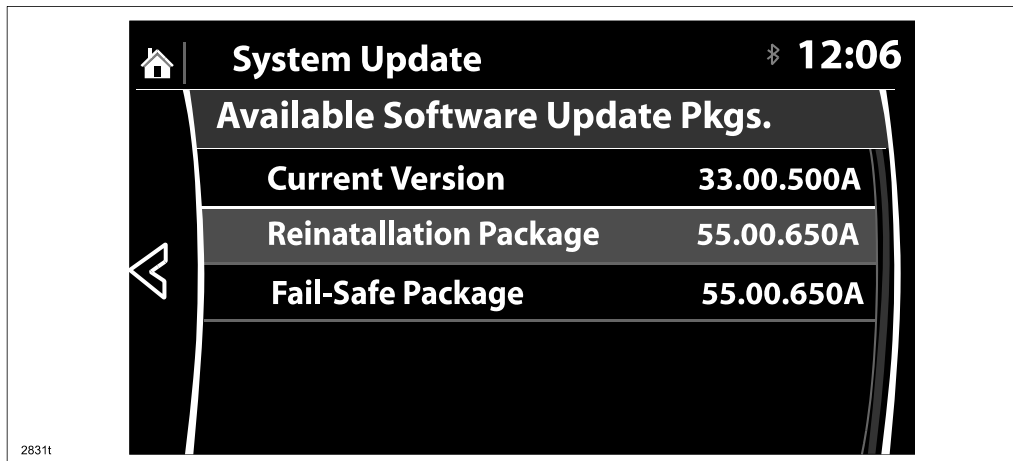
22. Select "Reinstallation Package" on the screen below.

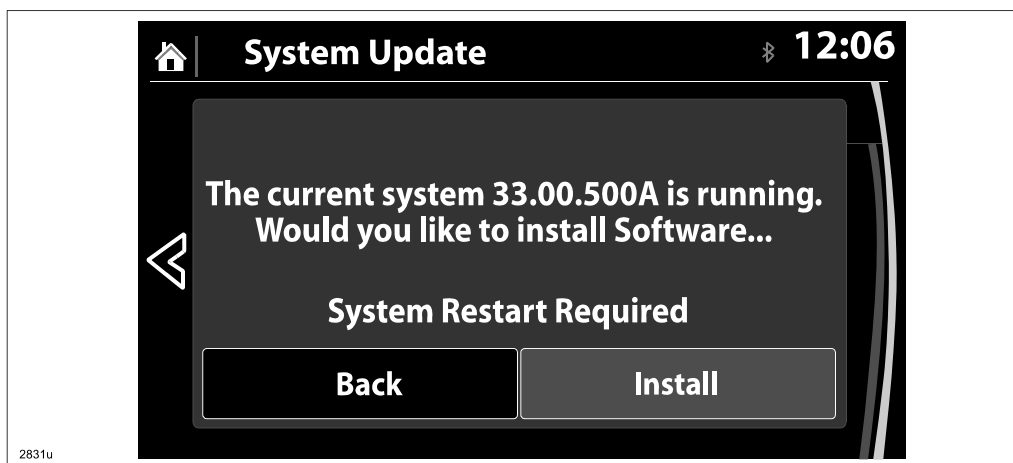
23. Select "Install" on the screen below.

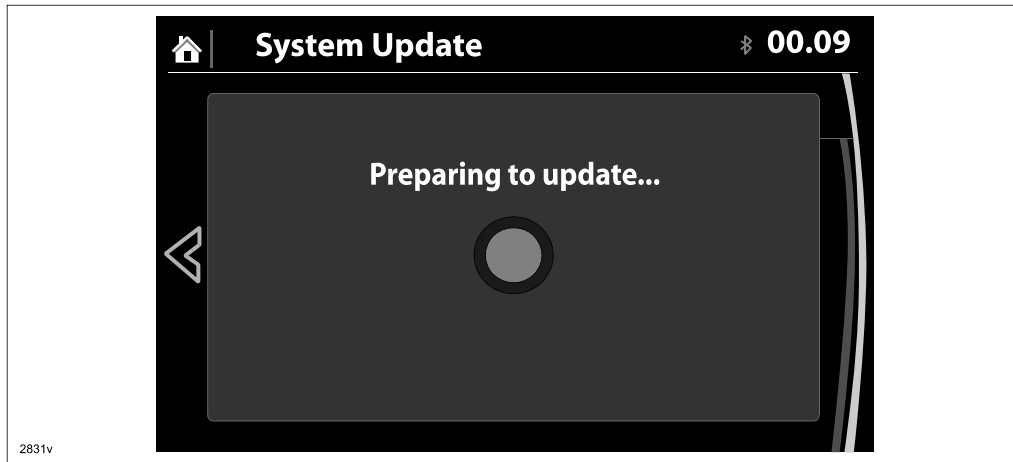
24. The screen below will be displayed.

NOTE: A blank screen is displayed momentarily. It will take approx. 2 minutes before the reflashing process moves to the next screen.

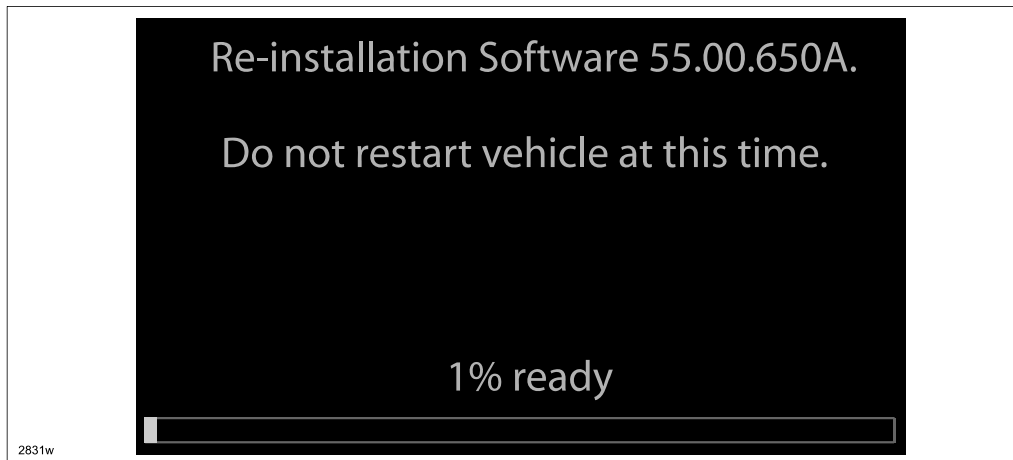
25. Reinstallation will start from 0% and as the reflashing process takes place, the progress bar will gradually increase to 100%.

NOTE: It may be difficult to read the display at times as it becomes dark, but "Do not restart vehicle at this time" is displayed.

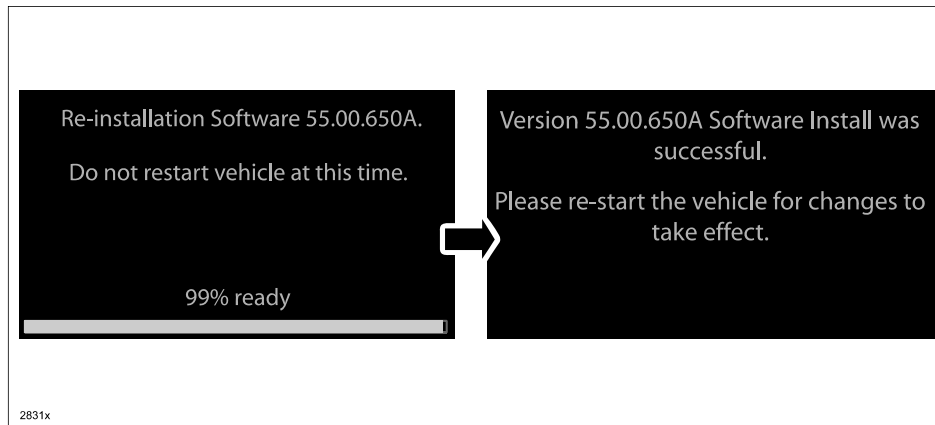
NOTE: It will take some time for the reflashing process to get from 98 % to “100%.”

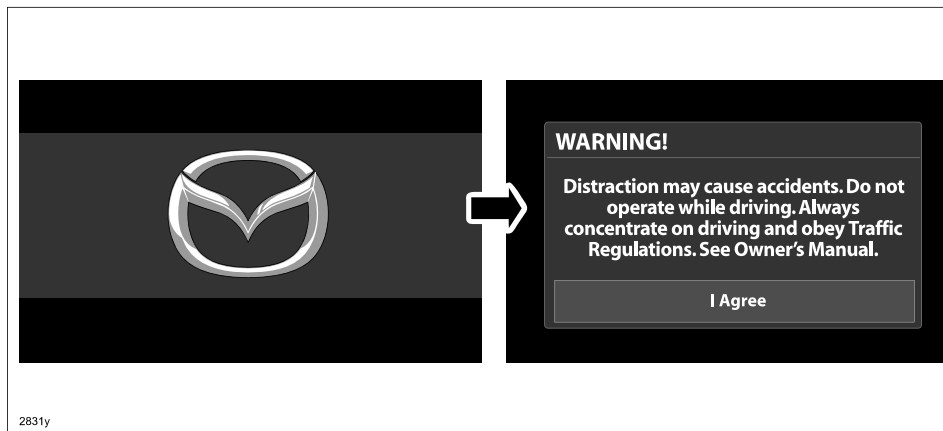
Type A: Reprogramming has already been completed. Go to next step.

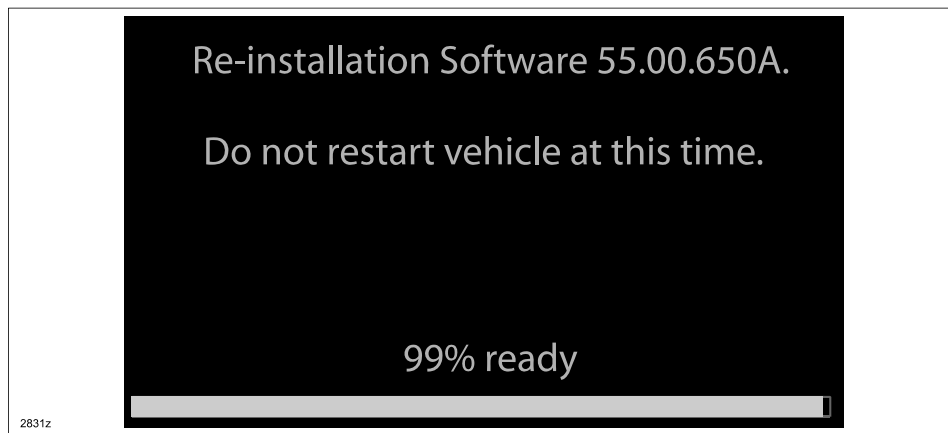
Type B: The ignition was turned “OFF” during the reflashing process. This screen will continue to be displayed until reflashing is completed. After the reflashing is completed, go to next step.
