Subject: TPMS WARNING LIGHT ON	Bulletin No: 02-002/15
	Last Issued: 03/06/2015

2014-2015 Mazda6 vehicles (except Canada and Mexico) with VINs between JM1 GJ1 ***** 100027-225009 (produced between October 25, 2012 - December 01, 2014)

2016 Mazda6 vehicles with VINs between JM1 GJ1 ***** 400011-412885 (produced between November 24, 2014 - February 11, 2015)

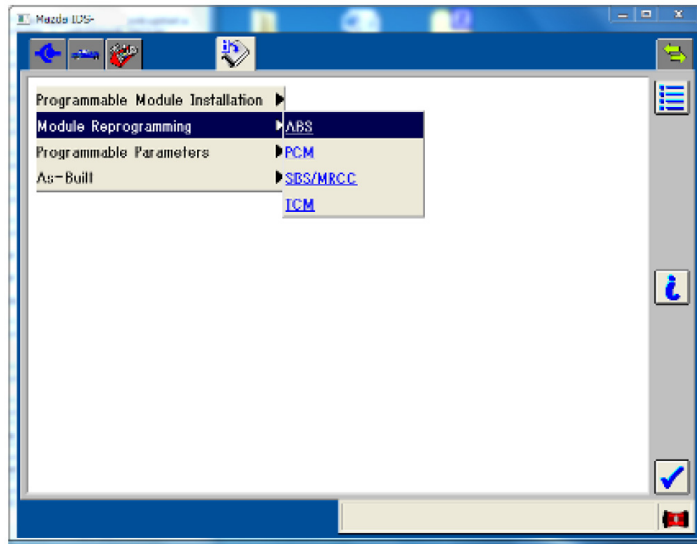
- a. Select “Module Reprogramming”, then select “ABS”.

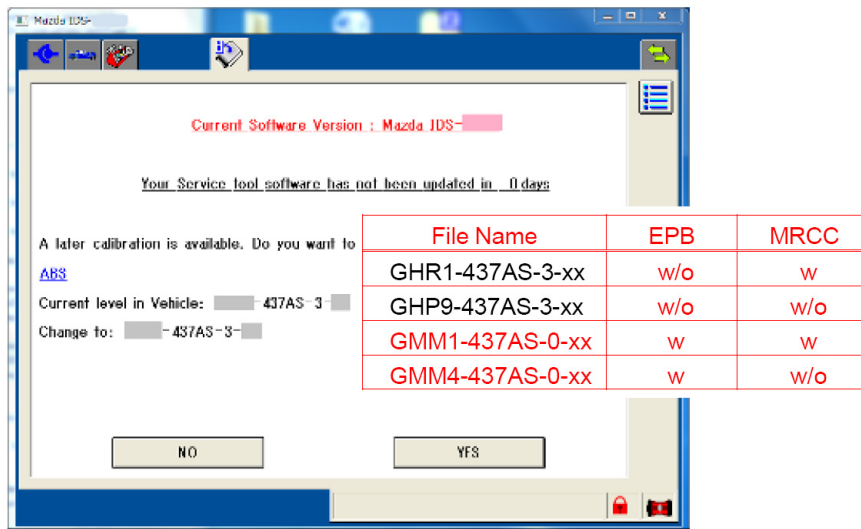
- b. The following screen will be displayed:
Click “YES” and follow the M-MDS instructions to reprogram the ABS module.

If the message “No later calibration is available on the system for this ABS” is displayed, the ABS module is already at the latest calibration. “Current level in Vehicle” will show the new file name. This service bulletin does not apply.

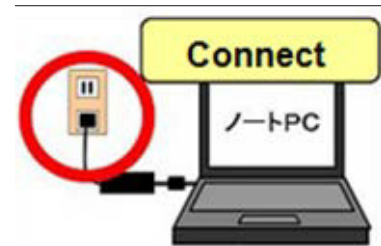
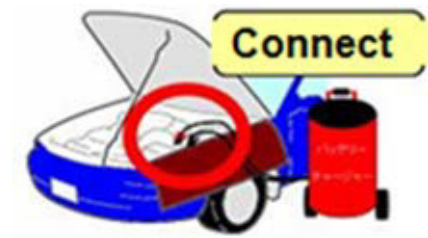
- Make sure the following connections are secured. Do NOT touch the VCM and DLC cable. This may cause electrical noise and connection disruption.
 - Between the vehicle-side connector and the DLC cable.
 - Between the PC-side connector and USB port of PC.
- Connect AC adapter to the PC in order to stabilize voltage fluctuation during reprogramming.
Do NOT use vehicle battery outlet as power source for the PC.
- When performing this procedure, we recommend using the “Power Supply” mode in the Battery Management System to keep the vehicle battery up to capacity. If a different charger is used, make sure it does not exceed 20 AMPS. If it exceeds 20 AMPS, it could damage the VCM.

NOTE: Poor connection between the vehicle and M-MDS and/or low voltage may result in abnormal termination and/or ABS data corruption.
