Subject: MAZDA CONNECT CLOCK DISPLAYS TIME OF INCORRECT TIME ZONE WHEN GPS SYNC IS ON	Bulletin No: 09-001/15
	Last Issued: 02/27/2015

DESCRIPTION

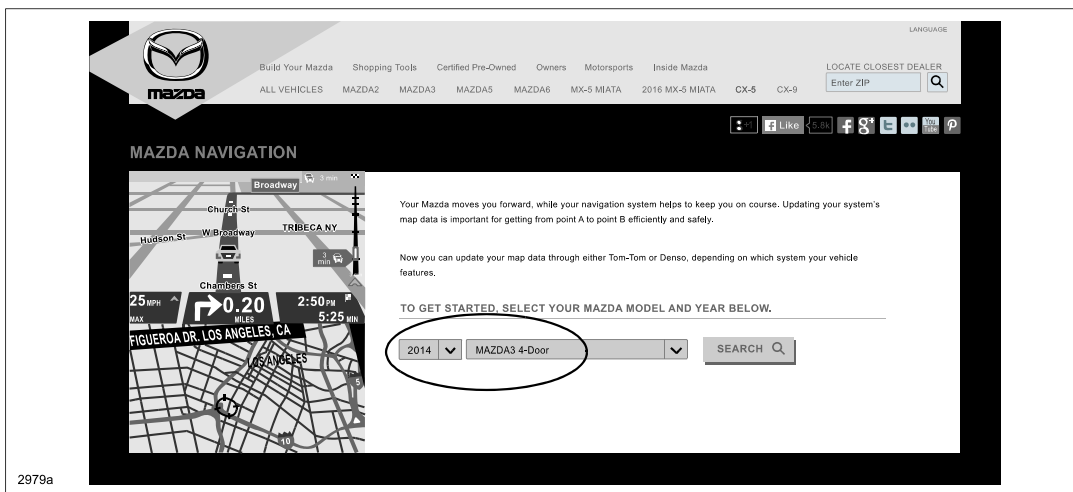
a. Select the year and model.

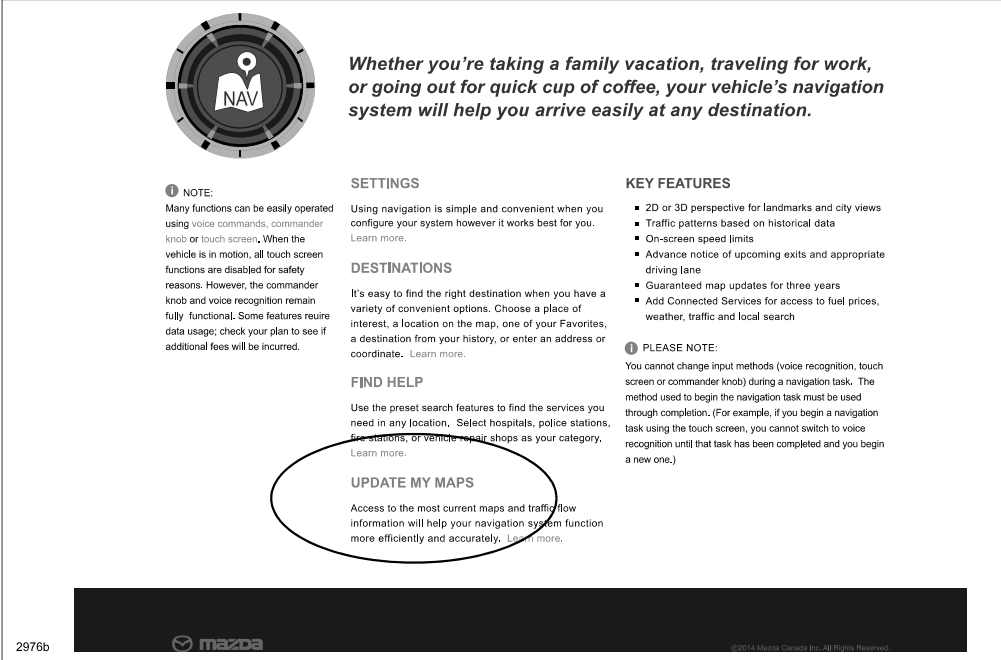
b. Select "UPDATE MY MAPS."

The image shows a screenshot of a vehicle's navigation system interface. At the top left is a circular icon with a map and the word "NAV". To its right is a headline: "Whether you're taking a family vacation, traveling for work, or going out for quick cup of coffee, your vehicle's navigation system will help you arrive easily at any destination." Below this are several sections: "NOTE" (explaining voice and touch screen usage), "SETTINGS" (describing navigation configuration), "DESTINATIONS" (explaining how to find destinations), "FIND HELP" (describing search features), and "UPDATE MY MAPS" (highlighted with a hand-drawn circle, describing map updates). A "KEY FEATURES" list includes 2D/3D perspectives, traffic patterns, speed limits, and map updates. A "PLEASE NOTE" section explains that input methods cannot be changed during a navigation task. At the bottom, there is a Mazda logo and a copyright notice for 2014 Mazda Canada Inc.
