<b>Subject:</b> MAZDA SERVICE PROGRAM (MSP45) – TIRE PRESSURE MONITORING SYSTEM WARNING LIGHT	<b>Bulletin No:</b> 02-006/15
	<b>Last Issued:</b> 11/03/2015

## DESCRIPTION

Some Mazda6 vehicles may experience Tire Pressure Monitoring System (TPMS) warning light on even if the TPMS system has been properly initialized at the specified tire air pressure.

## REPAIR PROCEDURE

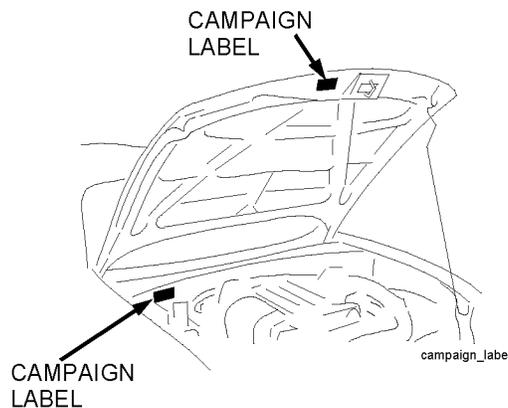
1. Verify the vehicle is within one of the following VIN ranges:  
 2014-2015 Mazda6 vehicles produced between October 26, 2012 and November 26, 2014
  - 2014 VIN Range: JM1 GJ \*\*\*\* 100042 - 162745
  - 2015 VIN Range: JM1 GJ \*\*\*\* 162748 - 224852
    - If the vehicle is within the above VIN and production date ranges, proceed to Step 2.
    - If the vehicle is not within the above VIN and production date ranges, return the vehicle to the customer or inventory.
2. Perform a Warranty Vehicle Inquiry using your eMDCS System and inspect the vehicle for a Campaign Label MSP45 attached either to the vehicle's bulkhead or to the vehicle's hood. Refer to eMDCS System - Warranty Vehicle Inquiry Results table below.

**NOTE:** Verify the campaign number as the vehicle may have multiple labels.

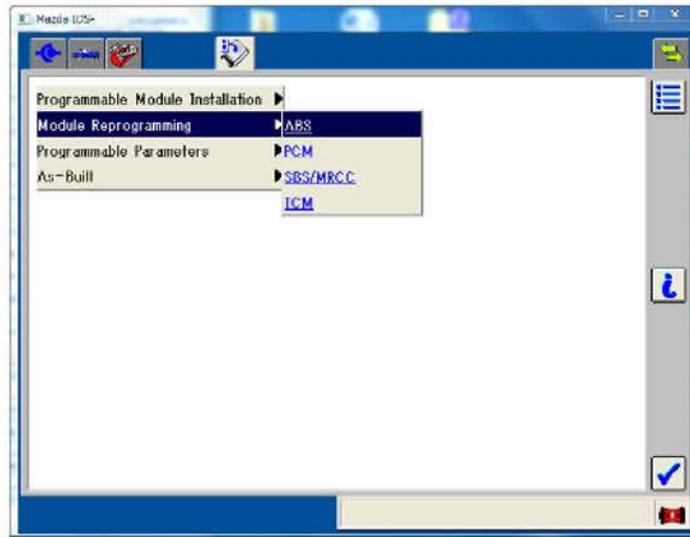
- a. Select "Module Reprogramming", then select "ABS".

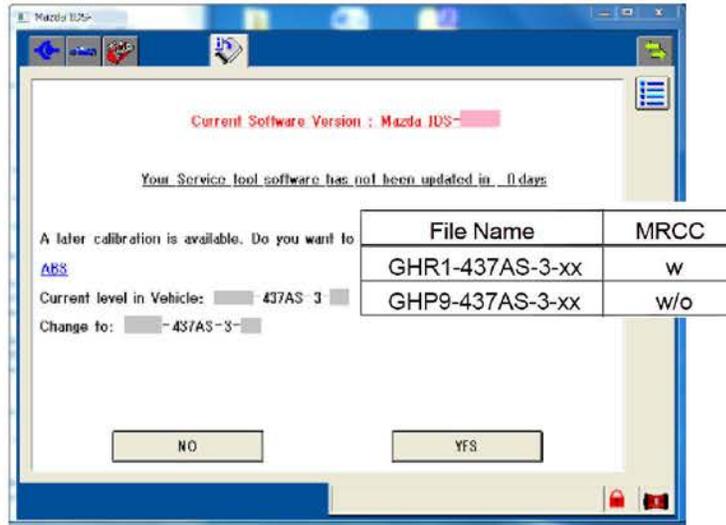
b. The following screen will be displayed:

Click "YES" and follow the M-MDS instructions to reprogram the ABS module.

If the message "No later calibration is available on the system for this ABS" is displayed, the ABS module is already at the latest calibration. "Current level in Vehicle" will show the new file name. This service bulletin does not apply.

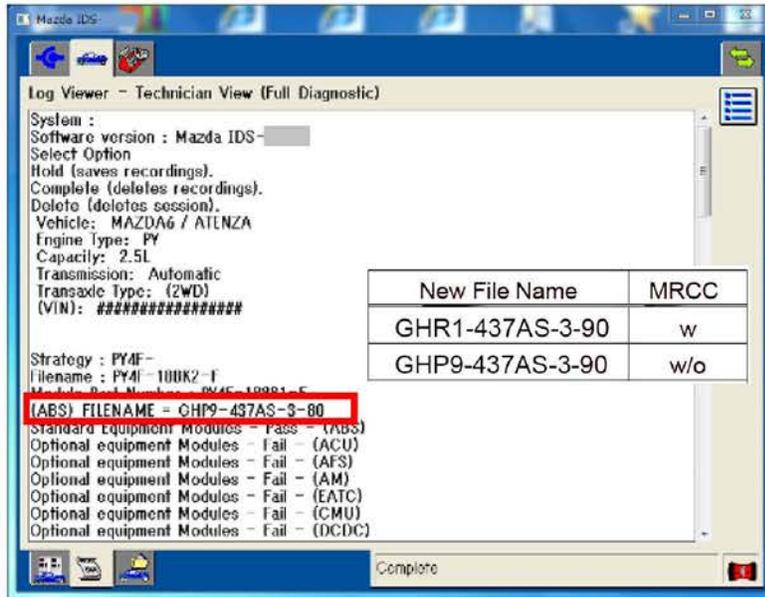
- c. After reprogramming, remove the session. Then, open a new session again and go to the “Log Viewer” screen on which the programmed file name is displayed as shown in figure below. If the new file name matches the list, the reprogramming has been successfully completed.

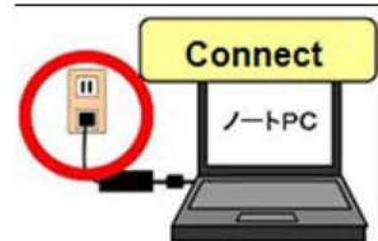
- a. Make sure the following connections are secured. Do NOT touch the VCM and DLC cable. This may cause electrical noise and connection disruption.

- Between the vehicle-side connector and the DLC cable.
- Between the PC-side connector and USB port of PC.

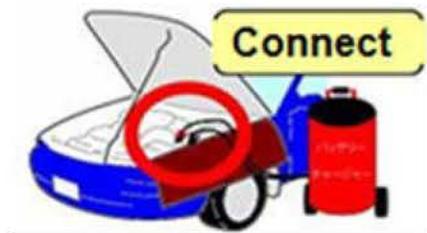
- b. Connect AC adapter to the PC in order to stabilize voltage fluctuation during reprogramming.

Do NOT use vehicle battery outlet as power source for the PC.

- c. When performing this procedure, we recommend using the “Power Supply” mode in the Battery Management System to keep the vehicle battery up to capacity. If a different charger is used, make sure it does not exceed 20 AMPS. If it exceeds 20 AMPS, it could damage the VCM.

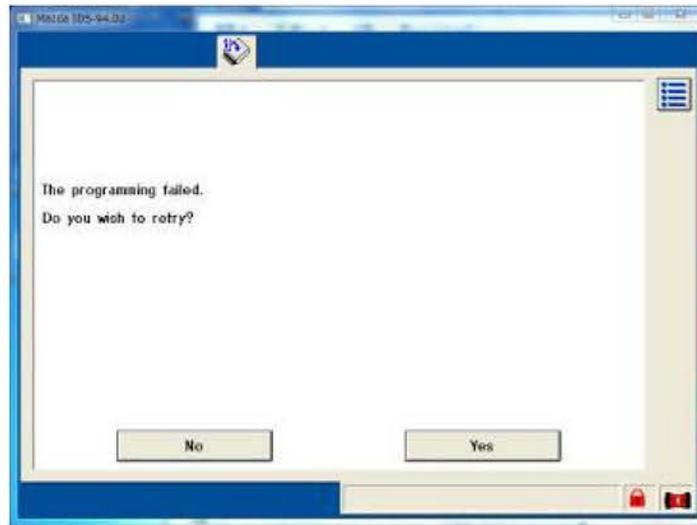
- a. If the screen shows “The programming failed. Do you wish to retry?” with Yes/No buttons, DO NOT Click the buttons and proceed to “**Recovery**” below.

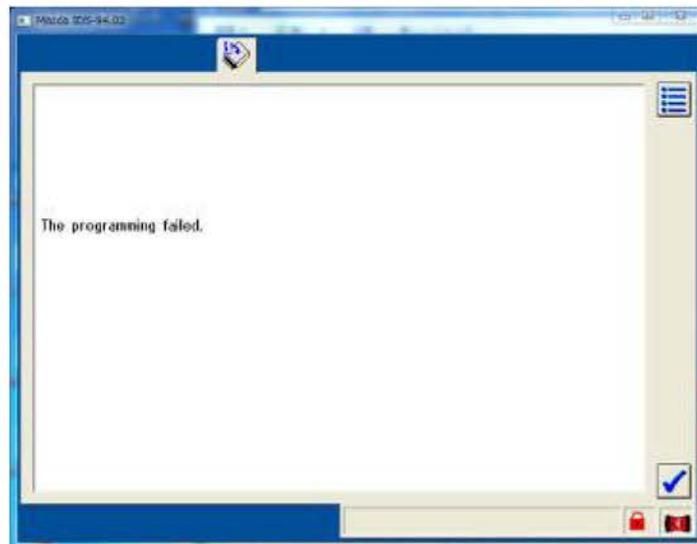
- b. If the screen shows “The programming failed.” without Yes/No buttons, the ABS module has to be replaced with new one.

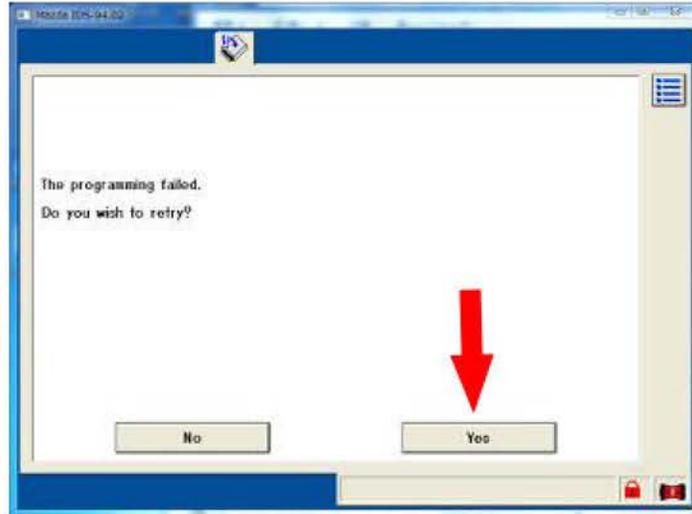
- a. Turn IG off. (If needed, press and hold the start button.)
- b. Remove the ABS/DSC 30A fuse for 10 seconds.
- c. Install the fuse and turn IG ON.
- d. Click "Yes" button and follow the on-screen instruction.

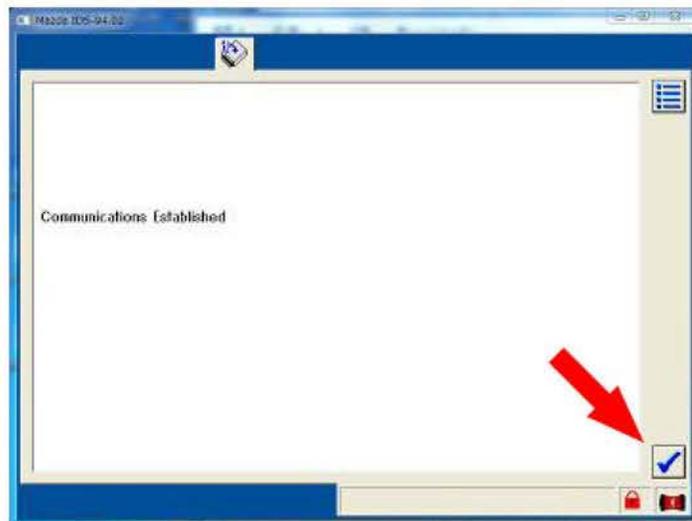
- e. Click the check button.

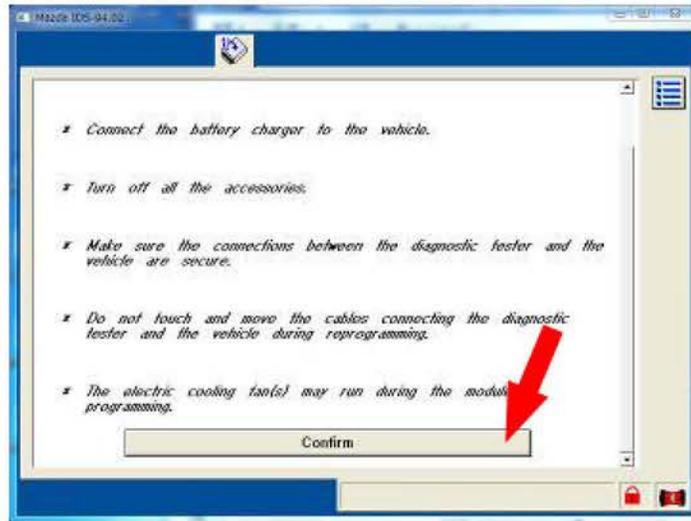
f. Click the "Confirm" button.

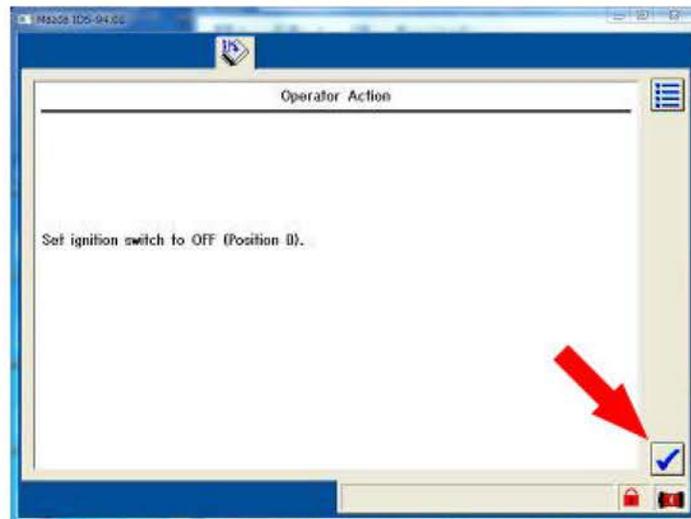
g. Turn IG OFF.

h. Click the check button.

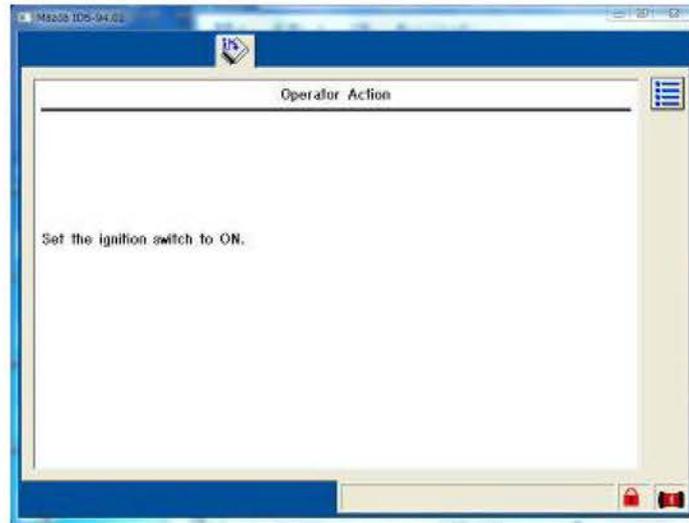
- i. Turn IG ON. Reprogramming will resume.
