September 24, 2015

02210 Version 2

HVAC Display Flashes or Flickers

Year	Model	Trim	VIN Range
2014-15	MDX	ALL with navigation	ALL

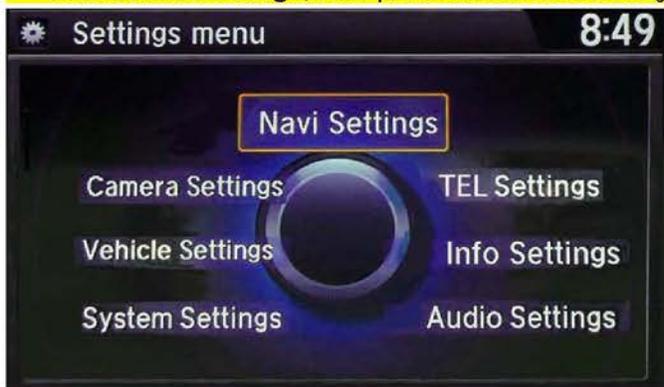
- Press the Settings button.
 - Select **Navi Settings**, then press the interface dial (jog knob).

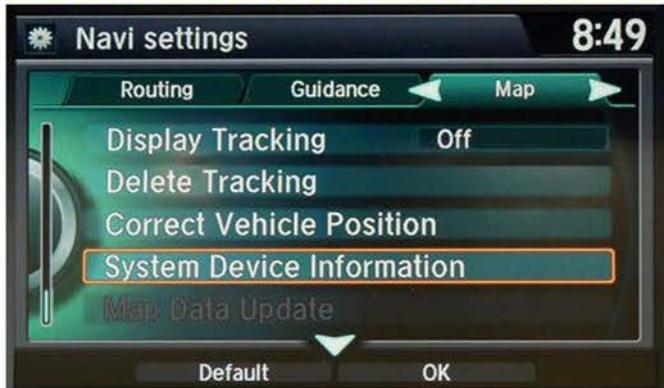
- Scroll down and select **System Device Information**.

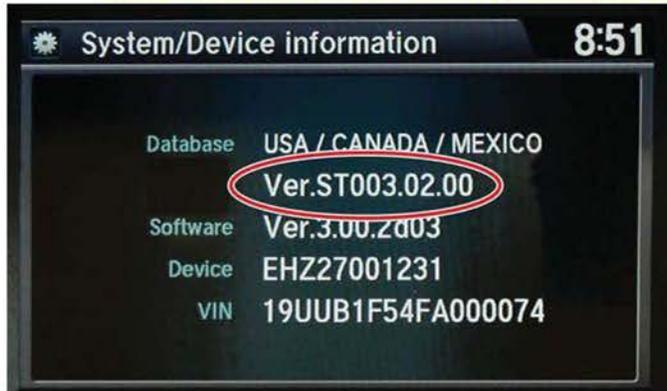
- Check the Database version is VER.ST003.02.00.
 - If the version matches, continue to step 4.
 - **If the version is different, go to S/B 14-037 and do the map database update. The map database must be completely installed, including the background update, before continuing with this bulletin. If you try to update the ODMD without doing 14-037, the ODMD will not work properly.**

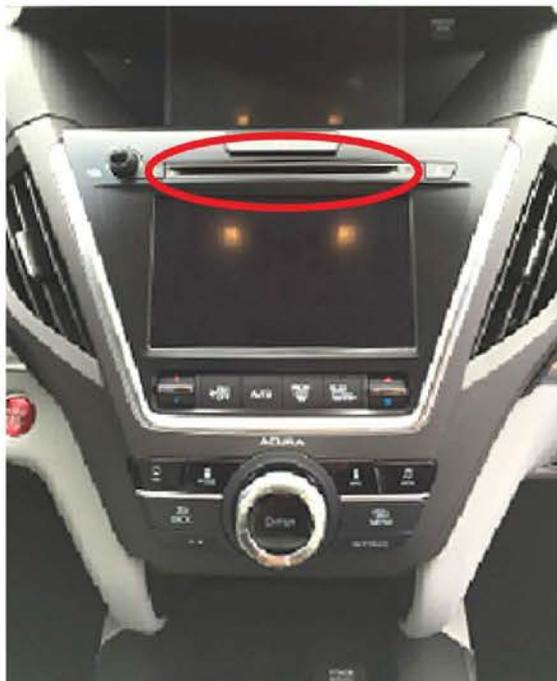
4. Set the power mode to OFF, then to ON and wait for the navigation system to boot up. **Insert the RED DVD** into the CD slot as shown. See TOOL INFORMATION.

NOTE: The power mode must remain ON during the entire update procedure. If the power mode is set to OFF, the engine is started, or the DVD is removed at any time during the update process, the audio-navigation unit will be locked up and you will need to use the RECOVERY PROCEDURE.

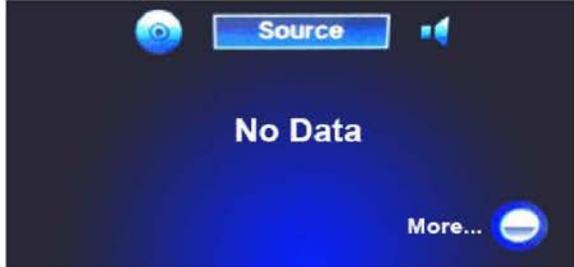
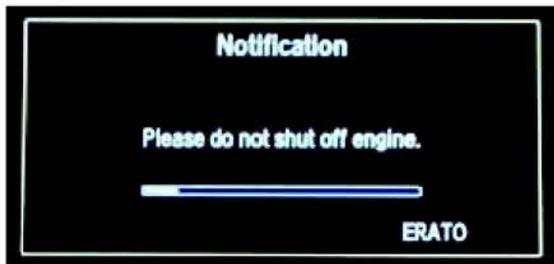
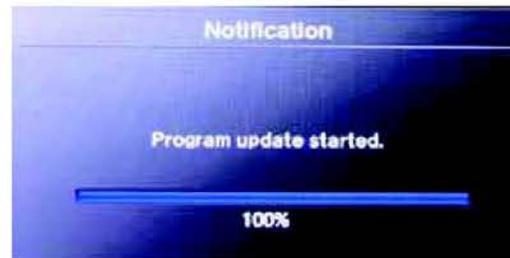
5. The software update will begin. The screen will show a **Reading the Disc** message, then both screens will shut off for about 10 seconds and reboot. The message **No Data** will appear on the screen. **Do not eject the disc**. The unit is uploading the update and may take up to 1 minute before beginning. The displays should change to a **Notification** screen loading bar.

Navigation screen

Touch screen

On the touch screen, the progress bar will stop at 100% after ERATO is updated and remain at 100% throughout all SH and Utility updates. The progress bar will go back to 0% and resume when the BUuCOM update starts.

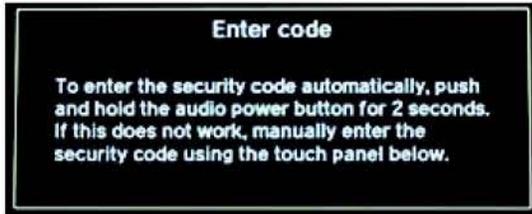
Navigation screen

- When the update is complete, the system will reboot to the AcuraLink screen. The **Enter code** message and keypad will appear on the screens, although they may not appear at the same time. **Wait for both screens to appear**, then press the engine start/stop button to set the power mode to OFF.

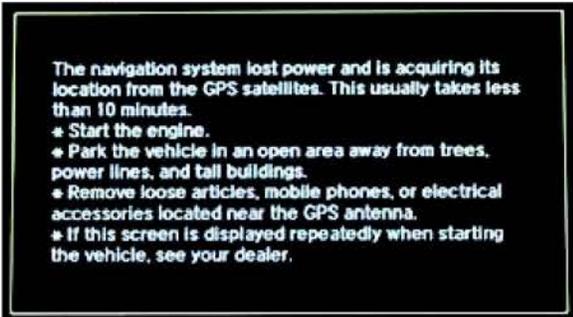
- Eject the DVD and wait at least 1 minute.
- Set the power mode to ON. Once both **Enter code** screens appear, press and hold the power button for 2 seconds until you hear the beep.
- The navigation screen will show the GPS initialization message.

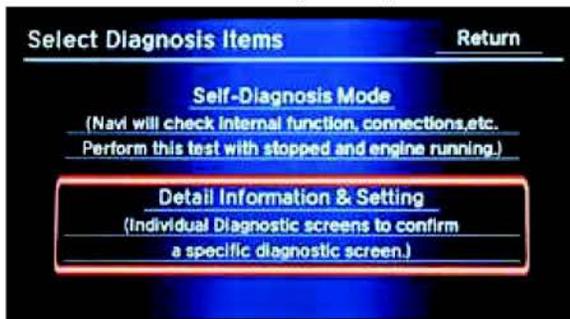
- Press and hold the NAVI, BACK, and MENU buttons until the **Select Diagnosis Items** screen appears.

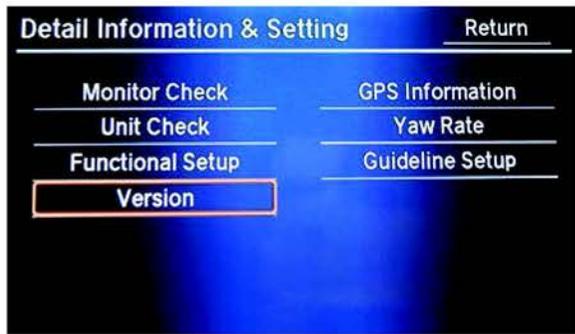
11. Select **Detail Information & Setting**, then select **Version**.

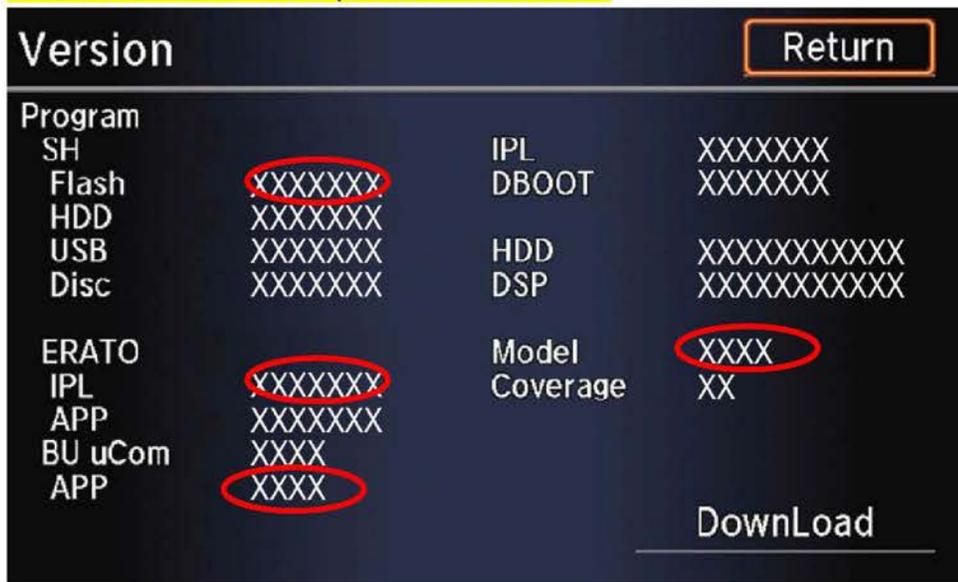
12. Verify that the software versions were updated to the new version as shown:

NOTE: If the Version information does not match the table above after doing the update, or the update won't auto start, select **Download** and press the interface dial.

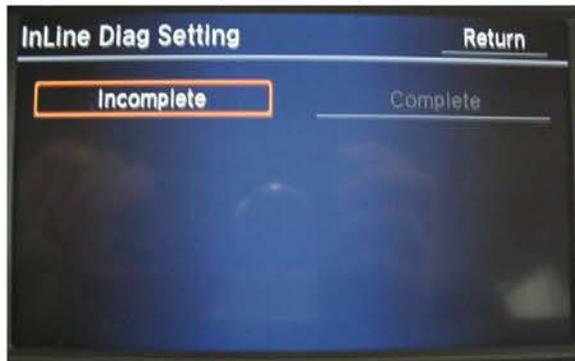
- Move the vehicle to an open area. Start the engine if not already done.
- Press and hold the NAVI, BACK, and MENU buttons until the **Select Diagnosis Items** screen appears.
- Press and hold the NAVI button.
- Select **Incomplete**. The system restarts.

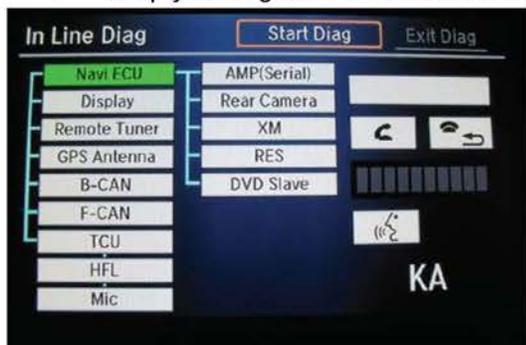
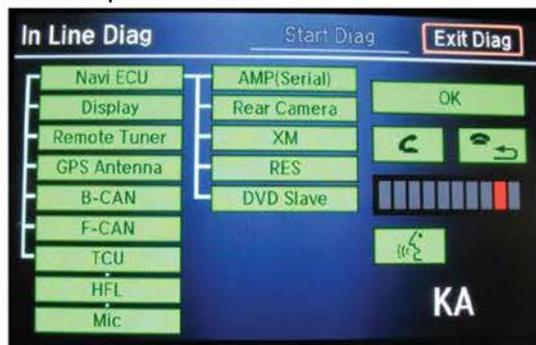
- When the **In-Line Diag** screen appears, select **Start Diag**.
- Make sure all the icons turn green.

- Press the Pick-up button.
- Press the Hang-up button.
- Press the Talk button.
- Snap your fingers in front of the microphone to complete the test.

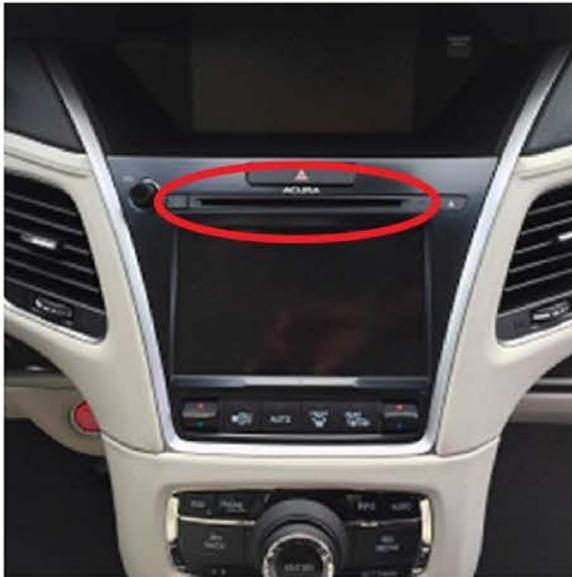
- **If the vehicle does not have navigation, do not use this software update.** If you do, you may permanently damage the audio unit.
 - Apply this software update only to the vehicles listed under **AFFECTED VEHICLES**; otherwise this software update can permanently damage the unit.
 - If you accidentally update the wrong vehicle, contact Tech Line; if the unit must be replaced, your dealership may be debited for the replacement cost.
1. Connect a battery charger or a fully charged jumper battery to the vehicle and leave it connected during the entire update procedure to maintain a steady voltage.
 2. Set the power mode to ON.
 3. Wait for the navigation system to boot up. **Insert the BLUE DVD** into the CD slot as shown. See **TOOL INFORMATION**.

NOTE: The power mode must remain ON during the entire update procedure. If the power mode is set to OFF, the engine is started, or the DVD is removed at any time during the update process, the audio-navigation unit will be locked up and you will need to use the **RECOVERY PROCEDURE**.

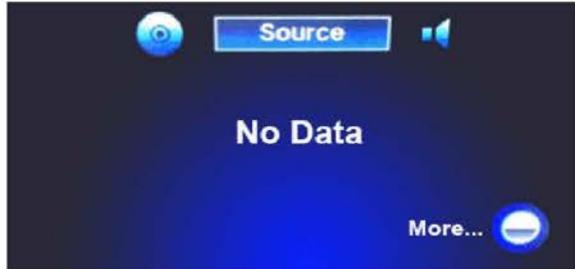
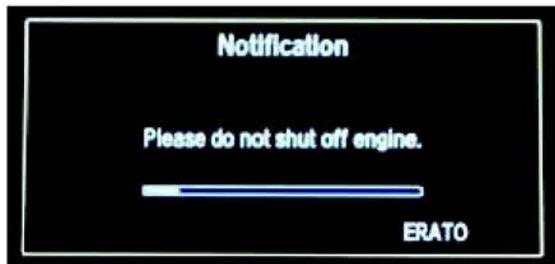
4. The software update will begin. The screen will show a **Reading the Disc** message, then both screens will shut off for about 10 seconds and reboot. The message **No Data** will appear on the screen. **Do not eject the disc**. The unit is uploading the update and may take up to 1 minute before beginning. The displays should change to a **Notification** screen loading bar.

Navigation screen

Touch screen

On the touch screen, the progress bar will stop at 100% after ERATO is updated and remain at 100% throughout all SH and Utility updates. The progress bar will go back to 0% and resume when the BUuCOM update starts.

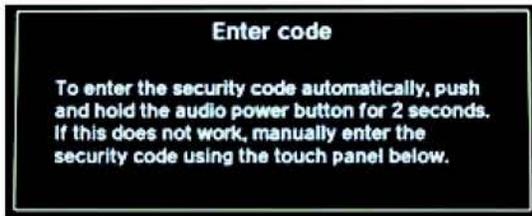
Navigation screen

- When the update is complete, the system will reboot to the AcuraLink screen. The **Enter code** message and keypad will appear on the screens, although they may not appear at the same time. **Wait for both screens to appear**, then set the power mode to OFF.

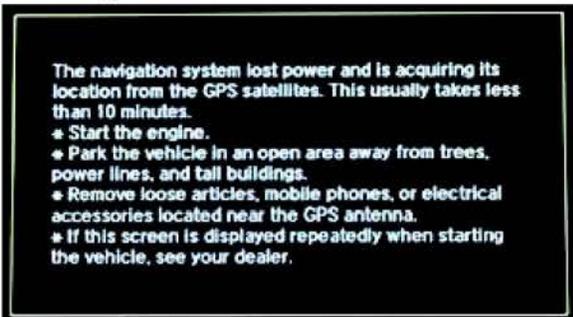
- Eject the DVD and wait at least 1 minute.
- Set the power mode to ON. Once both **Enter code** screens appear, press and hold the power button for 2 seconds until you hear the beep.
- The navigation screen will show the GPS initialization message.

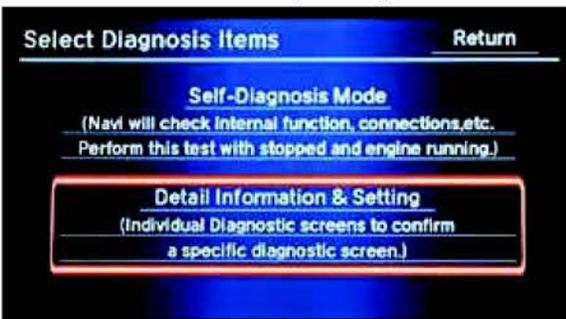
- Press and hold the NAVI, BACK, and MENU buttons until the **Select Diagnosis Items** screen appears.

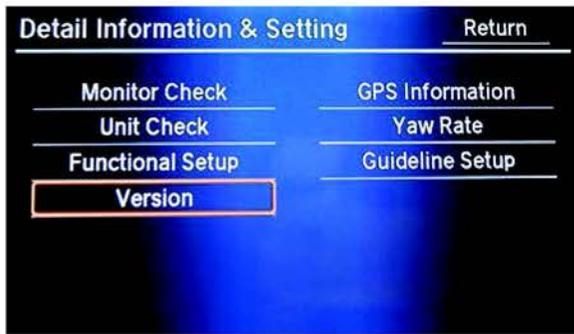
10. Select **Detail Information & Setting**, then select **Version**.

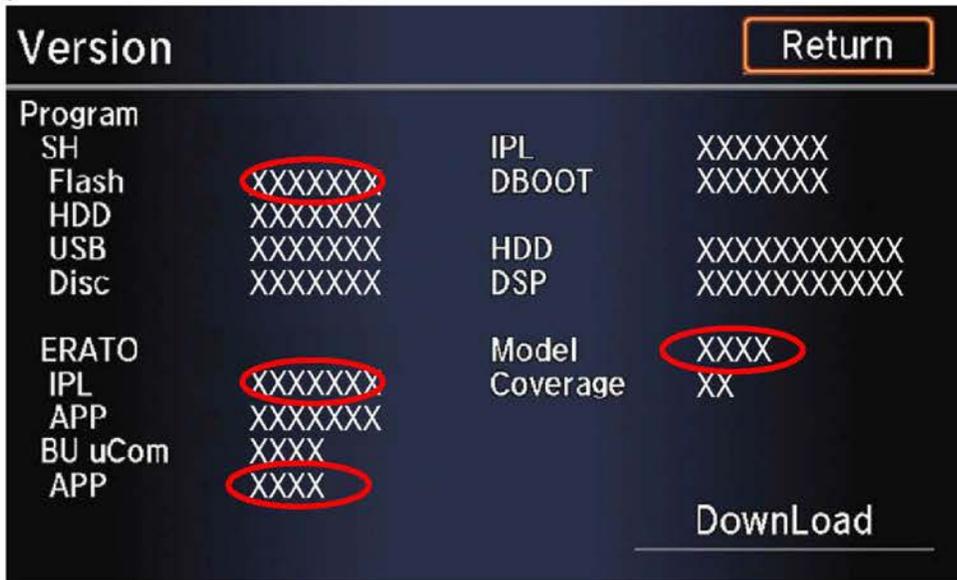
11. Verify that the software versions were updated to the new version as shown.

NOTE: If the software is not updated, set the power mode to OFF, and go back to step 2 and repeat the update procedure.

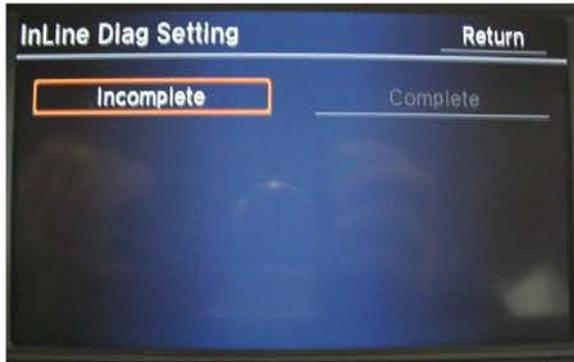
- Move the vehicle to an open area. Start the engine if not already done.
- Press and hold the NAVI, BACK, and MENU buttons until the **Select Diagnosis Items** screen appears.
- Press and hold the NAVI button.
- Select **Incomplete**. The system restarts.

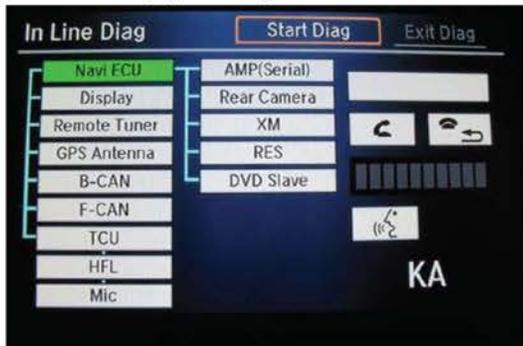
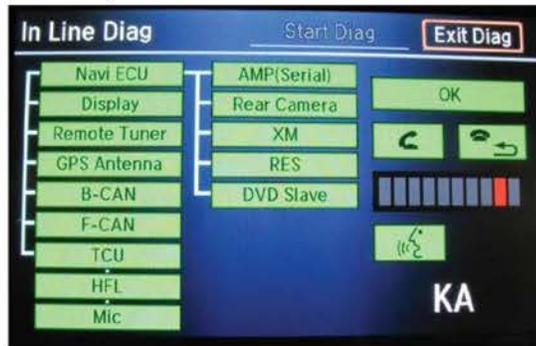
- When the **In-Line Diag** screen appears, select **Start Diag**.
- Make sure all the icons turn green.

- Press the Pick-up button.
- Press the Hang-up button.
- Press the Talk button.
- Snap your fingers in front of the microphone to complete the test.
