02202 Version 1

Vehicles with Navigation: Audio Turns Off After Using HFL, No Sound/Static in Rear Headphones, and Other Listed Issues

Replaces S/B 14-019, Product Update: Audio-Navigation Unit Software Update

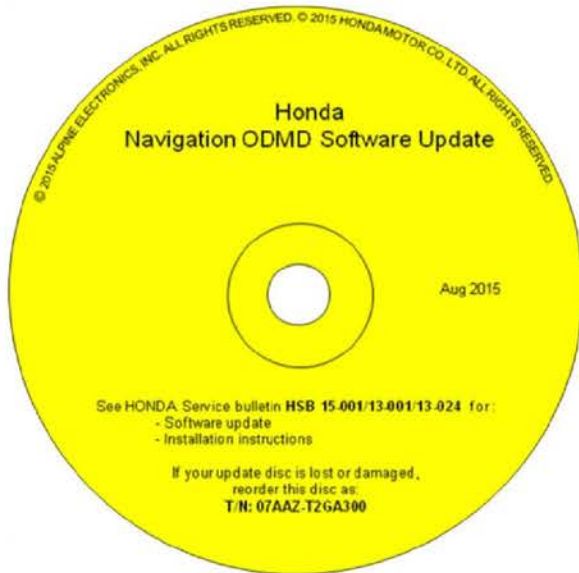
Part Name	Tool Number	Quantity
Navigation System DVD Update	07AAZ-T2GA300	1

The DVD update has been recently shipped to all dealers. Additional DVDs are available for purchase through the parts system.

3. Wait for the navigation system to boot up, then insert the DVD into the CD slot in the center console. See TOOL INFORMATION.

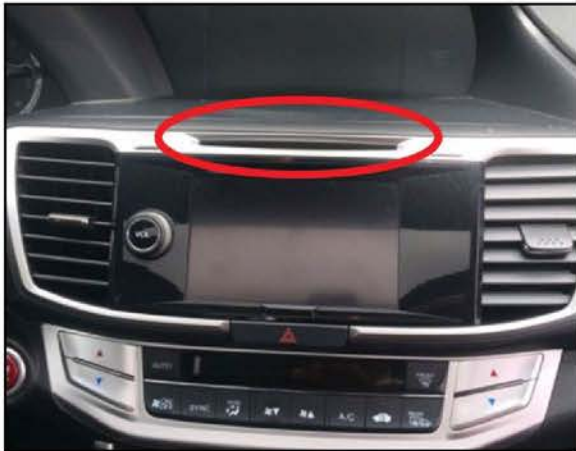
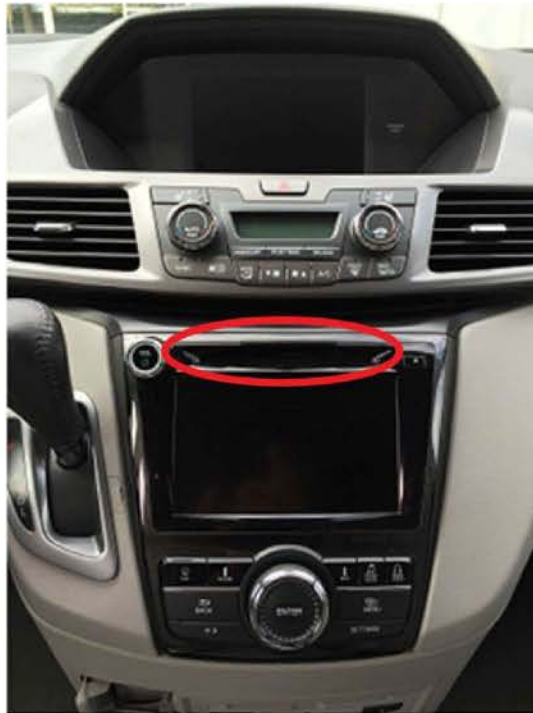
NOTE: The power mode must remain set to ON during the entire update procedure. If the power mode is set to OFF, the engine is started, or the DVD is removed at any time during the update process, the audio-navigation unit will be locked up and you will need to use the RECOVERY PROCEDURE.

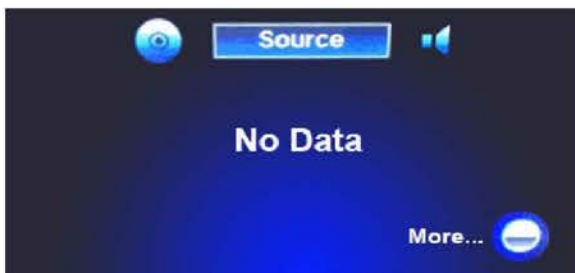
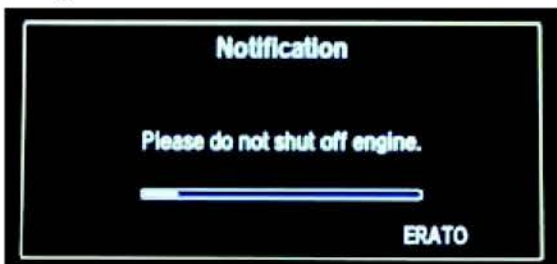
Navigation screen

- The software update will begin. The screen will show a **Reading the Disc** message, then display **No Data**. Do not eject the disc. The unit is uploading the update and may take up to 1 minute before beginning. Both screens will shut off for about 10 seconds and reboot with the update started on both screens. The display should change to a **Notification** screen loading bar.
- The engine does not need to be running to do this update, even if it says so on the screen.
- If the **No Data** screen does not change after about a minute, the software may already be updated. Go to step 9 to confirm the software versions.

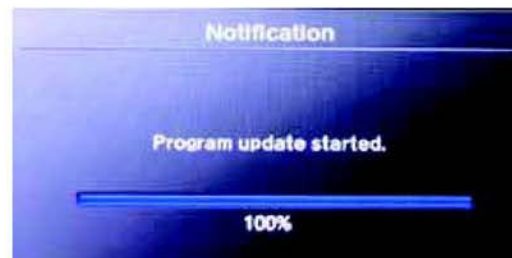
Touch screen

NOTE: The software update takes about 30 minutes to complete; you do not have to oversee the update during this time as no action is needed until the update is loaded.

On the touch screen, the progress bar will stop at 100% after ERATO is updated and remain at 100% throughout all SH and Utility updates. The progress bar will go back to 0% and resume when the BU uCOM update starts.

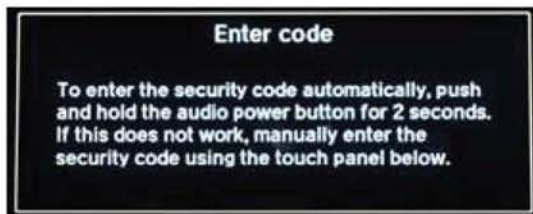
Navigation screen

4. When the update is complete, the system will reboot to the HondaLink screen. The **Enter code** message and keypad will appear on the screens, although they may not appear at the same time. **Wait for both screens to appear**, then set the power mode to OFF.

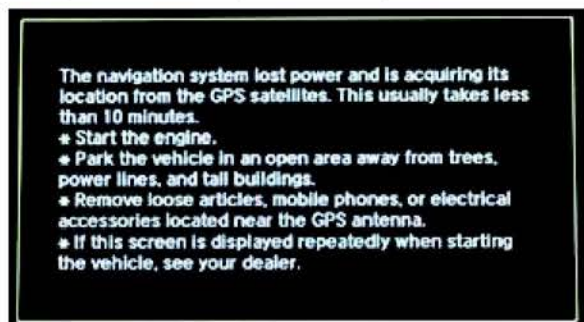
5. Eject the DVD and wait at least 1 minute.
6. Set the power mode to ON. Once both **Enter code** screens appear, press and hold the power button for 2 seconds until you hear a beep. The navigation screen will show the GPS initialization message.

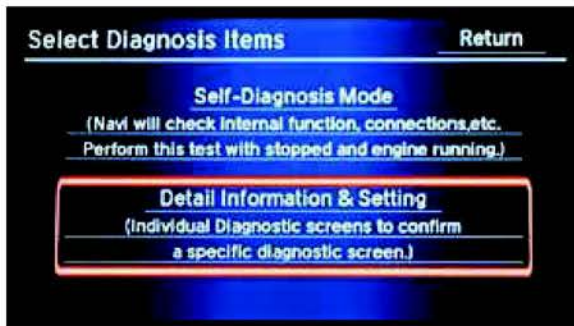
7. Press and hold the **NAVI, BACK** and **MENU** buttons until the **Select Diagnosis Items** screen appears

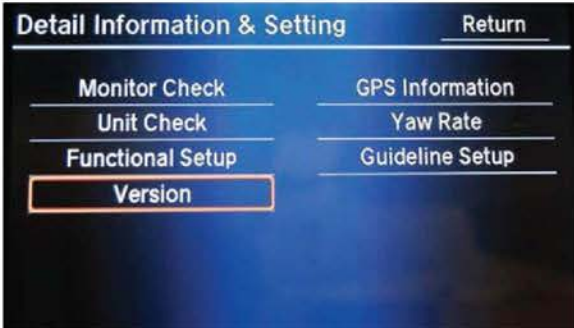
8. Select **Detail Information & Setting**.
 9. Select **Version**.

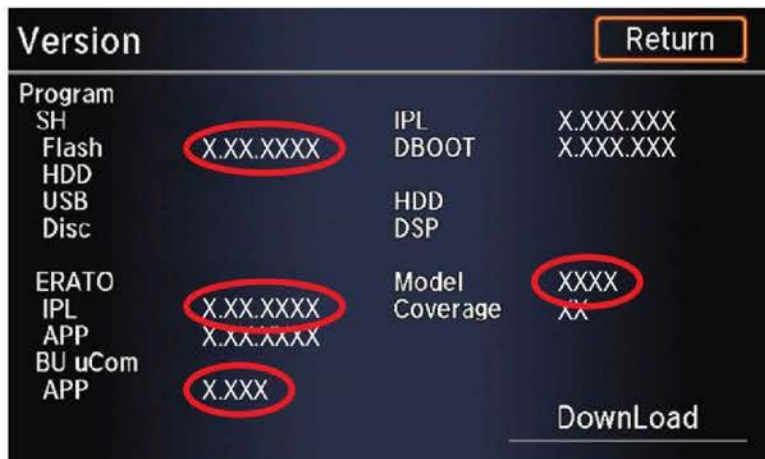
10. Verify that the software was updated to the new version as shown below. **Please note the SH-Flash, ERATO IPL, BU uCom APP, and model version information and make sure it matches the table below.**

NOTE: If the software is not updated, **set the power mode to OFF**, and go back to step 2 and repeat the update procedure.

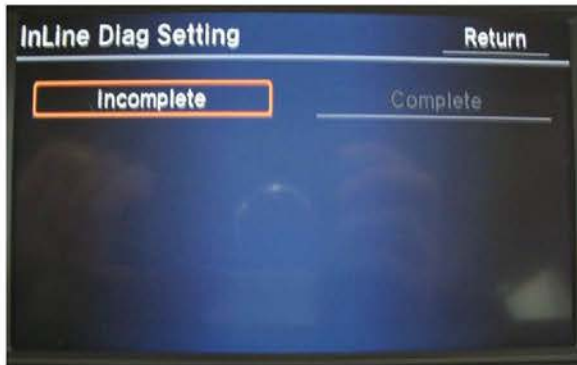
11. Make sure the rear camera, and LaneWatch are working properly. If not, reset the rear camera and LaneWatch.
 - Move vehicle to an open area. Start the engine if not already done.
 - Press and hold the NAVI, BACK, and MENU buttons.
 - Press and hold the NAVI button.
 - Select **Incomplete**. The system restarts.

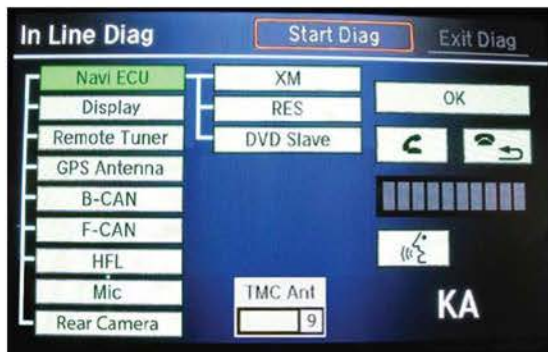
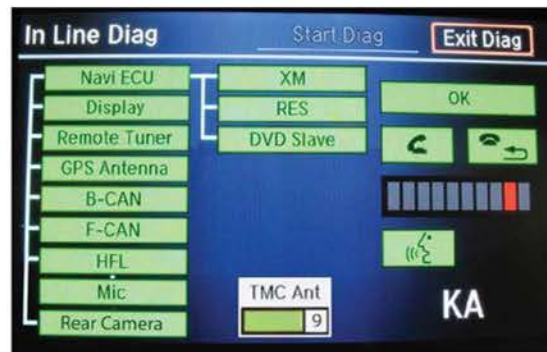
- When the **In-Line Diag** screen appears, select **Start Diag**.
- Make sure all the icons turn green.

NOTE: To get all icons to turn green, make sure that you do the following:

- Press the Pick-up button.
- Press the Hang-up button.
- Press the Talk button.
- Snap your fingers in front of the microphone to complete the test.
