August 21, 2015

02211 Version 1

## Vehicles with Navigation: Audio Turns Off After Using HFL, No Sound/Static in Rear Headphones, and Other Listed Issues

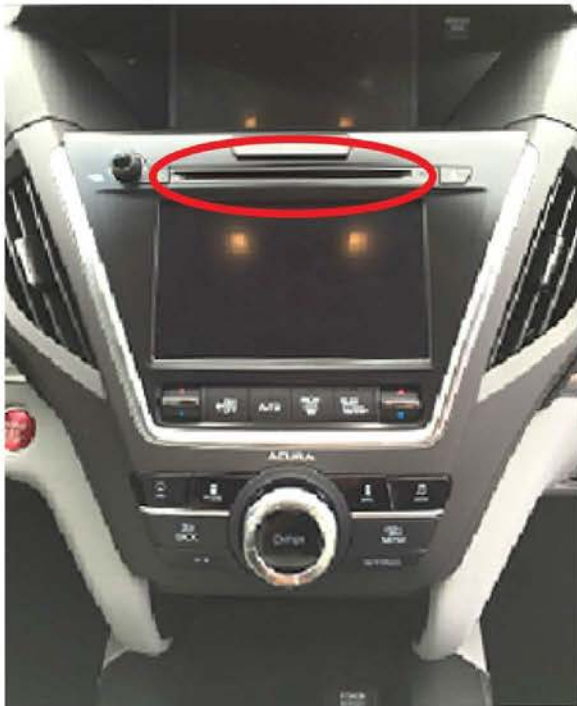
- Wait for the navigation system to boot up, then insert the DVD into the CD slot as shown. See TOOL INFORMATION.  
NOTE: The power mode must remain ON during the entire update procedure. If the power mode is set to OFF, the engine is started, or the DVD is removed at any time during the update process, the audio-navigation unit will be locked up and you will need to use the RECOVERY PROCEDURE.

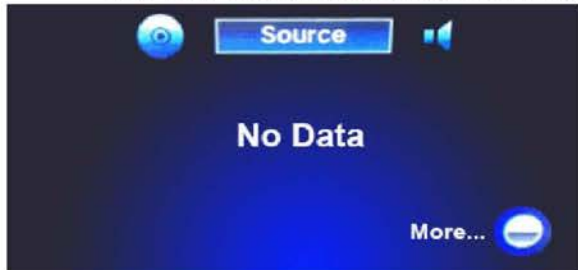
- The software update will begin. The screen will show a **Reading the Disc** message, then both screens will shut off for about 10 seconds and reboot. The message **No Data** will appear on the screen. **Do not eject the disc**. The unit is uploading the update and may take up to 1 minute before beginning. The displays should change to a **Notification** screen loading bar.

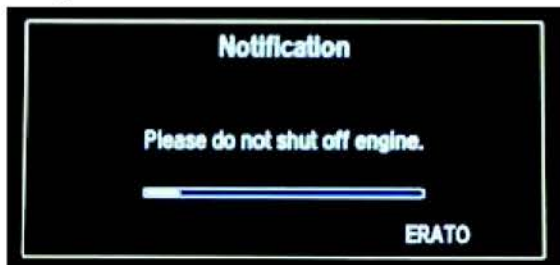
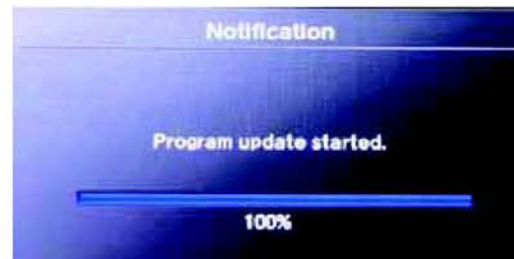
Navigation screen

Touch screen

On the touch screen, the progress bar will stop at 100% after ERATO is updated and remain at 100% throughout all SH and Utility updates. The progress bar will go back to 0% and resume when the BUuCOM update starts.

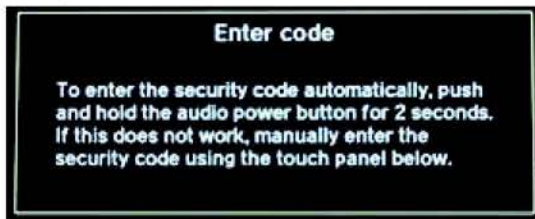
*Navigation screen*

5. When the update is complete, the system will reboot to the AcuraLink screen. The **Enter code** message and keypad will appear on the screens, although they may not appear at the same time. **Wait for both screens to appear**, then set the power mode to OFF.

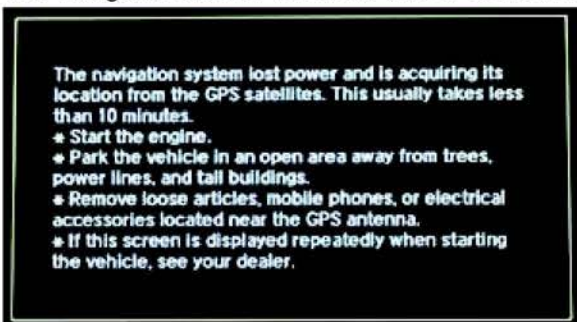
6. Eject the DVD and wait at least 1 minute.
7. Set the power mode to ON. Once both **Enter code** screens appear, press and hold the audio power button for 2 seconds until you hear the beep.
8. The navigation screen will show the GPS initialization message.

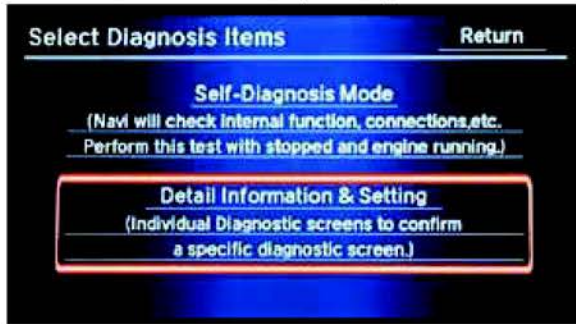
9. Press and hold the NAVI, BACK, and MENU buttons until the **Select Diagnosis Items** screen appears.

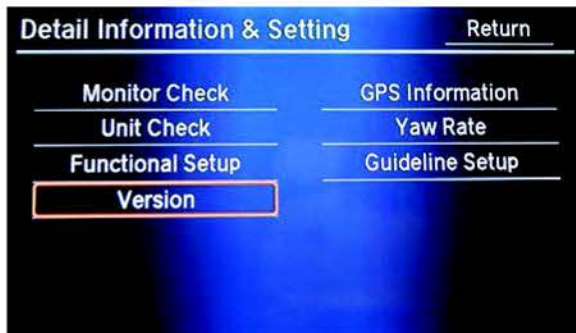
10. Select **Detail Information & Setting**, then select **Version**.

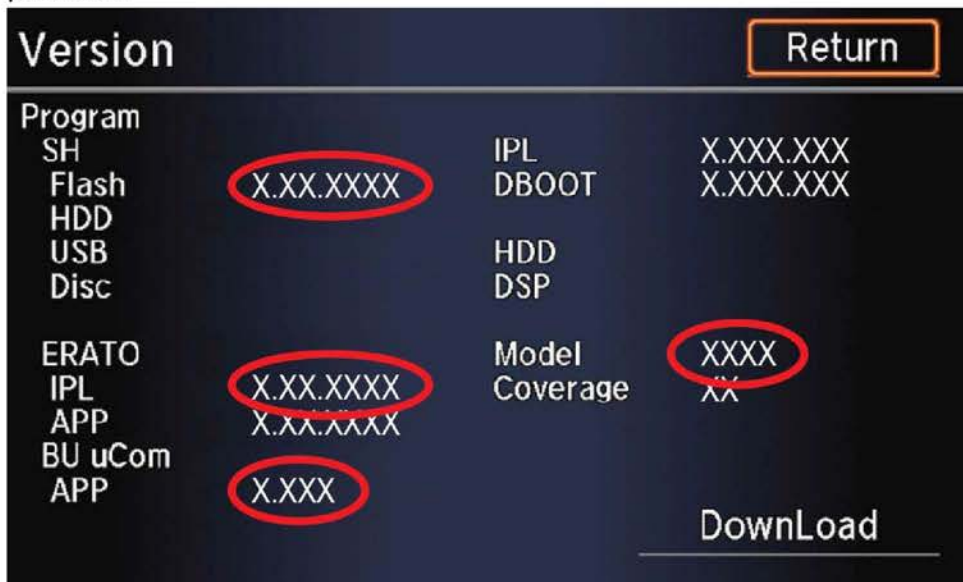
11. Verify that the applicable software versions were updated to the new versions listed:

Software	2014 MDX with RES	2014 MDX without RES	2014 RLX
SH Flash	3.00.2304	3.00.2304	3.00.2203
ERATO IPL	3.00.2004	3.00.2004	3.00.2002
BU uCom APP	3.002.604	3.002.804	3.001
Model	TZ5A	TZ5A	TY2A

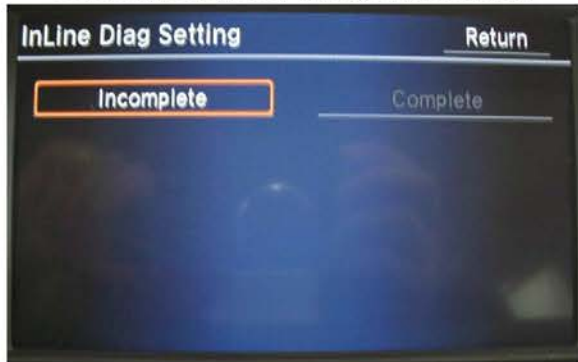
- Move the vehicle to an open area. Start the engine if not already done.
- Press and hold the NAVI, BACK, and MENU buttons until the **Select Diagnosis Items** screen appears.
- Press and hold the NAVI button.
- Select **Incomplete**. The system restarts.

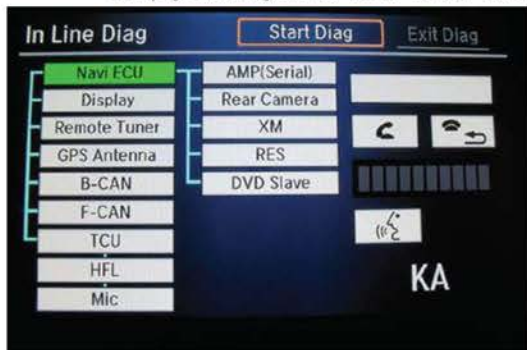
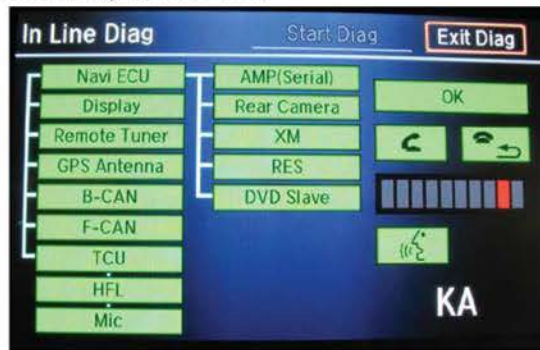
- When the **In-Line Diag** screen appears, select **Start Diag**.
- Make sure all the icons turn green.

NOTE: To get all the icons to turn green, make sure that you do the following:

- Press the Pick-up button.
- Press the Hang-up button.
- Press the Talk button.
- Snap your fingers in front of the microphone to complete the test.
