August 21, 2015

02210 Version 1

HVAC Display Flashes or Flickers

AFFECTED VEHICLES

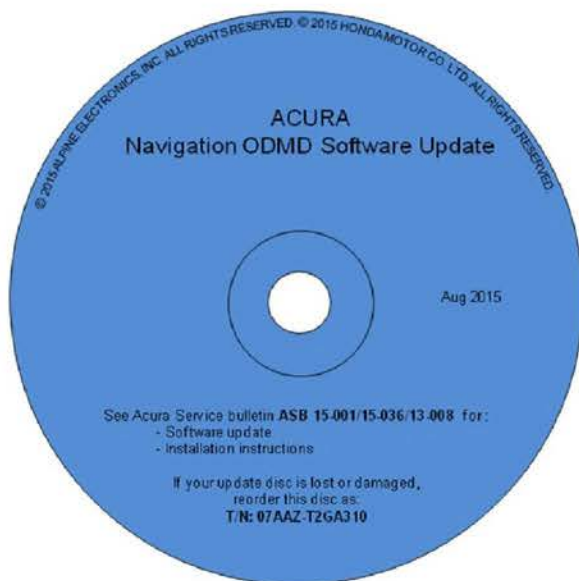
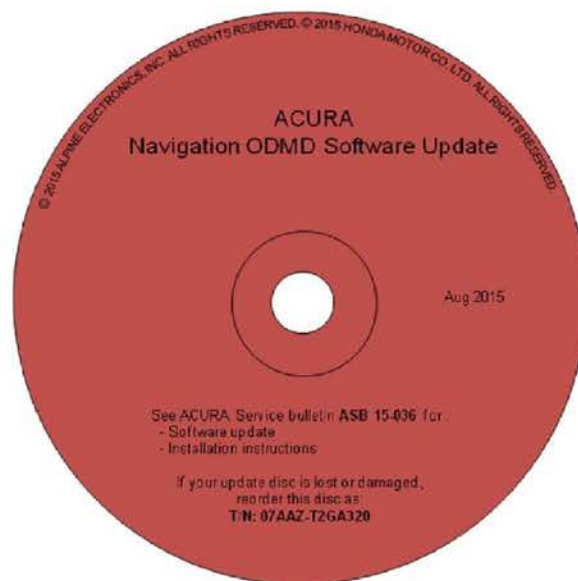
Tool Name	Tool Number	Quantity
2014 MDX Audio-Navigation System DVD Update (with navigation) (Blue)	07AAZ-T2GA310	1
2015 MDX Audio-Navigation System DVD Update (with navigation) (Red)	07AAZ-T2GA320	1

The DVD updates have recently shipped to all dealers. Additional DVDs are available for purchase through the parts system.

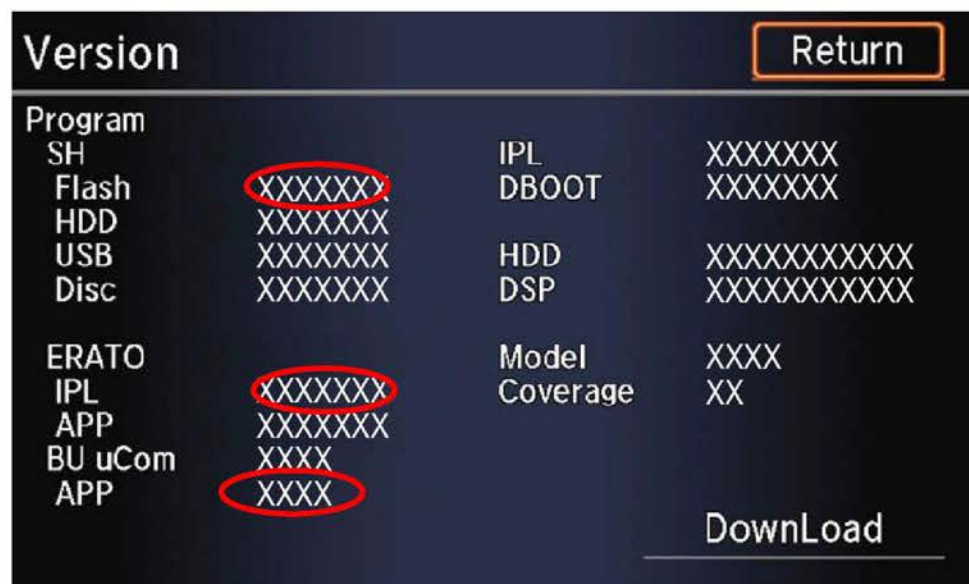
- Verify that the software version matches the version information for SB 14-037 as shown below. If unit does not match, do S/B 14-037 before doing the update. **If you do this update before 24-037, you may permanently damage the audio-navigation unit.** If the unit is up to date, go to step 7.

Software	2015 MDX with RES	2015 MDX without RES
SH Flash	4.00.2307	4.00.2307
ERATO IPL	4.00.2004	4.00.2004
BU uCom APP	4.002.604	4.002.804

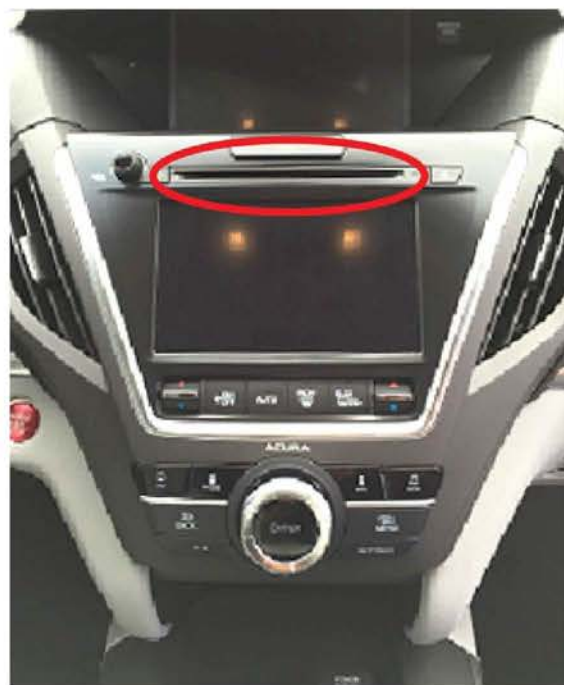
- Set the power mode to OFF, then to ON and wait for the navigation system to boot up. **Insert the RED DVD** into the CD slot as shown. See TOOL INFORMATION.

NOTE: The power mode must remain ON during the entire update procedure. If the power mode is set to OFF, the engine is started, or the DVD is removed at any time during the update process, the audio-navigation unit will be locked up and you will need to use the RECOVERY PROCEDURE.

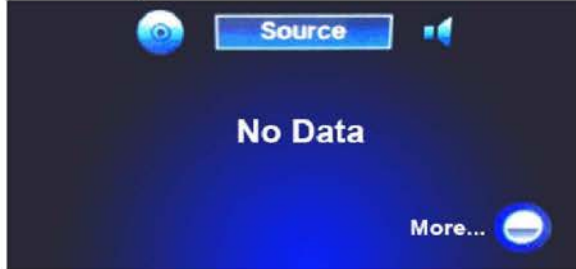
5. The software update will begin. The screen will show a **Reading the Disc** message, then both screens will shut off for about 10 seconds and reboot. The message **No Data** will appear on the screen. **Do not eject the disc**. The unit is uploading the update and may take up to 1 minute before beginning. The displays should change to a **Notification** screen loading bar.

- The engine does not need to be running to do this update, even if it says so on the screen.
- If the **No Data** screen does not change after about a minute, the software may already be updated. Go to step 11 to confirm the software versions.

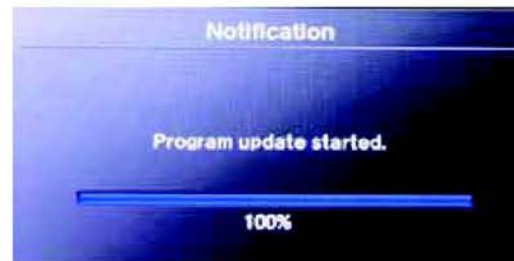
Touch screen

NOTE: The software update takes about 30 minutes to complete; you do not have to oversee the update during this time as no action is needed until the update is loaded.

On the touch screen, the progress bar will stop at 100% after ERATO is updated and remain at 100% throughout all SH and Utility updates. The progress bar will go back to 0% and resume when the BUuCOM update starts.

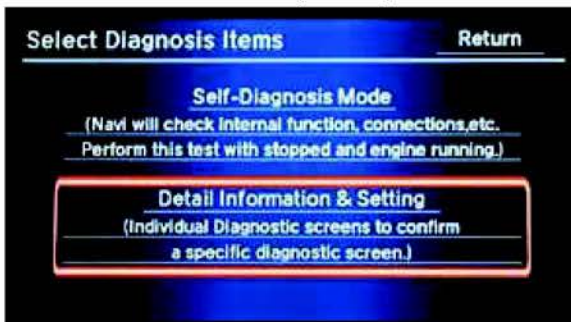
10. Press and hold the NAVI, BACK, and MENU buttons until the **Select Diagnosis Items** screen appears.

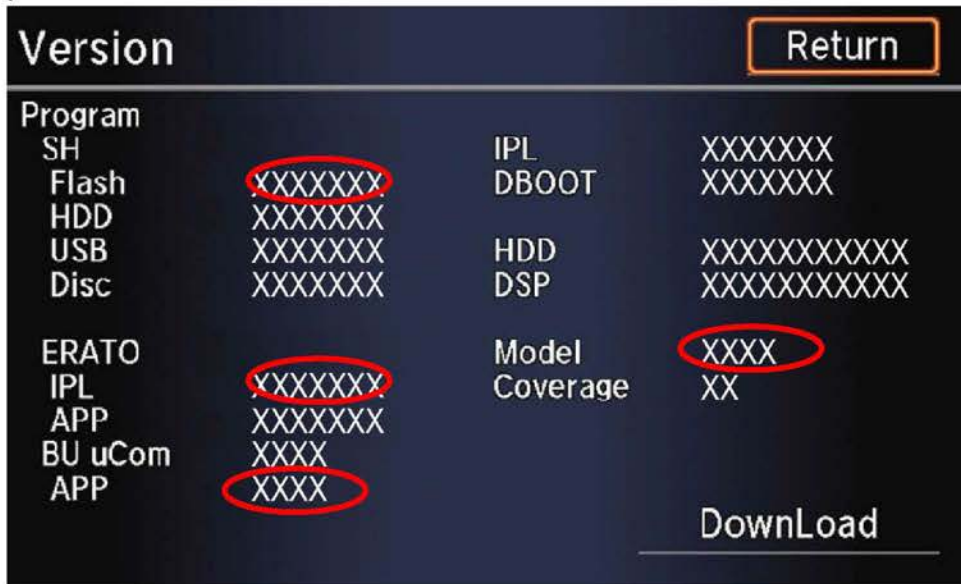
12. Verify that the software versions were updated to the new version as shown:

Software	2015 MDX with RES	2015 MDX without RES
SH Flash	4.00.2309	4.00.2309
ERATO IPL	4.00.5004	4.00.5004
BU uCom APP	4.003.604	4.003.804
Model	TZ5A	TZ5A

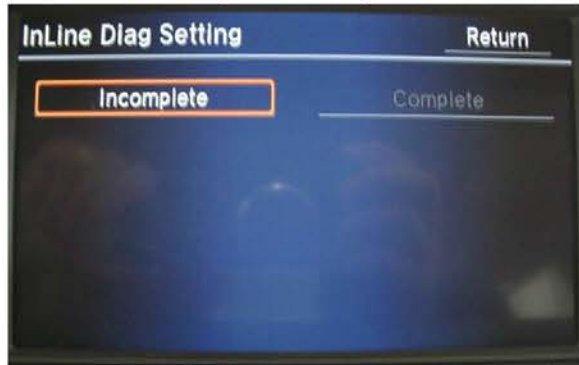
- Move the vehicle to an open area. Start the engine if not already done.
- Press and hold the NAVI, BACK, and MENU buttons until the **Select Diagnosis Items** screen appears.
- Press and hold the NAVI button.
- Select **Incomplete**. The system restarts.

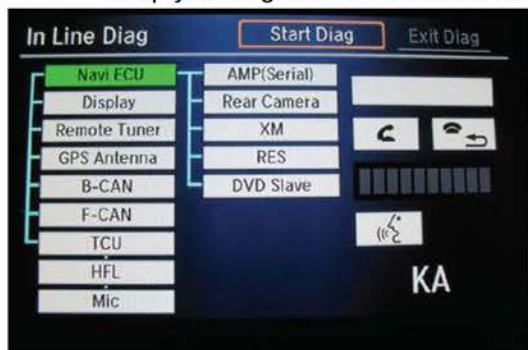
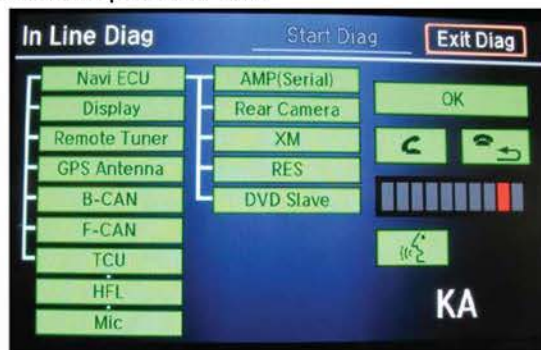
- When the **In-Line Diag** screen appears, select **Start Diag**.
- Make sure all the icons turn green.

NOTE: To get all the icons to turn green, make sure that you do the following:

- Press the Pick-up button.
- Press the Hang-up button.
- Press the Talk button.
- Snap your fingers in front of the microphone to complete the test.

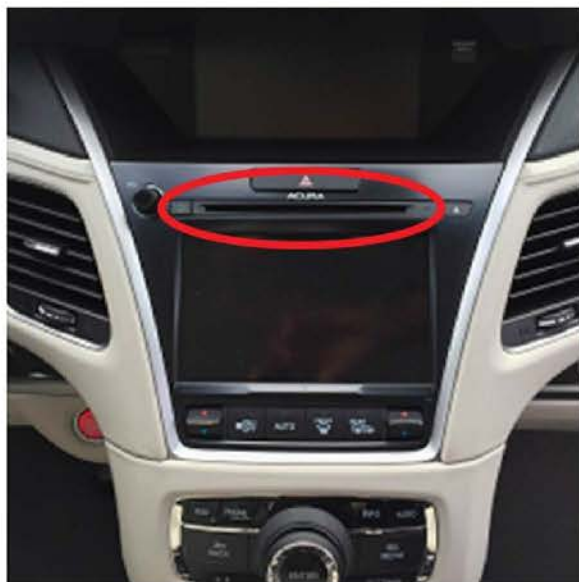
- **If the vehicle does not have navigation, do not use this software update.** If you do, you may permanently damage the audio unit.
 - Apply this software update only to the vehicles listed under AFFECTED VEHICLES; otherwise this software update can permanently damage the unit.
 - If you accidentally update the wrong vehicle, contact Tech Line; if the unit must be replaced, your dealership may be debited for the replacement cost.
1. Connect a battery charger or a fully charged jumper battery to the vehicle and leave it connected during the entire update procedure to maintain a steady voltage.
 2. Set the power mode to ON.
 3. Wait for the navigation system to boot up. **Insert the BLUE DVD** into the CD slot as shown. See TOOL INFORMATION.

NOTE: The power mode must remain ON during the entire update procedure. If the power mode is set to OFF, the engine is started, or the DVD is removed at any time during the update process, the audio-navigation unit will be locked up and you will need to use the RECOVERY PROCEDURE.

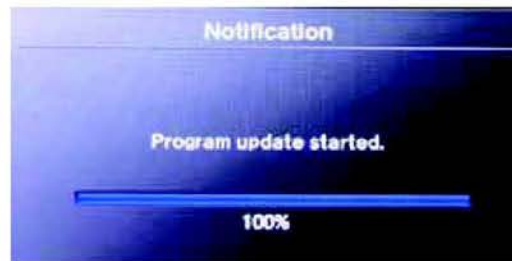
Touch screen

NOTE: The software update takes about 30 minutes to complete; you do not have to oversee the update during this time as no action is needed until the update is loaded.

On the touch screen, the progress bar will stop at 100% after ERATO is updated and remain at 100% throughout all SH and Utility updates. The progress bar will go back to 0% and resume when the BUuCOM update starts.

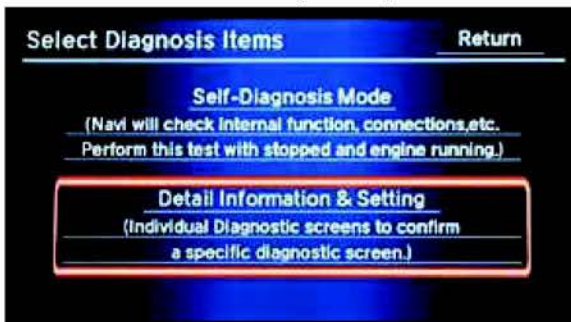
9. Press and hold the NAVI, BACK, and MENU buttons until the **Select Diagnosis Items** screen appears.

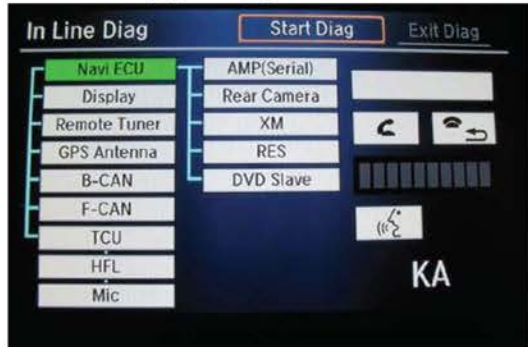
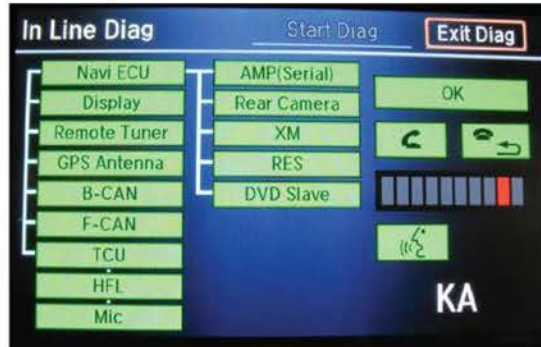
- When the **In-Line Diag** screen appears, select **Start Diag**.
- Make sure all the icons turn green.

NOTE: To get all the icons to turn green, make sure that you do the following:

- Press the Pick-up button.
- Press the Hang-up button.
- Press the Talk button.
- Snap your fingers in front of the microphone to complete the test.
