51788-02200 Version 5

Product Update: Audio and Audio-Navigation Unit Software UpdateSupersedes 13-001, dated June 24, 2014, to revise the information highlighted in **yellow**.**AFFECTED VEHICLES**

Year	Model	Trim	VIN Range
2013	Accord	ALL	Check the iN VIN status for eligibility
2013	Crosstour	ALL	Check the iN VIN status for eligibility

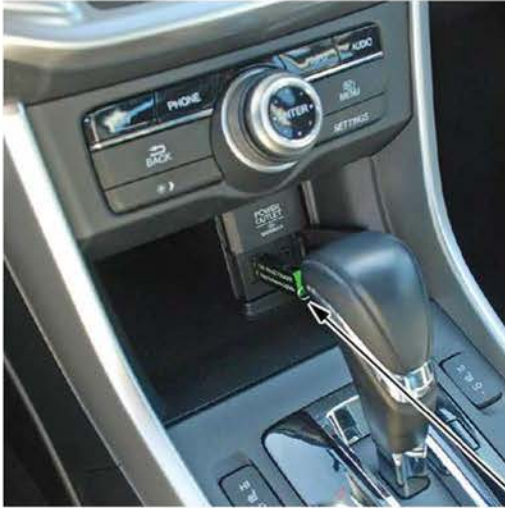
ACCORD

3. Wait for the audio system to boot up, then insert the USB update device into the USB port in the center console. See TOOL INFORMATION.

USB FLASH DRIVE - AUDIO ONLY
T/N: 07-AAZ-T2GA210

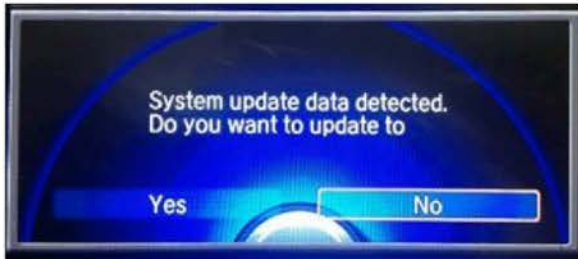
4. When the **System update data detected** screen appears, select **Yes**.

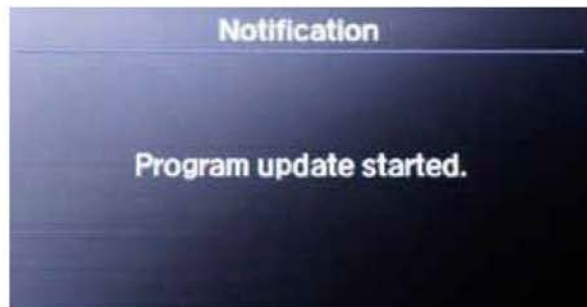
5. Both screens will shut off for about 10 seconds and reboot with the notification shown below on both screens.

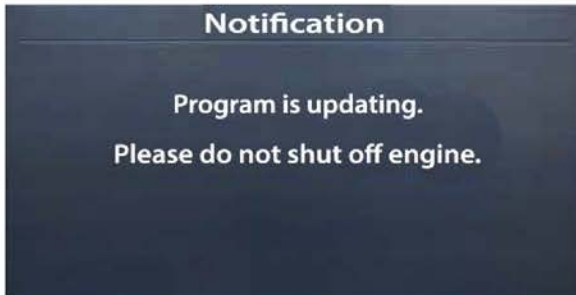
- The notification below will appear on the upper display screen for the duration of the update process.

- The engine does not need to be running, even if it says so on the screen.
- You do not have to oversee the update during this time as no action is needed until the update is loaded.

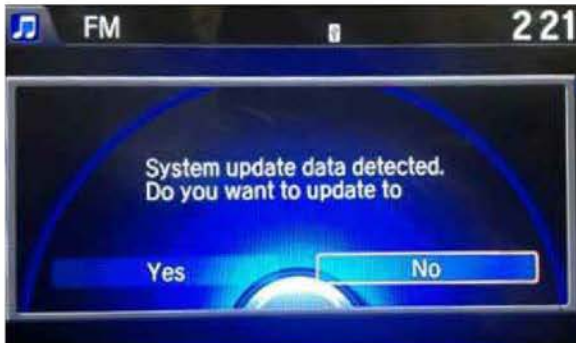
- When the update is complete, the system will reboot to the H screen and the **System update data detected** screen will reappear.

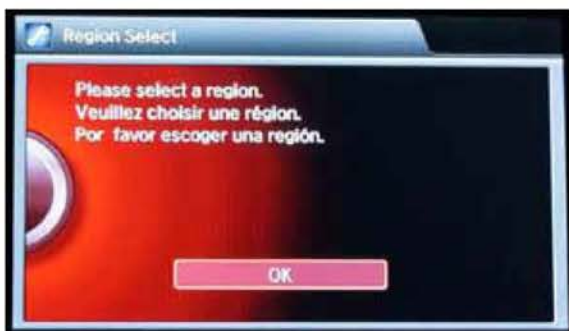
- Select **No**, set the power mode to OFF.
- Remove the USB update device and wait at least 1 minute.
- Set the power mode ON.
- When the **Region Select** screen appears, select **OK**.

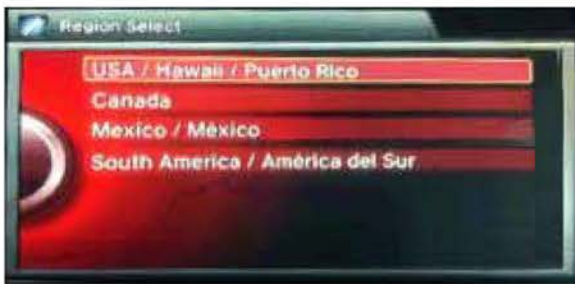
13. Select **USA/Hawaii/Puerto Rico**.

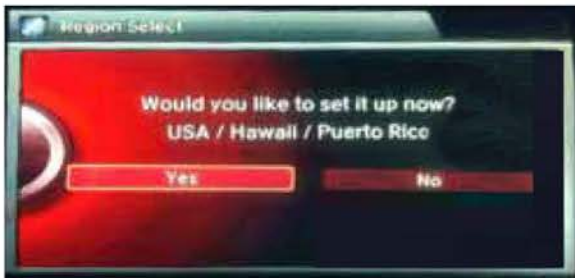
14. Select **Yes**.

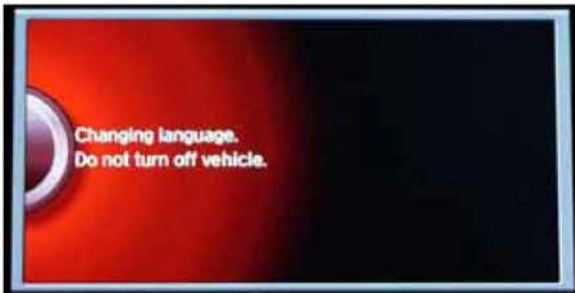
The screen below appears momentarily, then the system reboots to the **Enter code** screen.

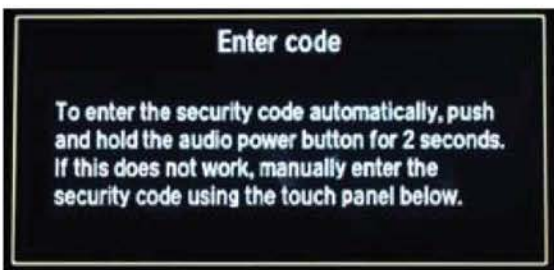
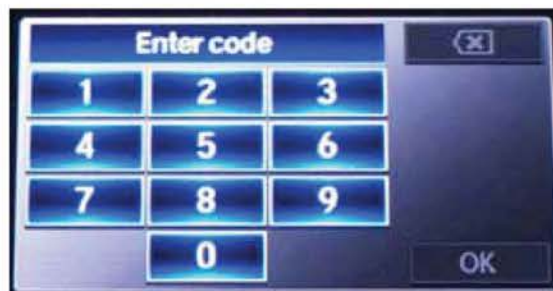
15. The **Enter Code** message and keypads screens will appear, although they may not appear at the same time. Wait for both screens to appear. Then, press and hold the power button for 2 seconds until you hear the beep.

UPPER DISPLAY

TOUCH SCREEN

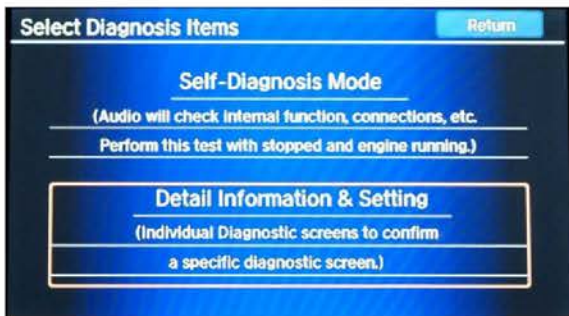
16. Press and hold the **DISP**, **BACK**, and **VOL** buttons until the **Select Diagnosis Items** screen appears.

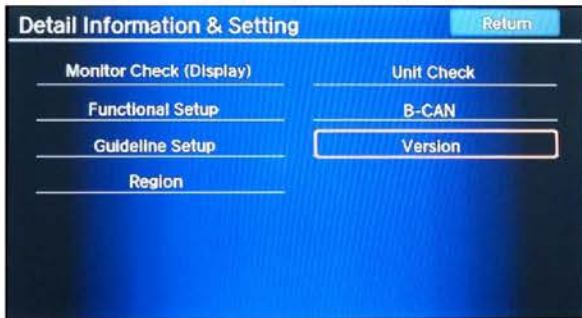
17. Select **Detail Information & Setting**, then select **Version**.

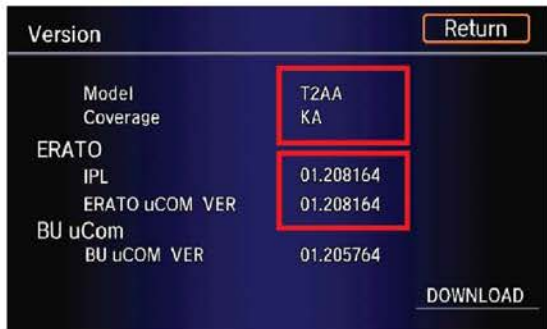
ACCORD

18. Verify that the software was updated to the new version as shown below. If the software is not updated, set the power mode to OFF, and go back to step 2 and repeat the update procedure.

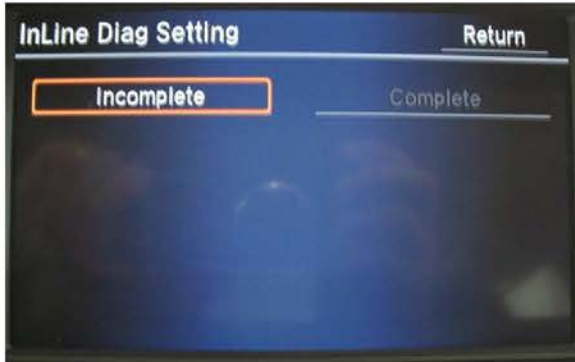
19. Make sure the compass, rear camera, and LaneWatch are working properly. If not, reset the compass, rear camera and LaneWatch.
 - Move the vehicle to an open area. Start the engine if not already done.
 - To enter the In line Diag mode, press and hold the DISP, BACK, and VOL buttons.
 - Press and hold the Day/Night button.
 - Select **Incomplete**. The system restarts.

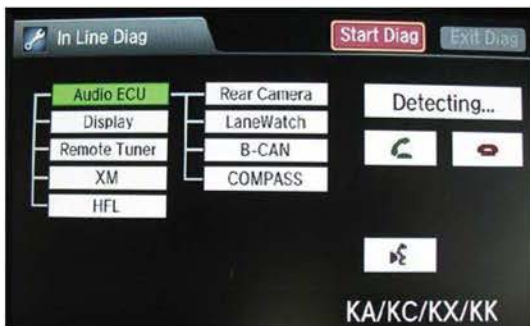
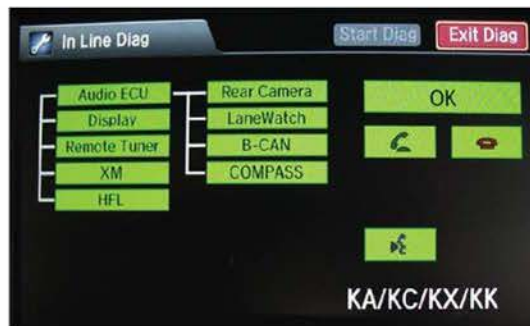
- When the **In-Line Diag** screen appears, select **Start Diag**.
- Make sure all the icons turn green.

- Press the Pick-up button.
- Press the Hang-up button.
- Press the Talk button.
- Snap your fingers in front of the microphone to complete the test.

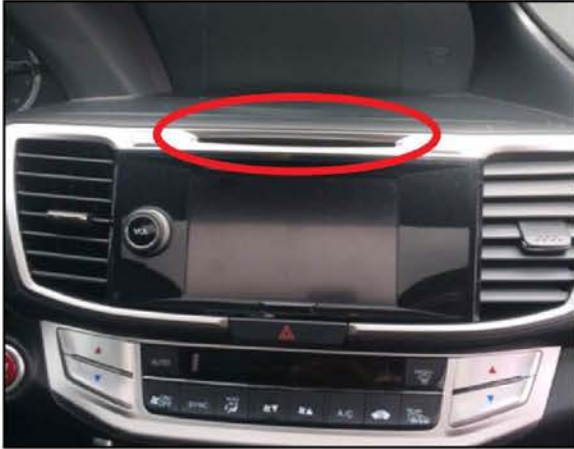
3. Wait for the navigation system to boot up, then insert the DVD into the CD slot in the center console. See TOOL INFORMATION.

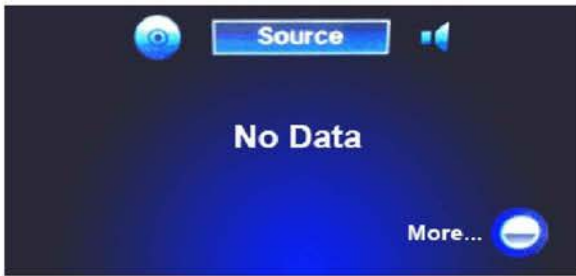
4. The software update will begin. The screen will show a **Reading the Disc** message, then display **No Data**. **Do not eject the disc**. The unit is uploading the update and may take up to 1 minute before beginning. Both screens will shut off for about 10 seconds and reboot with the update started on both screens. The displays should change to a **Notification** screen loading bar.

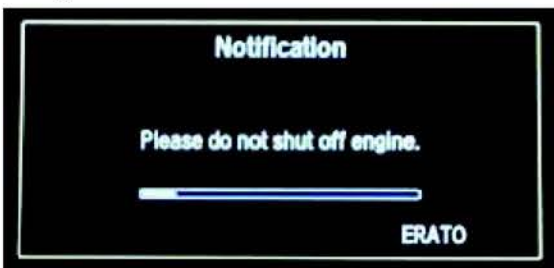
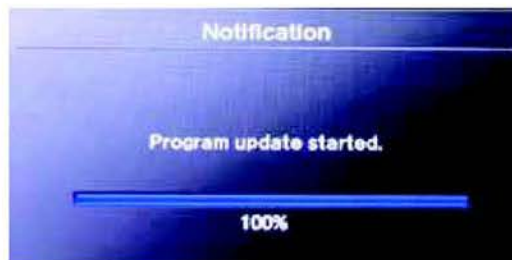
Navigation screen

Touch screen

On the touch screen, the progress bar will stop at 100% after ERATO is updated and remain at 100% throughout all SH and Utility updates. The progress bar will go back to 0% and resume when the BUuCOM update starts.

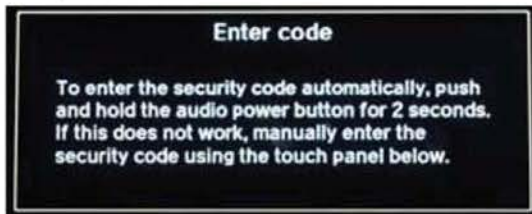
Navigation screen

5. When the update is complete, the system will reboot to the AcuraLink screen. The **Enter code** message and keypad will appear on the screens, although they may not appear at the same time. **Wait for both screens to appear**, set the power mode to OFF.

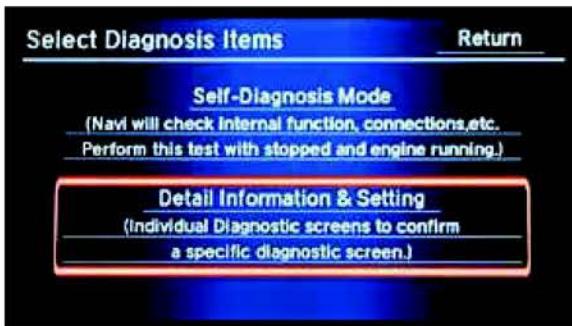
10. Press and hold the **NAVI, BACK** and **MENU** buttons until the **Select Diagnosis Items** screen appears.

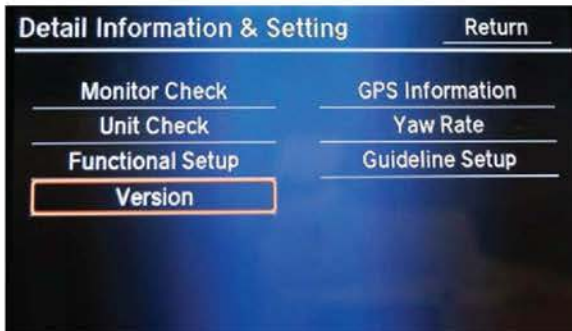
11. Select **Detail Information & Setting**.
 12. Select **Version**.

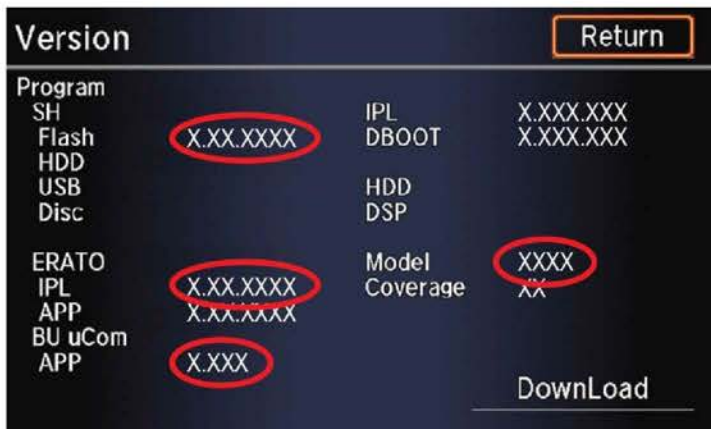
13. Verify that the software was updated to the new version as shown below. **Please note the SH-Flash, ERATO IPL and BU uCom APP version information and make sure it matches the table below.**

Software	2013 Accord	Crosstour (ALL)
SH	3.00.2003	3.00.2703
ERATO	3.00.0001	3.00.0001
BU	3.001	3.001
Model	T2AA	TP6X

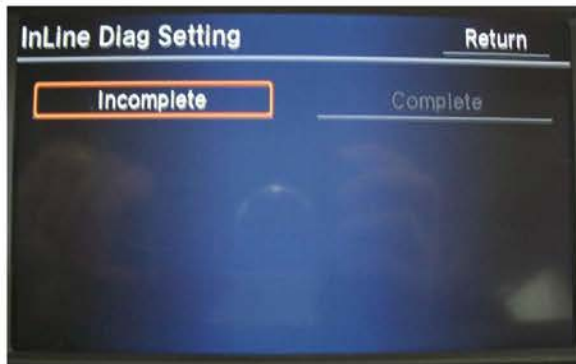
14. Make sure the rear camera and LaneWatch are working properly. If not, reset the rear camera and LaneWatch.
 - Move the vehicle to an open area, start the engine if not already done.
 - Press and hold the **NAVI**, **BACK**, and **MENU** buttons.
 - Press and hold the **NAVI** Button.
 - Select **Incomplete**. The system restarts.

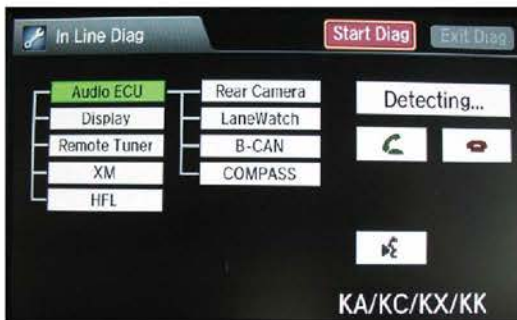
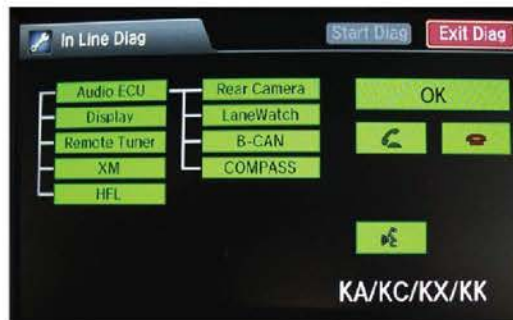
- When the **In-line Diag** screen appears, select **Start Diag**.
- Make sure all the icons turn green.

- Press the Pick-up button.
- Press the Hang-up button.
- Press the Talk button.
- Snap your fingers in front of the microphone to complete the test.
