August 21, 201551787-02204 Version 4

Product Update: Audio-Navigation Unit Software Update

Year	Model	Trim	VIN Range
2014	Accord Plug-In	ALL	Check the iN VIN status for eligibility

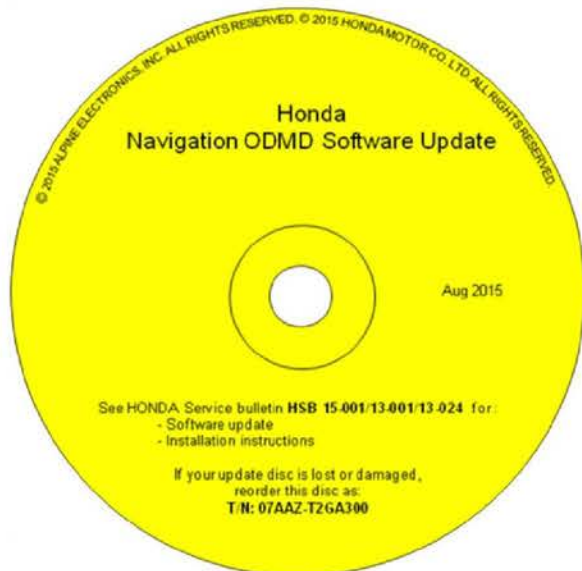
Part Name	Tool Number	Quantity
Audio–Navigation System DVD Update	07AAZ-T2GA300	1

The DVD updates were recently shipped to all dealers. Additional DVD updates are available for purchase through the parts system.

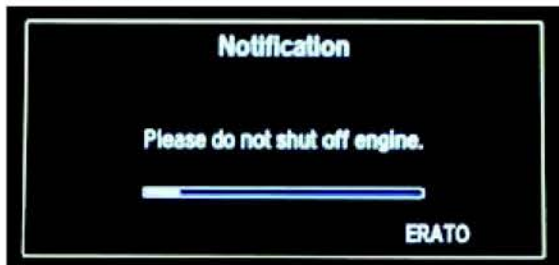
Navigation screen

- The software update will begin. The screen will show a Reading the Disc message, then display No Data. Do not eject the disc. Both screens will shut off for about 10 seconds and reboot with the update started on both screens. The unit is uploading the update and may take up to 1 minute before beginning. The display should change to a **Notification** screen loading bar.
- The engine does not need to be running to do this update, even if it says so on the screen.
- If the **No Data** screen does not change after about a minute, the software may already be updated. Go to step 9 to confirm the software versions.

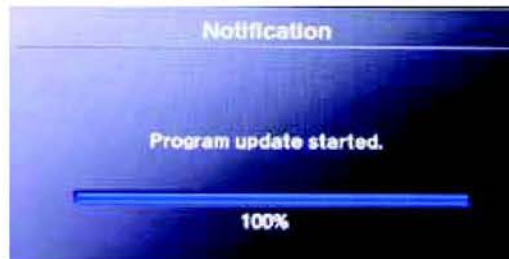
Touch screen

NOTE: The software update takes about 30 minutes to complete; you do not have to oversee the update during this time as no action is needed until the update is loaded.

Update Order:

1. ERATO
2. SH-BOOT
3. SH-IPL
4. SH-NK
5. Utility
6. BU uCOM

On the touch screen, the progress bar will stop at 100% after ERATO is updated and remain at 100% throughout all SH and Utility updates. The progress bar will go back to 0% and resume when the BU uCOM update starts.

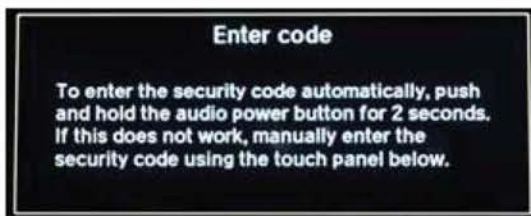
Navigation screen

4. When the update is complete, the system will reboot to the HondaLink screen. The **Enter code** message and keypad will appear on the screens, although they may not appear at the same time. **Wait for both screens to appear**, then set the power mode to OFF.

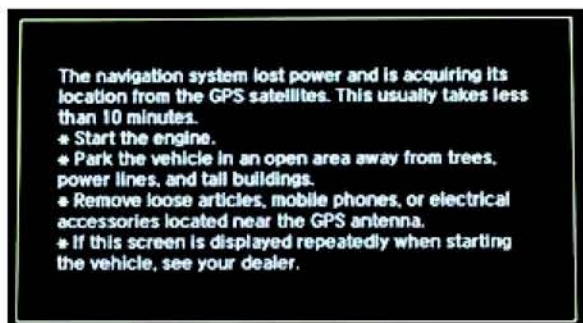
5. Eject the DVD and wait at least 1 minute.
6. Set the power mode to ON. Once both **Enter code** screens appear, press and hold the power button for 2 seconds until you hear a beep. The navigation screen will show the GPS initialization message.

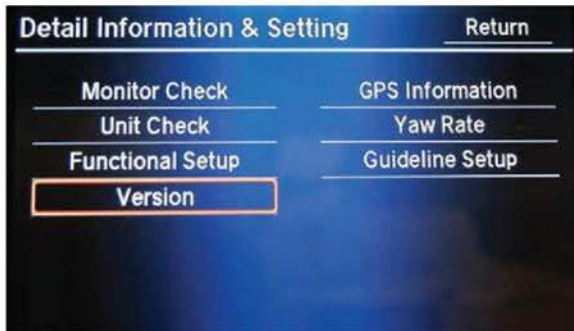
- Select **Detail Information & Setting**.
- Select **Version**.

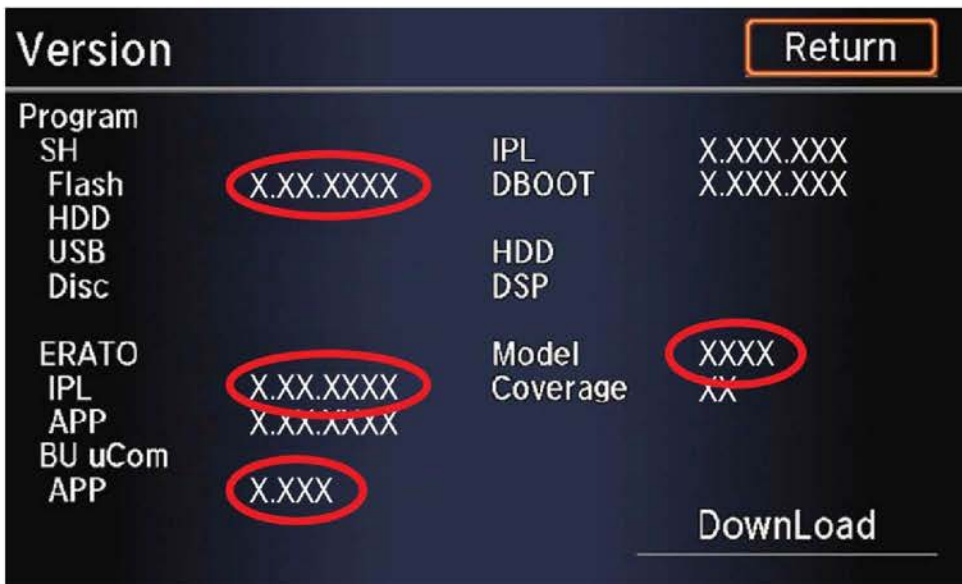
- Verify that the software was updated to the new version as shown below. **Please note the SH-Flash, ERATO IPL, BU uCom APP, and model version information and make sure it matches the table below.**

Software	2014 Accord Plug-In
SH	3.00.2103
ERATO	3.40.0001
BU	3.400
Model	T3VA
