51786-02199 Version 3

Product Update: Audio-Navigation Unit Software Update

Year	Model	Trim	VIN Range
2014	RLX (excluding Sport Hybrid)	ALL with navigation	Check the iN VIN status for eligibility

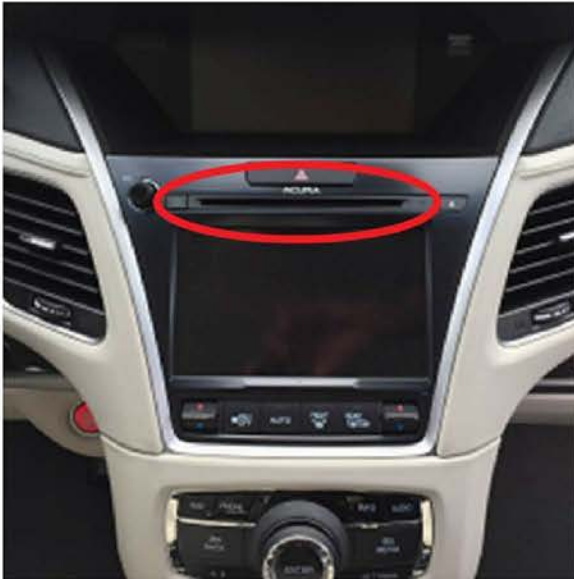
3. Wait for the navigation system to boot up, then insert the DVD into the CD slot in the center console. See TOOL INFORMATION.

NOTE: The power mode must remain ON during the entire update procedure. If the power mode is set to OFF, the engine is started, or the DVD is removed at any time during the update process, the audio-navigation unit will be locked up and you will need to use the RECOVERY PROCEDURE.

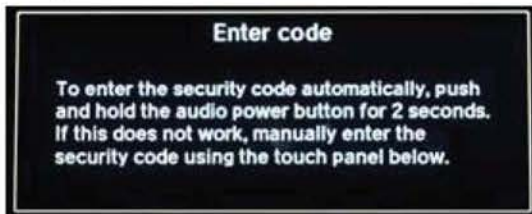
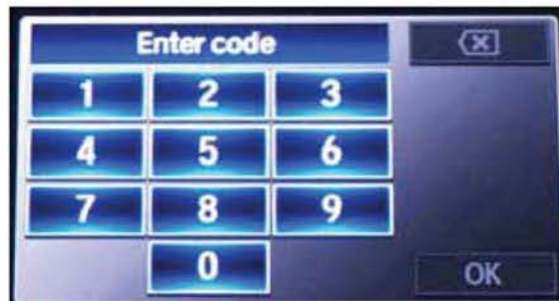
4. When the update is complete, the system will reboot to the AcuraLink screen. The **Enter code** message and keypad will appear on the screens, although they may not appear at the same time. **Wait for both screens to appear**, then set the power mode to OFF.

Navigation screen

Touch screen

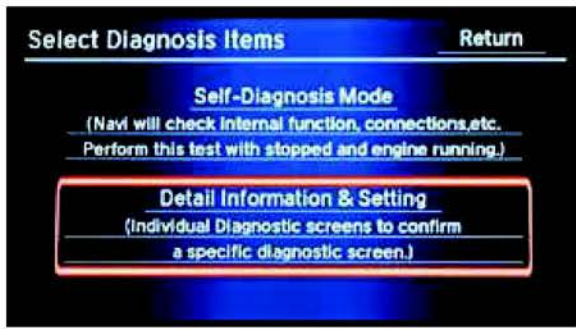
7. Press and hold the **NAVI**, **BACK** and **MENU** buttons until the **Select Diagnosis items** screen appears.

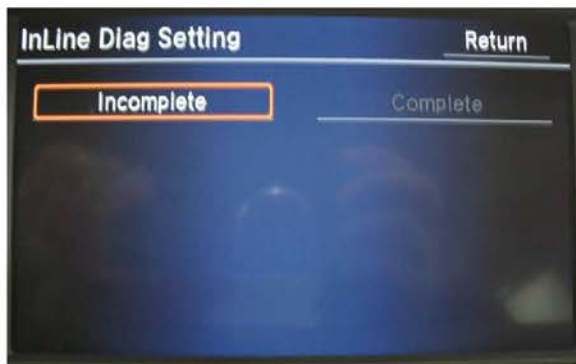
- Move vehicle to an open area. Start the engine if not already done.
- Press and hold the NAVI, BACK, and MENU buttons.
- Press and hold the NAVI button.
- Select **Incomplete**. The system restarts.

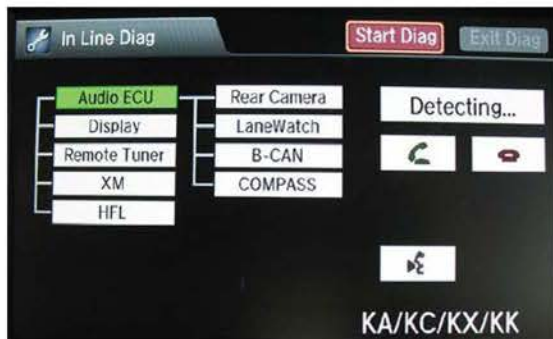
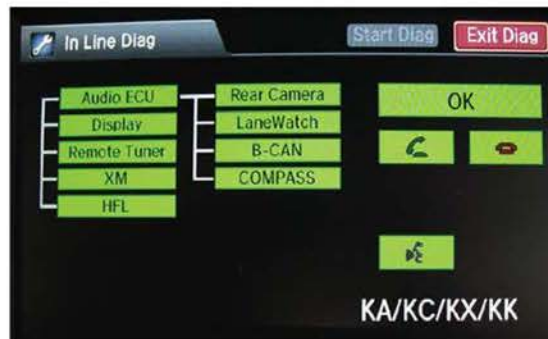
- When the **In-Line Diag** screen appears, select **Start Diag**.
- Make sure all the icons turn Green.

NOTE: To get all icons to turn green, make sure that you do the following:

- Press the Pick-up button.
- Press the Hang-up button.
- Press the Talk button.
- Snap your fingers in front of the microphone to complete the test.
