GROUP <b>ENG</b>	MODEL <b>2015MY Soul (PS) w/2.0L engine</b>
	NUMBER <b>152</b>	DATE <b>January 2016</b>
<b>TECHNICAL SERVICE BULLETIN</b>		
<b>SUBJECT: ECM UPGRADE – MIL ON WITH DTC P0128</b>

This bulletin provides information related to the ECM software upgrade for some 2015MY Soul (PS) vehicles, produced from June 14, 2014 through November 18, 2015, which may experience a malfunction indicator lamp (MIL) illuminated with the Electronic Control Module (ECM) system-related DTC; P0128. To correct this condition, the ECM should be reprogrammed using the GDS/KDS download as described in this bulletin. Before performing this procedure, verify the VIN falls within the production ranges by consulting the table on page 6. For confirmation that the latest reflash has been done to a vehicle you are working on, verify ROM ID using the tables in this TSB.

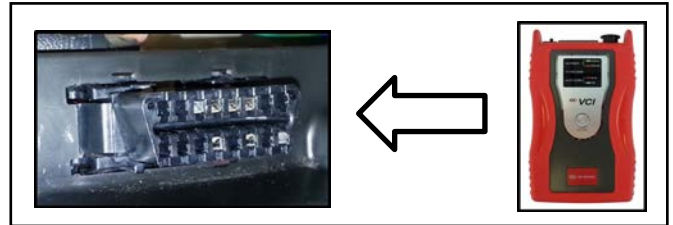
4. Connect the Main 16-pin DLC cable (GHDM – 241000) to the OBD-II connector, located under the driver's side of the instrument panel.

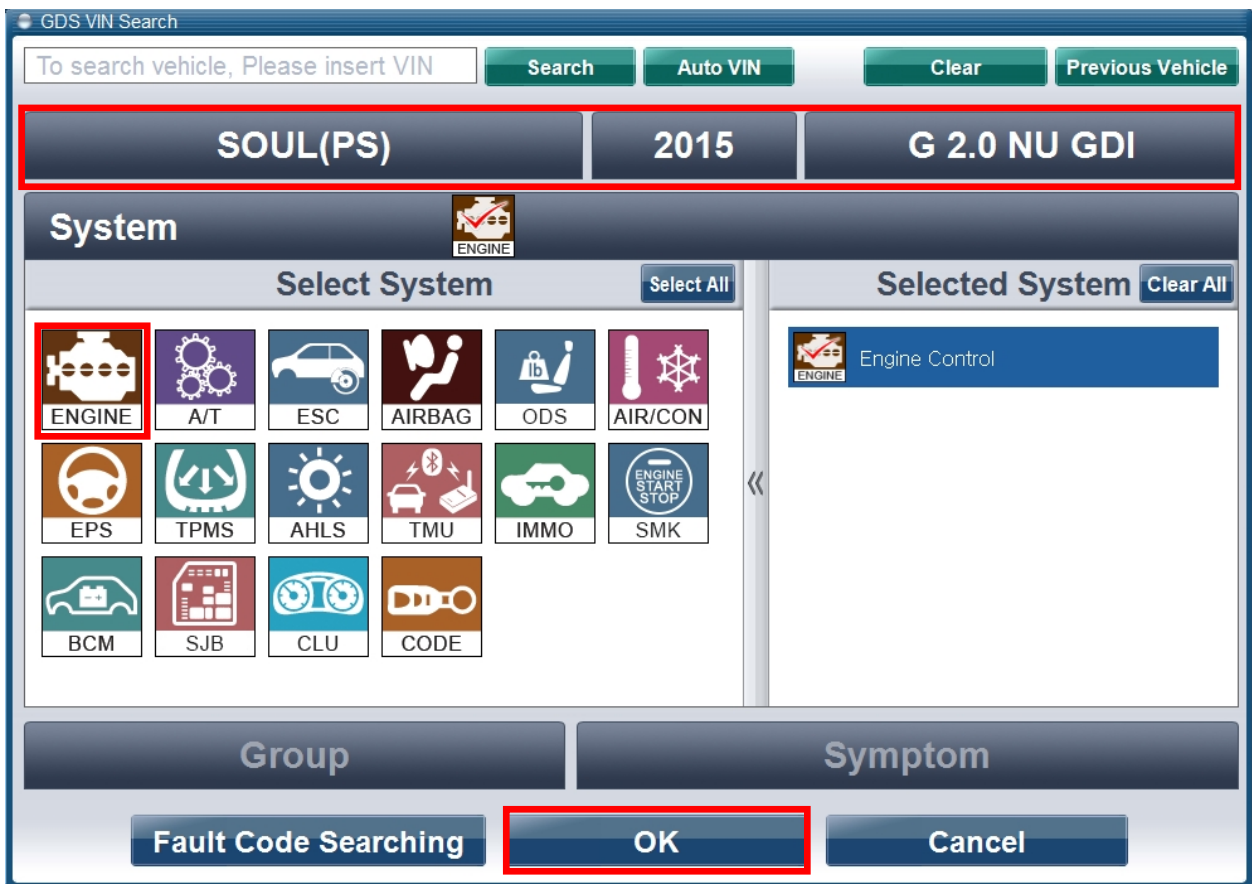
5. With the ignition key ON, turn ON the VCI and GDS. Access the GDS vehicle identification number (VIN) screen and configure the vehicle using the **VIN AUTO DETECT** Function.

6. Select **ENGINE** system, and click **OK**.
