NISSAN BULLETIN

ECM Reprogram Dealer Inventory Service Action

Reference: PC465
Date: June 9, 2016

DEALER SERVICE ACTION PC465 - 2016 TITAN (A61) – ECM REPROGRAM #2

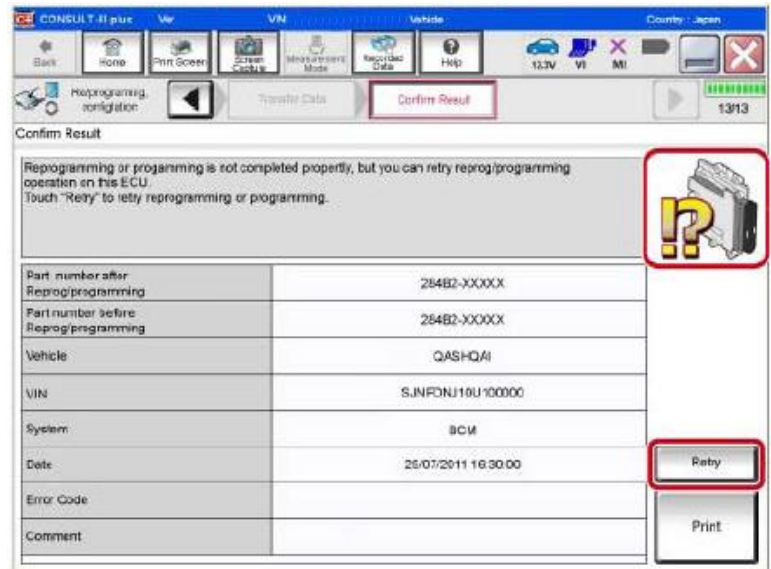
Figure 5

If reprogramming does **NOT** complete and the “!?” icon displays as shown in Figure 5:

- Check battery voltage (12.0 - 15.5 V).
- Ignition is ON, engine OFF.
- External Bluetooth® devices are OFF.
- All electrical loads are OFF.
- **Select retry and follow the on screen instructions.**
- “Retry” may not go through on first attempt and can be selected more than once.
