Service Bulletin

Subject: High Voltage Drive Motor Battery Repair And Exchange Process

Models: 2011-2015 Chevrolet Volt

2014-2016 Cadillac ELR

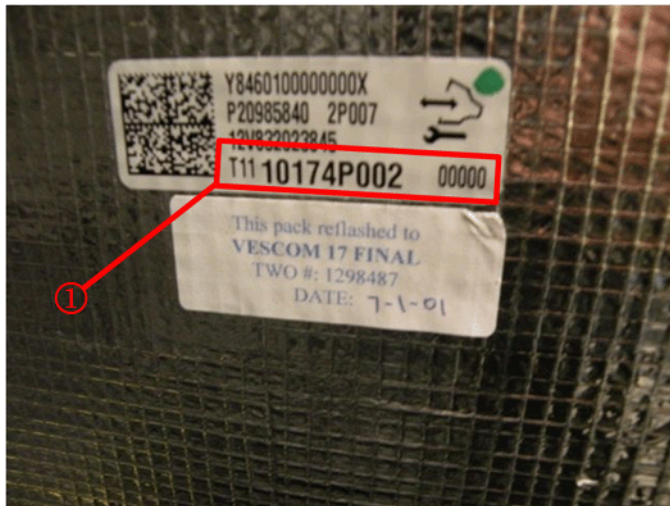
6.2 The battery has two battery identification tags that are located on the front of the battery above the coolant inlet and outlet pipes and an identical tag that is located on the right side of the battery. Locate one of the tags and record the 16 digit battery identification number (BIN). The BIN is the bottom most number on the label and it starts with a "T" indicator (See Photo Below). If the battery is not out of the vehicle yet, you can find the BIN by installing the MDI and using GDS 2. Access the Battery Energy Control Module and look under the identification information section and the sixteen digit number will be listed under the parameter: Hybrid/EV Battery Pack Identification Number.
