Technical Service Bulletin

37K1 UPDATE – TCM Software Update (FED_EMS)

June 14, 2016

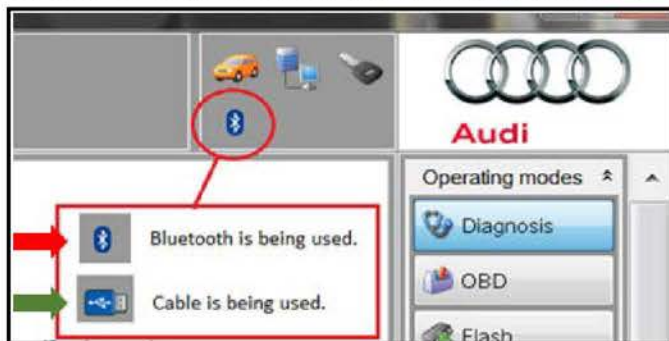
1. Follow all instructions in TSB 2011732: *00 Software Version Management (SVM), operating instructions*.
2. Attach an appropriate battery charger to the vehicle.
3. Attach the scan tool to the vehicle using a USB cable.
4. Confirm that the scan tool is communicating with the diagnostic head by USB <Green Arrow>. If the Bluetooth symbol is shown <Red Arrow> then disconnect the diagnostic head from the vehicle and then reattach the USB cable to the diagnostic head and then reattach to the vehicle.

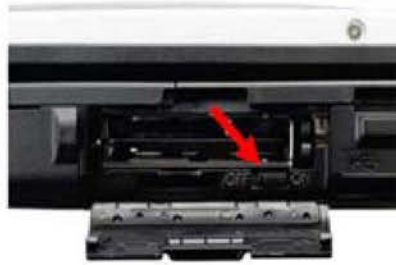
VAS 6150 & VAS 6150A
(Front panel behind handle)

The Bluetooth function of the scan tool **MUST BE PHYSICALLY SWITCHED OFF** prior to performing this update. <See pictures>
