SERVICE BULLETIN

EC16-013d

2016 TITAN XD; MIL ON WITH ENGINE DTCs STORED AND/OR IDLE FLUCTUATION

APPLIED VEHICLES: 2016 Titan XD (A61)

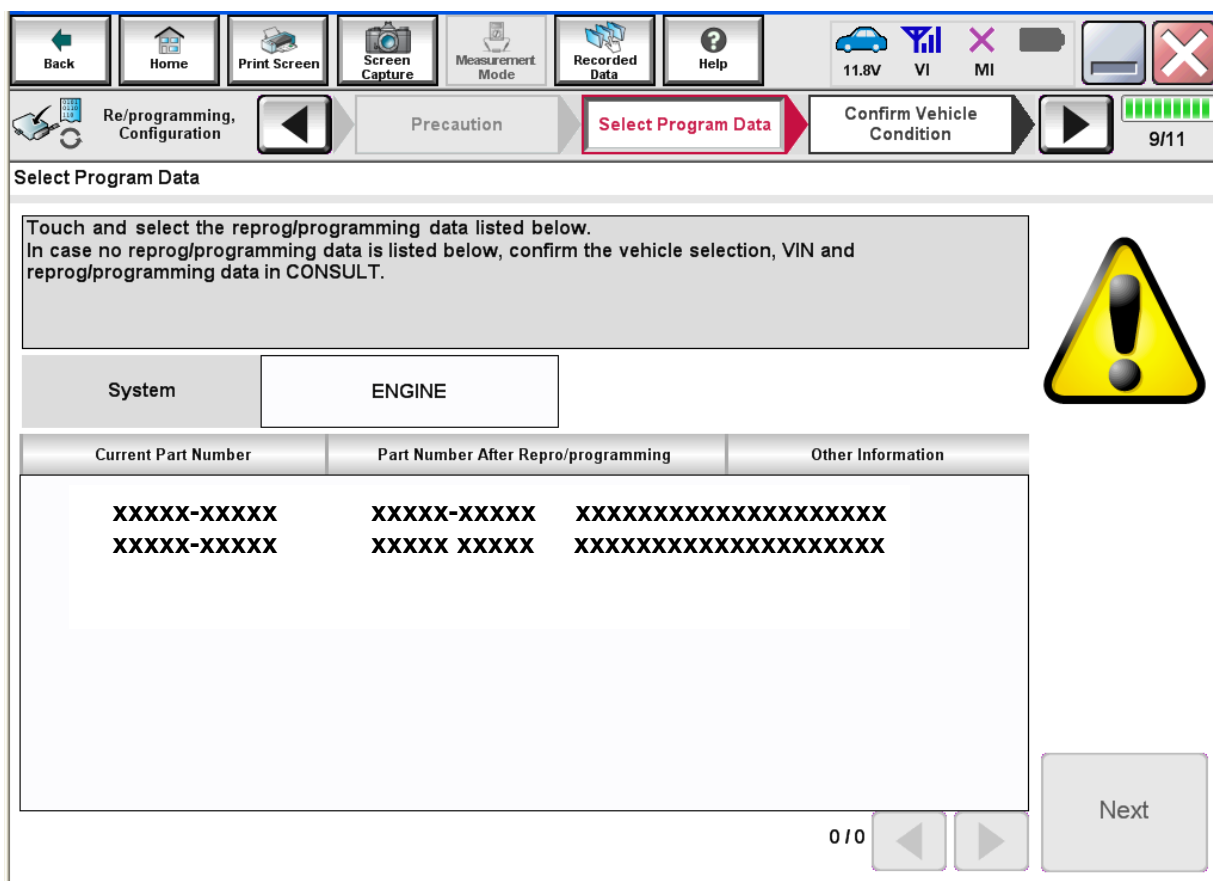
- In some cases, more than one new P/N for reprogramming is available.
 - If more than one new P/N is available, the screen in Figure 3 displays.
 - Select and use the reprogramming option that does not have the message “Caution! Use ONLY with NTBXX-XXX”.
- If you get this screen and it is blank (no reprogramming listed), it means there is no reprogramming available for this vehicle. Close C-III plus and refer back to ASIST for further diagnosis.
