MODEL  
2017MY  
Sportage (QL) w/  
2.0T-GDI/2.4 GDI

## TECHNICAL SERVICE BULLETIN

SERVICE ACTION: TCU UPGRADE – DRIVING  
PERFORMANCE IMPROVEMENT (SA257)

This bulletin provides information related to the TCU (Transmission Control Unit) software upgrade of some 2017MY Sportage (QL) 2.0T-GDI/2.4GDI vehicles produced from December 10, 2015 through October 27, 2016 to improve the gear shift and acceleration performance logic. To apply the improved logic, the TCU should be reprogrammed using the GDS/KDS download, as described in this bulletin. For confirmation that the latest reflash has been applied to a vehicle you are working on, verify the ROM ID using the tables in this TSB. Kia is requesting the completion of this Service Action on all affected vehicles in dealer stock, prior to delivery. Before conducting the procedure, verify that the vehicle is included in the list of affected VINs.

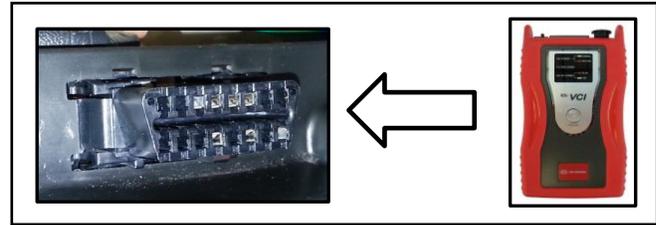
4. Connect the Main 16-pin DLC cable (GHDM – 241000) to the OBD-II connector, located under the driver's side of the instrument panel.

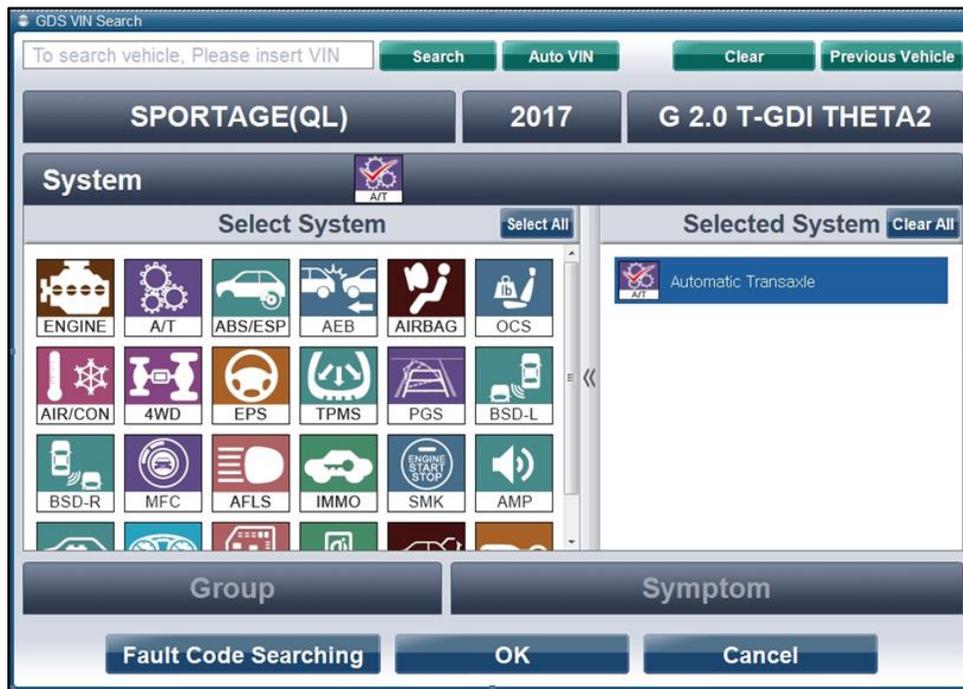
5. With the ignition key ON, turn ON the VCI and GDS. Access the GDS vehicle identification number (VIN) screen and configure the vehicle using the **VIN AUTO DETECT** Function.
6. Select **A/T** system and click **OK**.

**Image shown is for reference purposes only and will vary by model.**

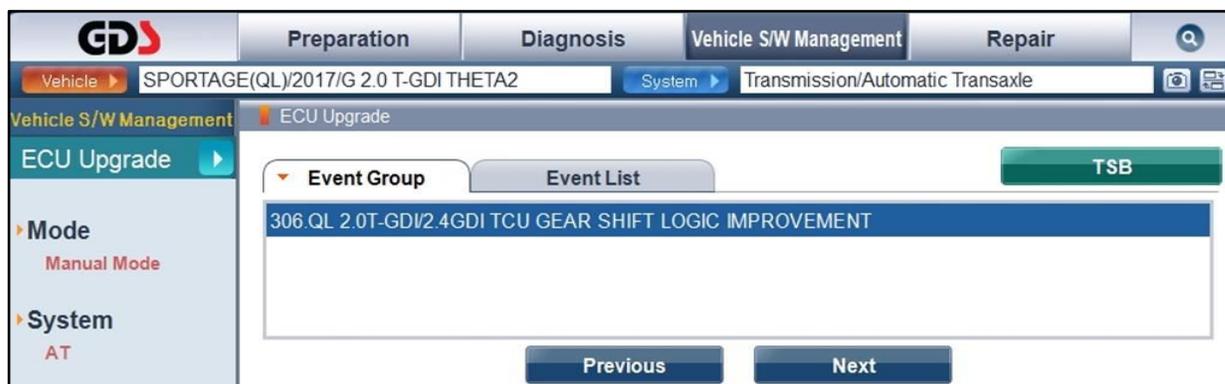
1. Within the ECU Upgrade screen, select **Manual Mode** in the left column, select **AT** and then select **Upgrade Event #306**. Select the appropriate control unit part number by referring to the ROM ID Information Table on Page 3, and click **OK**.
