JTB00512NAS2

TECHNICAL BULLETIN

419-00

Clock 'Loses' Time

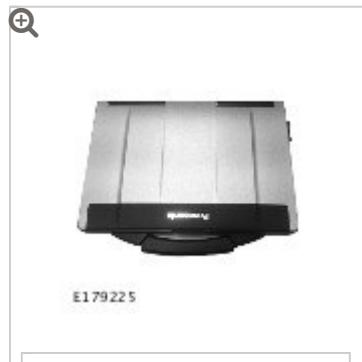
Jaguar Land Rover-
approved diagnostic tool
with latest SDD software
and Calibration File

- A Jaguar Land Rover-approved Midtronics battery power supply must be connected to the vehicle battery during diagnosis / module programming.
- Ensure all ignition ON/OFF requests are carried out; failure to perform these steps may cause damage to control modules in the vehicle.
