JTB00534NAS

TECHNICAL BULLETIN

Windows Will Not Lower/Raise

MODEL:	MODEL YEAR:	VIN:	ASSEMBLY PLANT:
XE (X760)	2016	900466-930368	Solihull
F-PACE (X761)	2017	045000-095600	Solihull

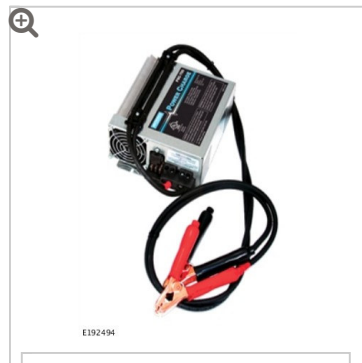
Jaguar Land Rover-
approved Midtronics
battery power
supply

- A Jaguar Land Rover-approved Midtronics battery power supply must be connected to the vehicle battery during diagnosis / module programming.
- Make sure all ignition ON/OFF requests are carried out; failure to perform these steps may cause damage to control modules in the vehicle.

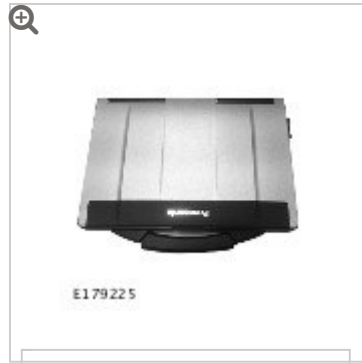
Jaguar Land Rover-approved diagnostic tool with latest SDD software, Calibration File

- 3 Connect the Jaguar Land Rover-approved diagnostic tool to the vehicle and begin a new session.
- 4 Follow the on-screen prompts, allowing the diagnostic tool to read the VIN, identify the vehicle, and initiating the data collect sequence.
- 5 Select **Diagnosis** from the Session Type screen.
- 6 Select the **Selected Symptoms** tab and then select:
 - **Body - Glass panels - Glass movement**
- 7 Select **continue**.
- 8 Select the **Recommendations** tab.
- 9 Select **Run** to perform the '**Configure existing module - Driver door module**' option.
- 10 Follow all on-screen instructions to complete this task, ensuring all Diagnostic Trouble Codes (DTC) are cleared.
- 11 When all tasks are complete, select the **Session** tab and then select the **Close Session** option.
- 12 Disconnect the diagnostic tool and battery power supply from the vehicle.
