# Service Bulletin

Bulletin No.: 15-NA-081

**Subject:** Radio Locks Up and/or Resets, Bluetooth® Pairing, iPhone Loses Pairing, Bluetooth Connection And Audio Concerns, Street Names Flickering, TBT Routing Screen Displayed After Download is Finished, XM Weather Alerts Cannot Be Selected Off, Voice Recognition and Navigation Updates, Various Rear Vision Camera Concerns, Podcast Will Not Play, Cannot Edit Device List

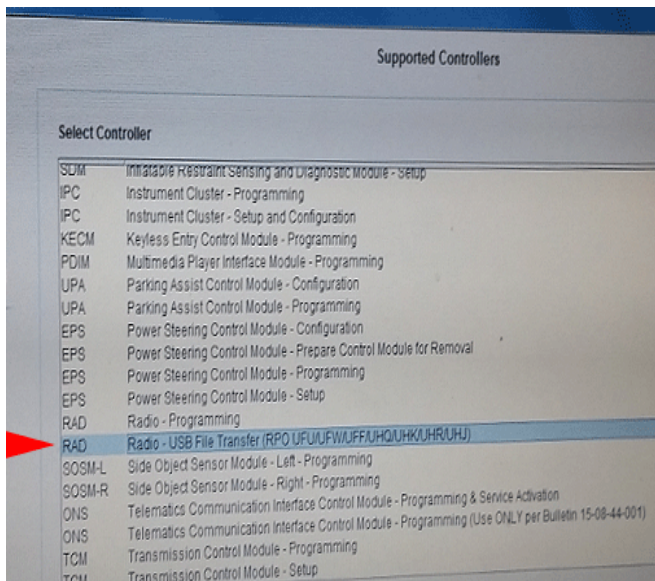
4520348

**Note:** Example of Equinox Supported Controllers Menu

5. Select: RAD/A11 – “RAD/A11 - USB File Transfer - Programming” from the Supported Controllers screen and follow the on-screen instructions carefully.

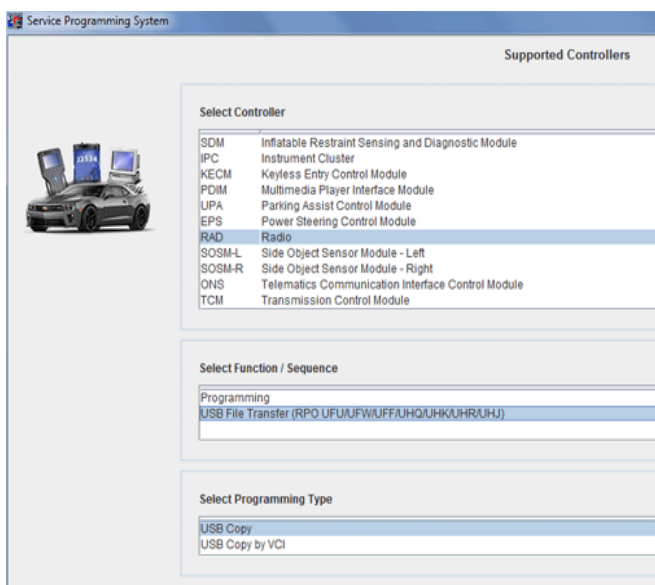
4520663

**Note:** Example of Cruze Supported Controllers Menu

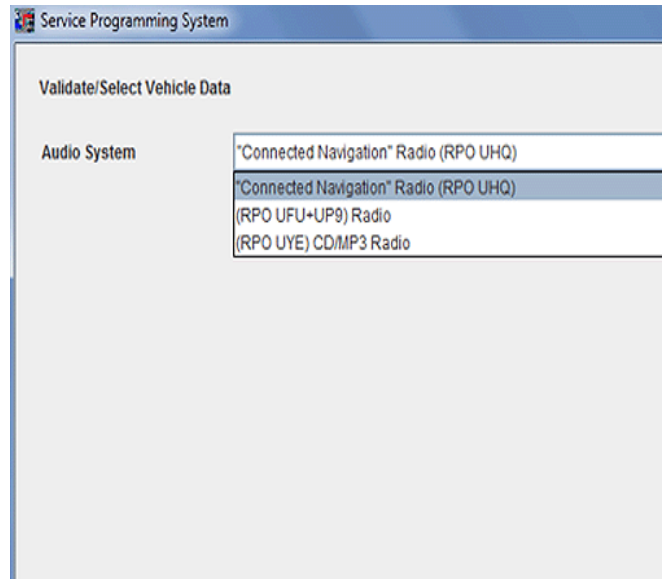
4520352

6. At this point, you *may* be required to select the proper RPO choices for the vehicle you are servicing. Refer to the vehicle SPID label or the vehicle build information in GWM (Global Warranty Management - VIS) to find the specific RPOs that the vehicle is equipped with. Once you have selected the proper vehicle options, click “Next.”

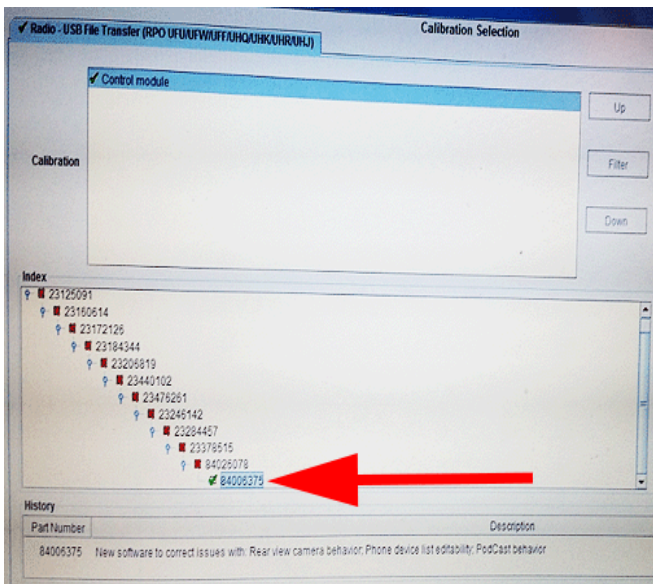
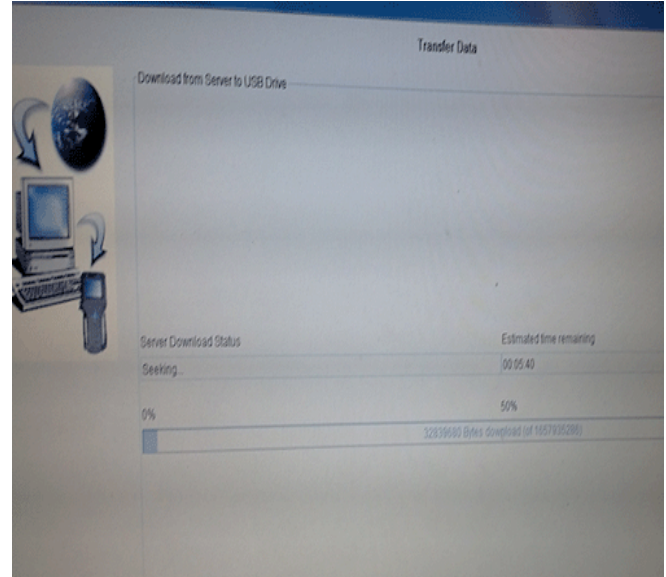
9. Select: NEXT from the TIS2web Calibration Selection and Summary screens as shown above, which will automatically download the latest USB calibration files to your USB flash drive.

**Important:** Note the USB Calibration Part number you are installing, this will be necessary for verification at end of bulletin,

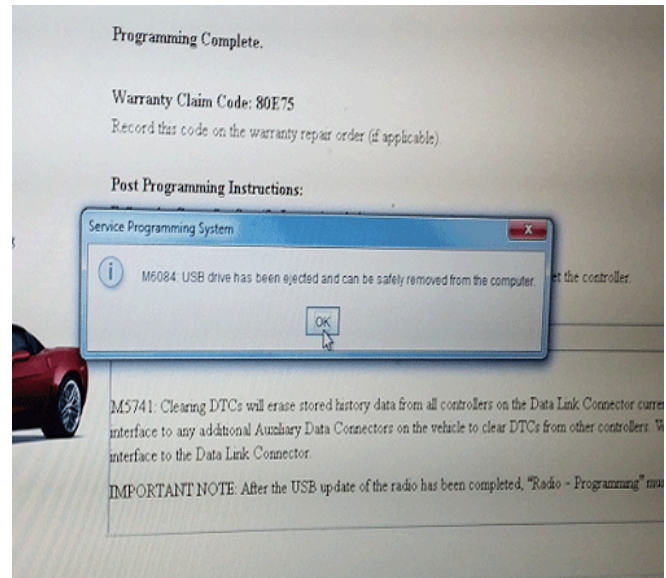
10. Monitor the Progress Status bar at the bottom of the TIS2web Transfer Data screen.

11. Once the Progress Status bar is complete/full and a message like the one above is displayed to indicate that the USB download is complete, remove the USB flash drive from the computer.

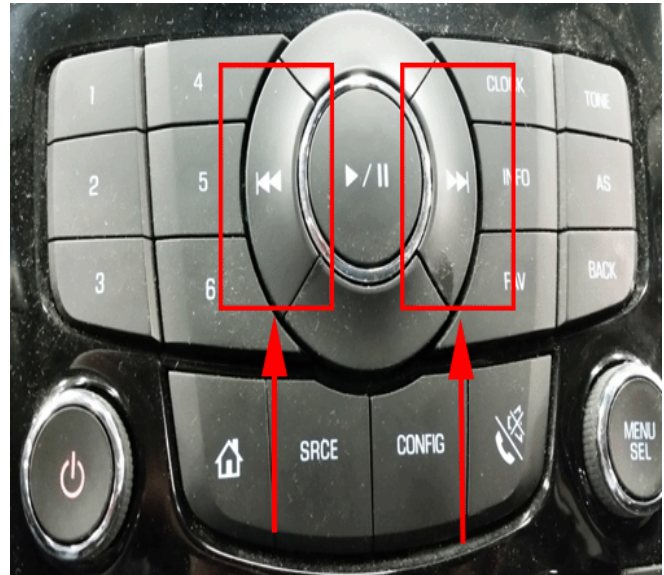
4520665

17. If the "Press the Key Sequence" screen above is displayed, DO NOT press Cancel if displayed. It is important to press the displayed button press sequence on the screen to start the update. This requires the displayed button press sequence to be followed in proper order. Please note that each button press requires a momentary press of the right "seek up" or left "seek down" button (shown in the photo above).

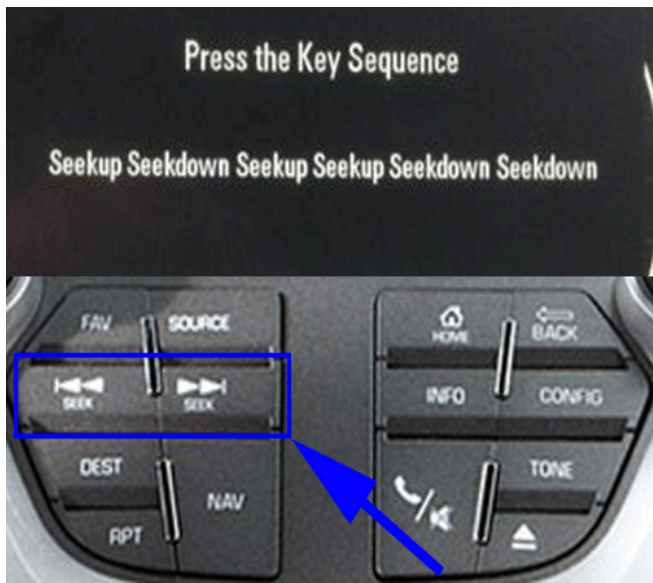
4452607

- (1) Seekup = Arrow Right
- (2) Seekdown = Arrow Left

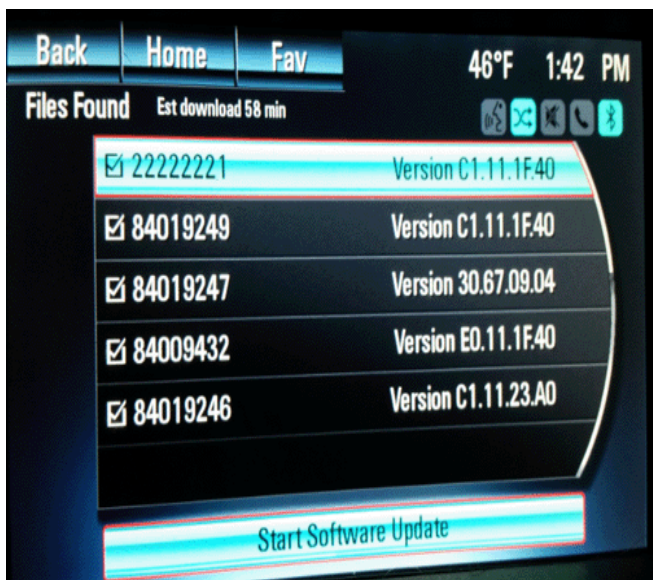
4520372

18. If the screen above is displayed and the update does not start automatically, press "Start Software Update."

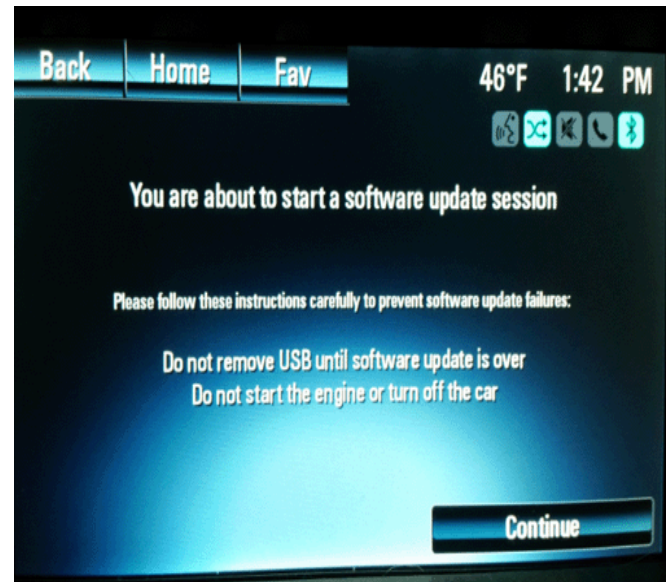
4520373

19. If the screen above is displayed and the update does not start automatically, note the instructions on the screen and press "Continue."

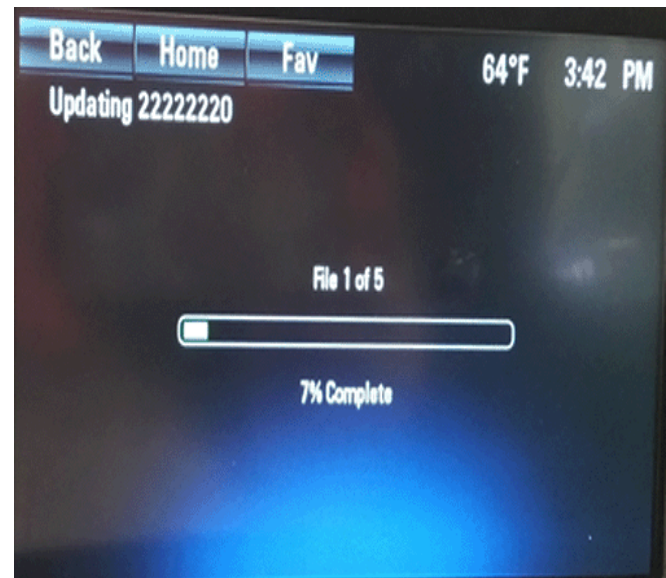
4520377

**Important:** Once the USB programming starts, the technician will see a series of files being installed as shown above and evidenced by a progress bar and "file 1 of 5, file 2 of 5, etc." messages or similar messages depending on year, model, and software. As these files are installing, it is normal to experience a momentary blank screen, loss of audio, and/or "splash screen" after/during installation of file 4 of 5. Do not interrupt programming if this is noted – please be patient and allow programming to completely finish as described below. Typically this step will take 30-60 minutes to complete as USB files 1-5 are installed into the radio.

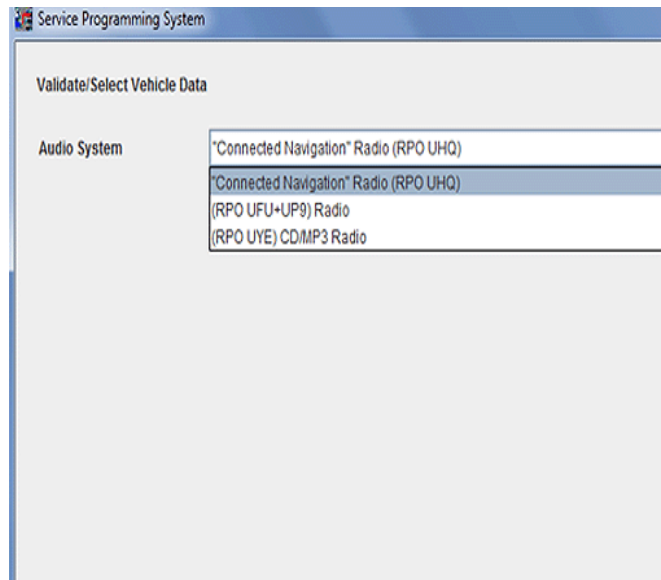
4520379

23. At this point, you *may* be required to select the proper RPO choices for the vehicle you are servicing. Refer to the vehicle SPID label or the vehicle build information in GWM (Global Warranty Management - VIS) to find the specific RPOs that the vehicle is equipped with. Once you have selected the proper vehicle options, click "Next." In some cases, it may start to process the request and then return to this screen. If this occurs, press "Next" a second time to continue.

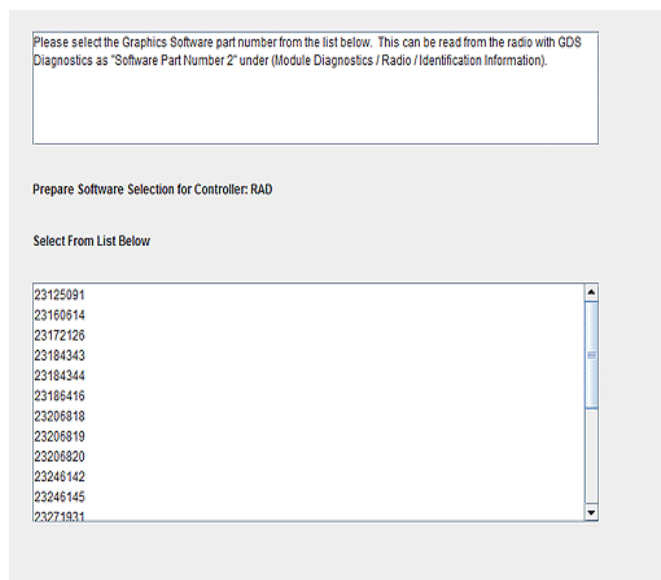
4520380

24. On rare occasions, the screen above *may* be displayed at this point if the USB calibration part number that was just installed cannot be read for some reason when TIS2web interrogates the radio via serial data. If this occurs, close TIS2web, turn

off the ignition, open the driver's door, close the driver's door, wait at least 60 seconds, turn the ignition back on with the engine off, and go back to step 21 to start the SPS programming process again. If this still happens, close TIS2web, connect your GDS2 scan tool, navigate to the radio information screen (Module Diagnostics>> Radio>> Identification Information), and note the "Software Part Number 2" parameter that is listed, which is the USB calibration part number you just installed. Once noted, close GDS2, open TIS2web again, select this part number from the list of TIS2web part numbers, and click next to proceed with SPS programming. This will allow TIS2web to install the correct SPS programming files. DO NOT pick a random number from the list or the wrong SPS programming files will be installed. If the "Software Part Number 2" parameter is not available in GDS2 or your "Software Part Number 2" is not listed in the TIS2web dropdown list, contact Techline (TCSC) at 1-800-828-6860 (English) or 1-800-503-3222 (French) for programming assistance.

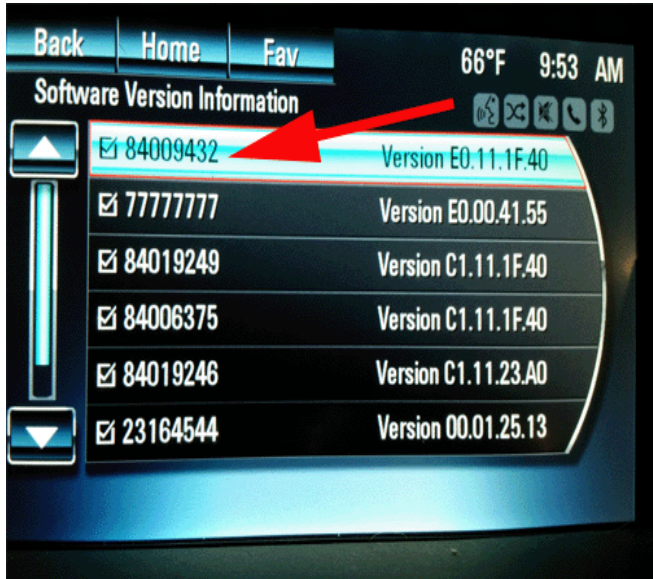
4522820

**Note:** 84006375 is the USB Calibration Part number that was noted during Step 9, 84009432 is the SPS Operating System Part number that was noted during step 25.

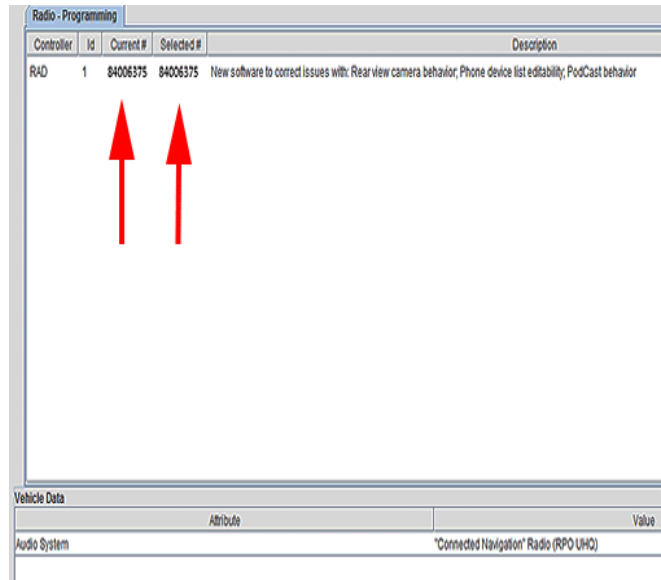
### USB Calibration Summary Screen

- Press the following radio button sequence HOME>>CONFIG>>RADIO SETTINGS>>SOFTWARE VERSIONS MENU>>SOFTWARE VERSIONS INFORMATION.
- Compare the “current” and “selected” calibration numbers displayed on the USB and SPS Summary screens as shown below and in steps 9 (USB) and 25 (SPS) to ensure that they now match each other. A related pop-up should also be displayed to advise that you are attempting to reprogram with the same calibration again – press “Cancel” to abort the programming process if the “current” and “selected” calibration numbers displayed on the USB and SPS summary screens match.
