Title: Ambient Air Temperature (AAT) Sensor Faults/Location/Diagnostics

Applies To: Navistar N13 Engines and Cummins ISX Engines Cummins ISB, N9 and N10

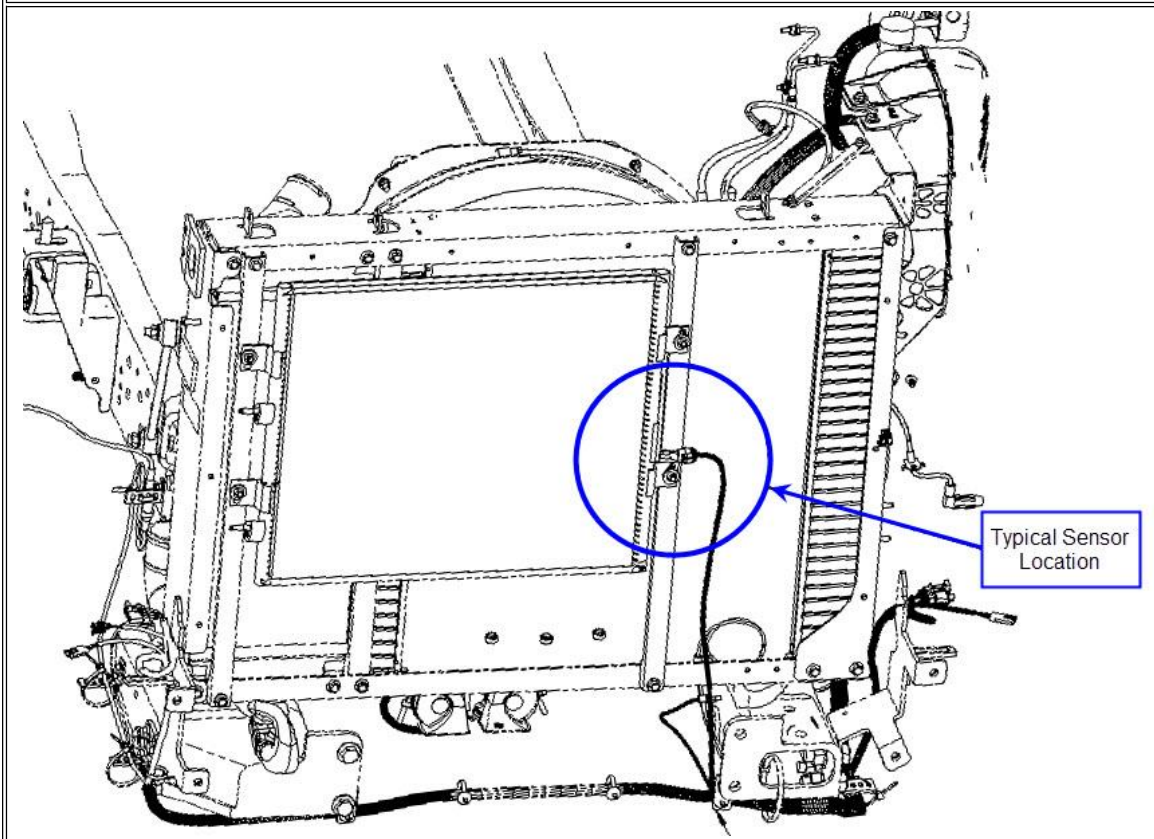
Figure 2

The Cab Temperature Sensor is typically mounted near the front bumper or on the cooling package. If the sensor cannot be found verify the wiring to the gauge cluster is present or that the outside air temp monitor feature as ordered on the truck.

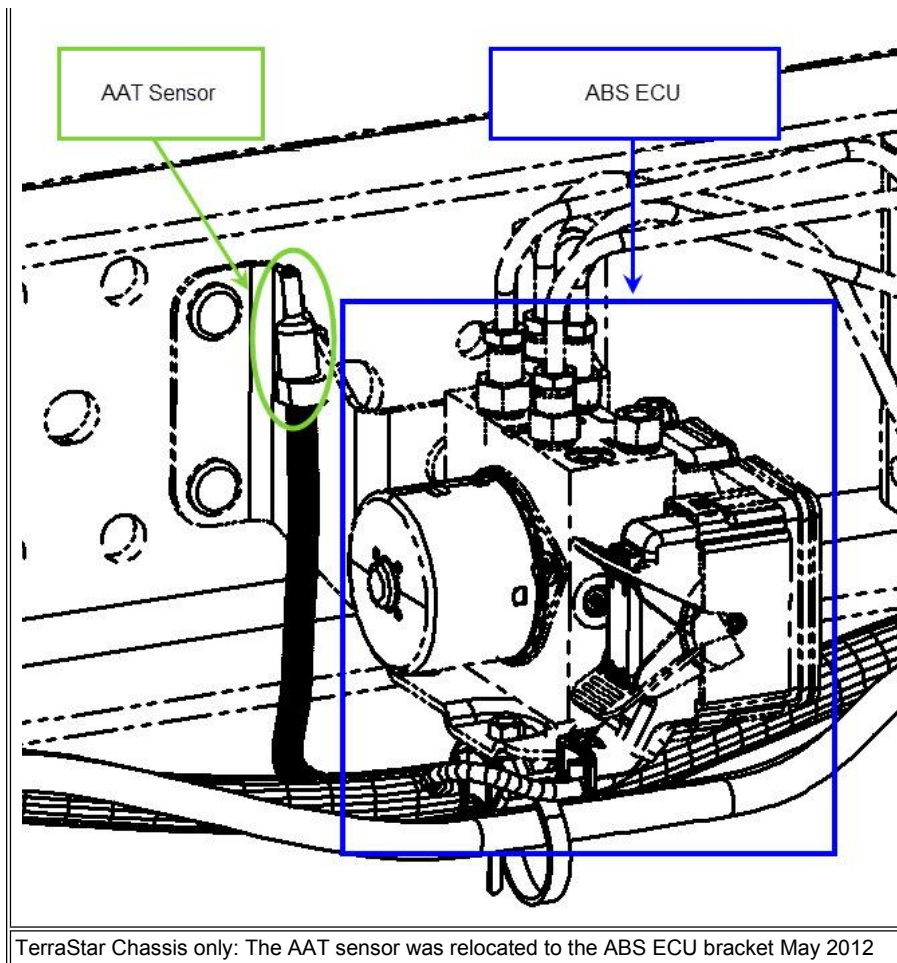
Figure 3

Medium Duty Chassis Standard Mounting Location for Cluster Sensor

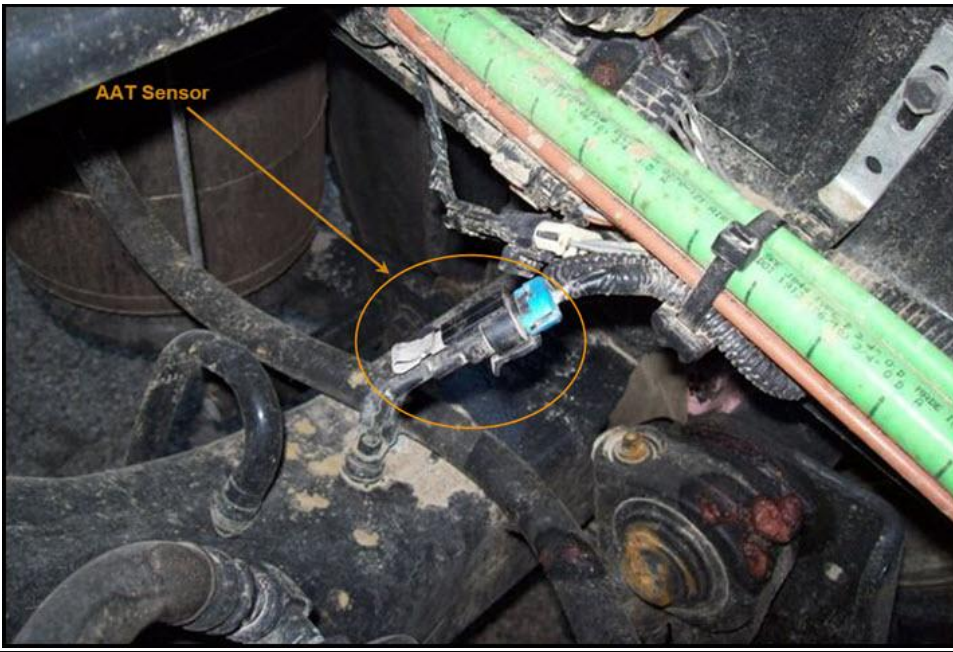
The engine sensor is located on the left frame rail midway between the back of cab and front drive axle, or near the front drive axle. The two photos below show both possible mounting locations (*Figure 4 and Figure 5*).

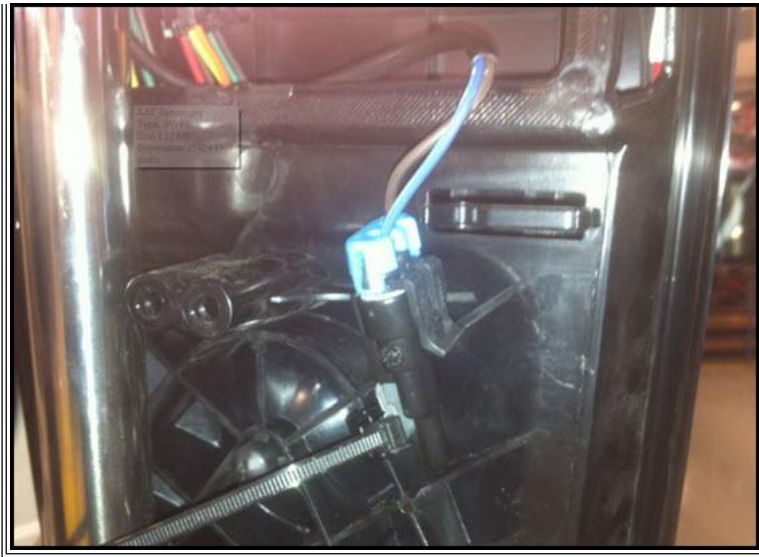
**Big Bore Post August 2013 build w/SCR engine, driver's side mirror head (Figure 6):****Figure 6**

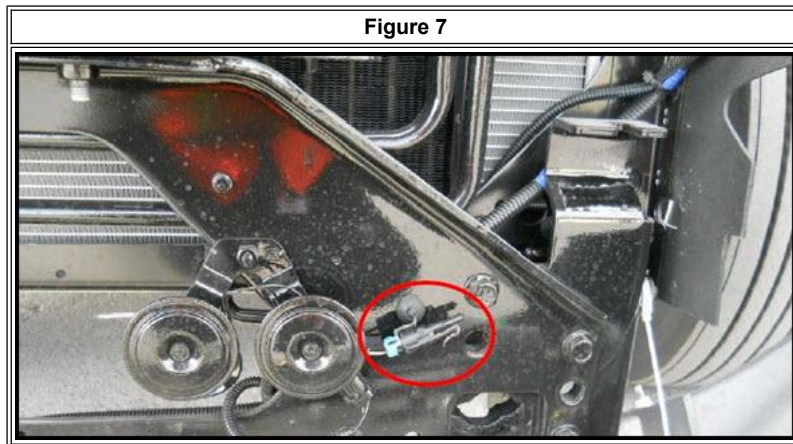
ISX15 and N13 Alternate Location (Figure 7):

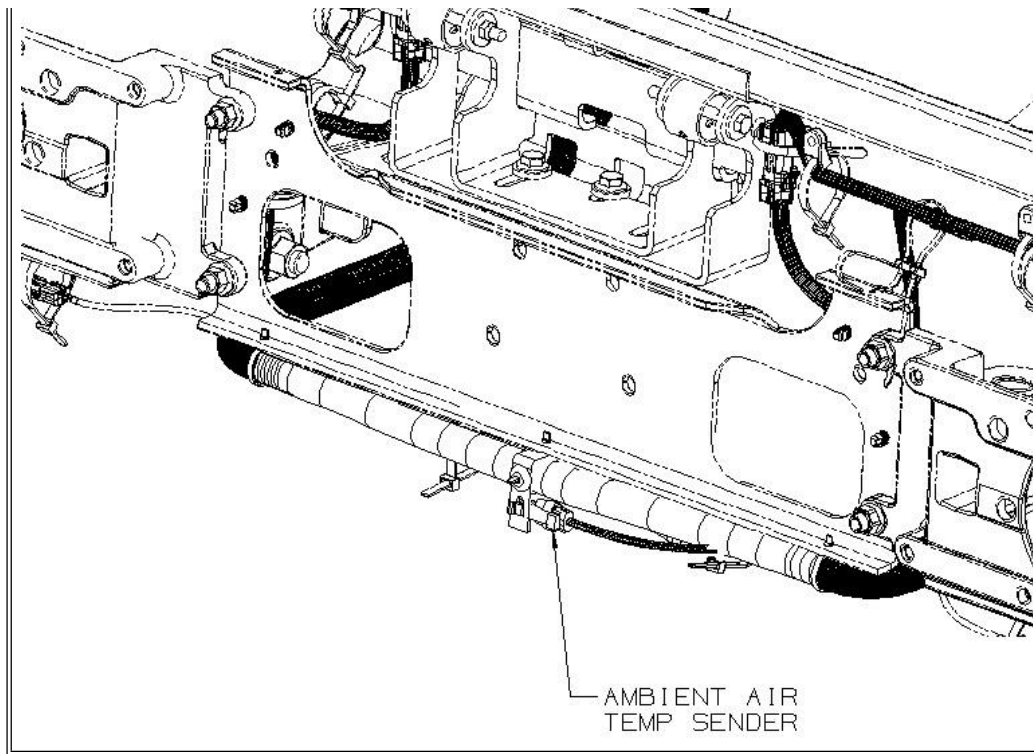
ISX15 and N13 Alternate Location PayStar / 9900i (Figure 8):

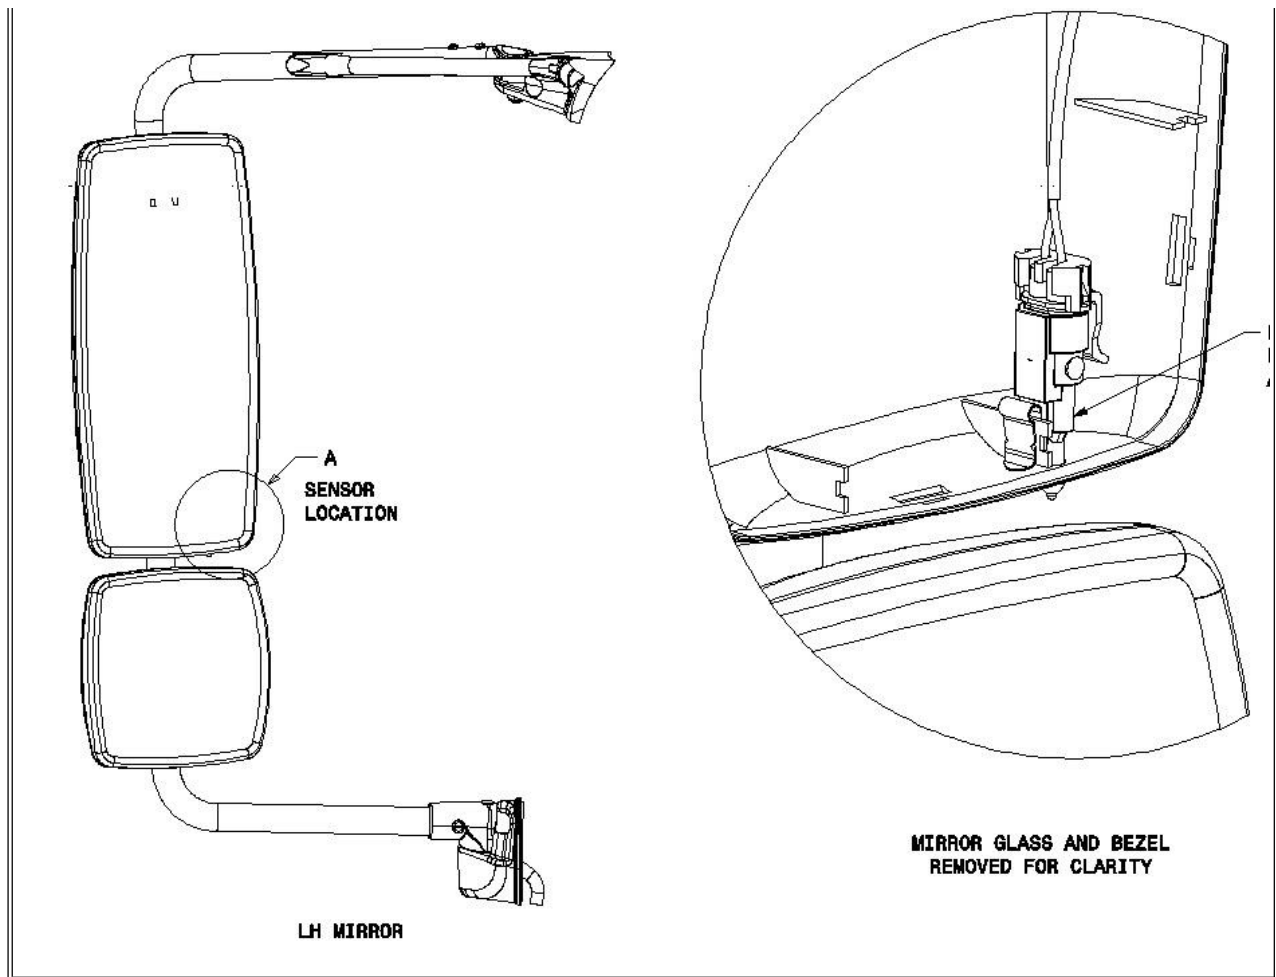
Figure 9

N9/10 and ISB engine platforms moved the Engine AAT to the driver mirror on August 8, 2014 (*Figure 9*):

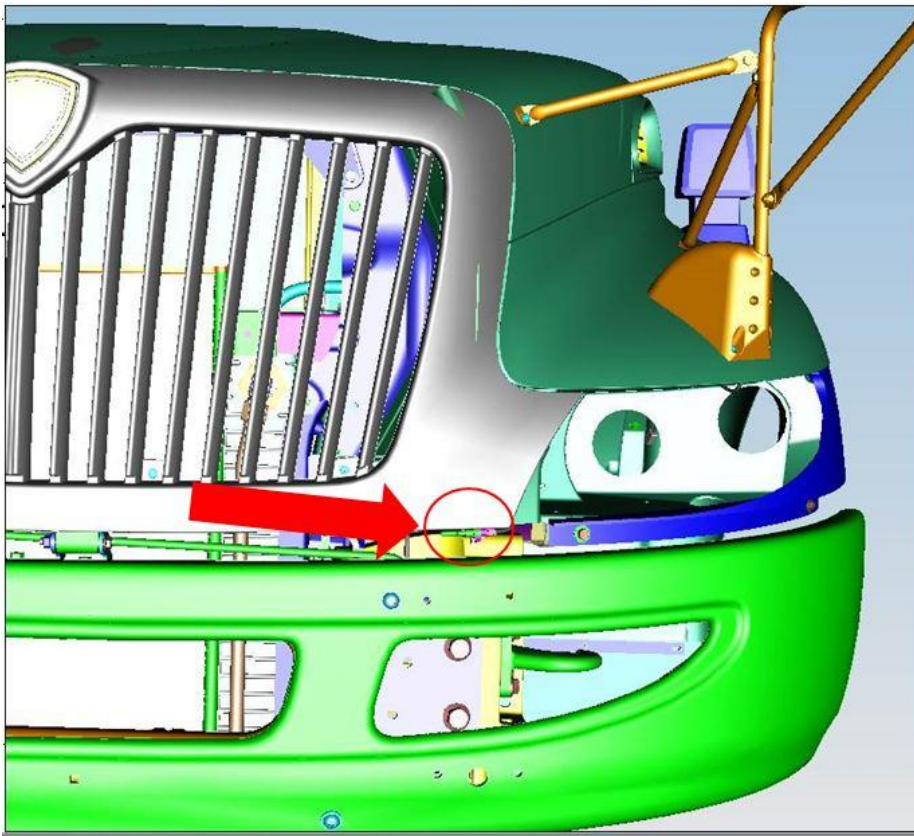
Location prior to August 8, 2014 on CE Bus
