**Title:** 2659-10 Slow EGR Response Diagnostics

**Applies To:** EPA 10 N13B Engines

This document is intended to provided updated diagnostics for fault code 2659-10 in N13B engines.

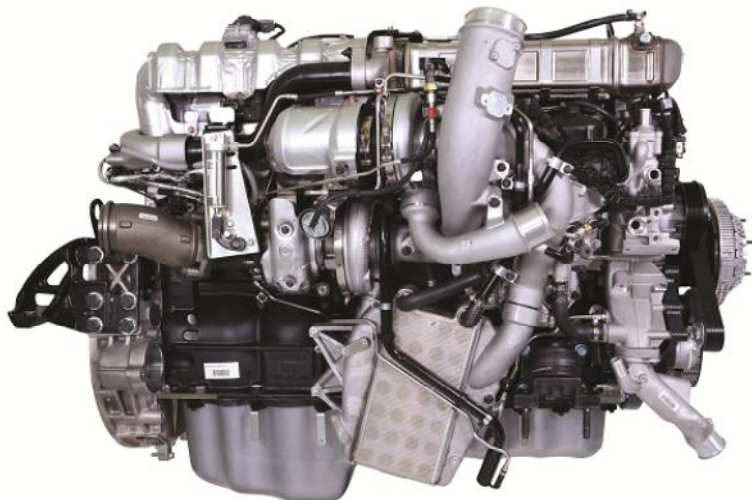
**N13B Identification by ESN 4400001 and up**

**N13B Visual Identification (see image below)**

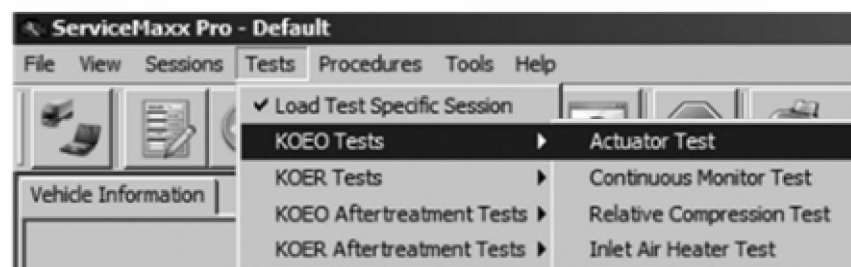
Figure 811 Selecting Actuator Test

1. Key-On Engine-Off (KOEO)
2. Connect Electronic Service Tool (EST) to Vehicle Diagnostic Connector and launch ServiceMaxx™ software. (page 2010).

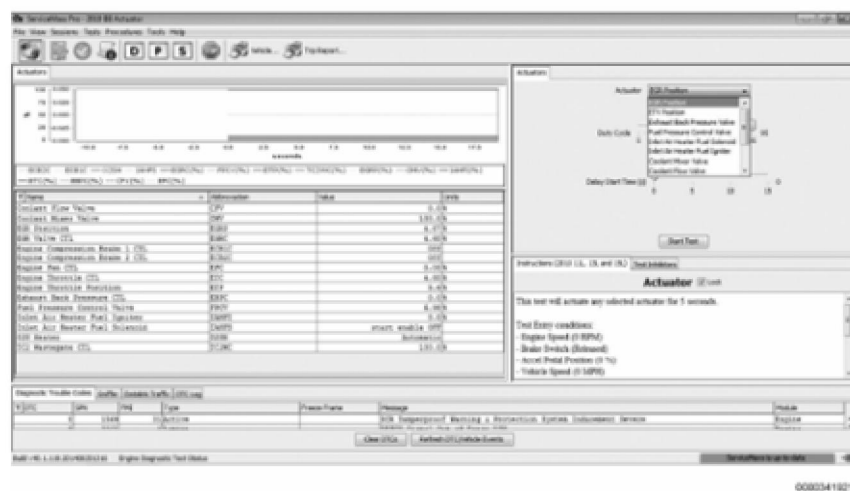
Figure 812 Actuator Control Panel

- From the actuator control panel (Figure 812) select EGR Position and set duty cycle to 95%.
- Press the Start Test button and monitor the EGR Position (EGRP) signal to see if EGRV can meet commanded position.
- After monitoring EGRP signal, set desired delay time to run actuator test again and visually monitor EGRV movement.
- Verify duty cycle is at 95% and press the Start Test button.
- With front EGR bellows(between EGR cooler and EGRV) removed, monitor EGRV movement. Check for debris and carbon build-up in EGRV.
- Repeat steps 2–6 with duty cycle set to 15% in steps 2 and 5.
