05269 Version 2

Emissions Recall: 2017 HR-V PCM Incorrectly Adjusts Air to Fuel Ratio

Supersedes 16-103, titled *Emissions Recall: 2017 HR-V Primary Converter and AF Sensor Deterioration*, dated November 10, 2016 to include SOFTWARE INFORMATION, WARRANTY CLAIM INFORMATION, and REPAIR PROCEDURE.

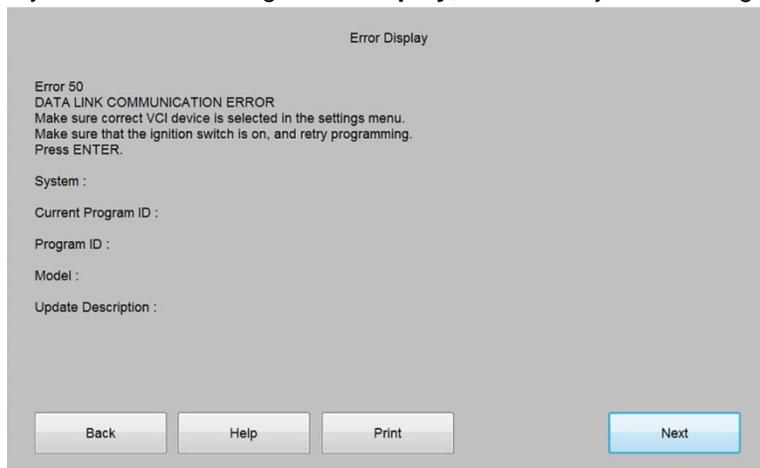
- You can't update the vehicle using the MVCI as a standalone tool.
- **Do not** use the MongoosePro VCI tool.
- Make sure the 12-volt battery is fully charged before starting an update.
- Connect a fully charged jumper battery to the vehicle, and leave it connected during the entire procedure to maintain steady voltage.
- Never turn the ignition to OFF or ACCESSORY during the update. If there is a problem with the update, leave the ignition turned to ON.
- To prevent PCM damage, do not operate anything electrical (headlights, audio system, brakes, A/C, power windows, door locks, etc.) during the update.
- If you see the following **Error Display**, check that you are using the correct tool (MVCI or DST-i) with the i-HDS.

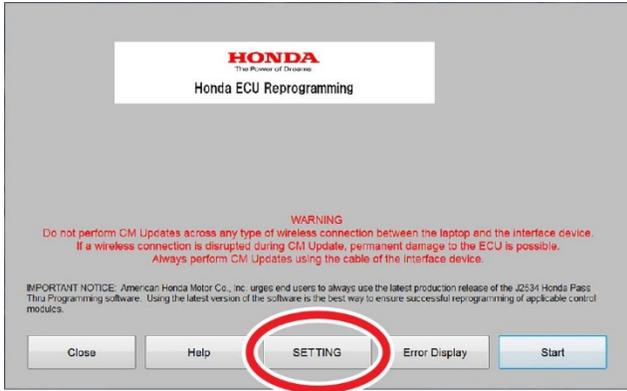
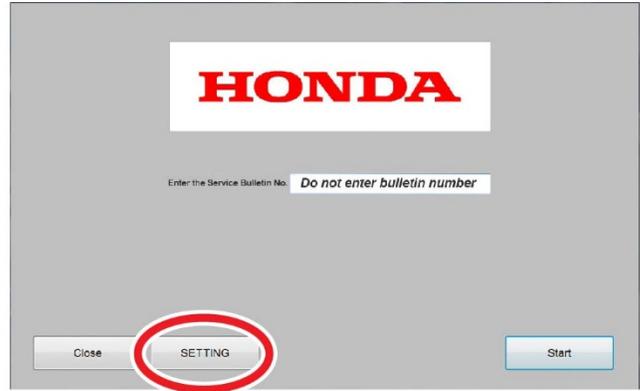
To change this, click on either of the **SETTING** selection buttons at the bottom of the J2534 initial screens as shown.

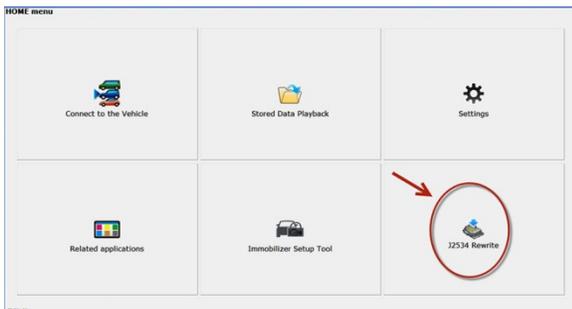
2. Select **J2534 Rewrite**.

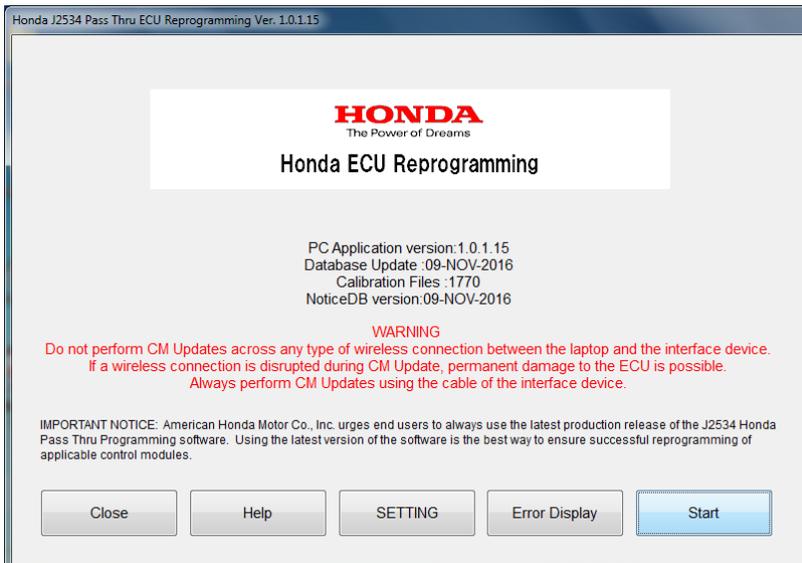
3. Confirm the software is the same **or later** as listed in SOFTWARE INFORMATION.

- Select **Start**, then follow the screen prompts.

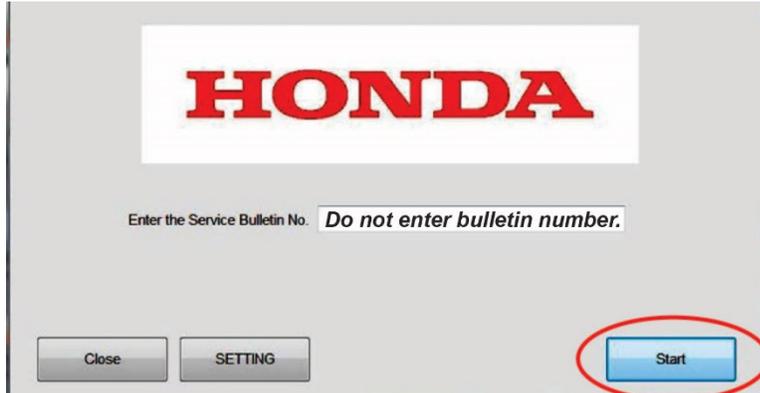
- Don't enter a bulletin number.**
- If you receive a message that the vehicle has been already updated or that no update is available, check the PGM-FI data list. The header should indicate one of the following numbers (or later).

37805-51M-C02	37805-51M-C12	37805-51M-C52	37805-51M-C62
37805-51M-C72	37805-51M-C82

- If the program part numbers do not match those listed above, the i-HDS software needs to be reinstalled. Contact the Special Tools Hotline at **800-346-6327** for assistance.
